# The Bulletin

Vol. 36 no. 3 Autumn 2011 [www.bvws.org.uk](http://www.bvws.org.uk)

- 2 Advertisement
- 3 From the Chair
- 4 The infamous 'Personna' pocket 5, kit radio
- 9 Exhibition of John Elgar-Whinney collection of covert equipment at NVCF
- 12 Ekco A22 rebuild
- 16 An Aussie Treasure – the story of an Australian Radio Museum
- 18 A Medium Wave AM Transmitter for the Home
- 24 Garden Party at the British Vintage Wireless and Television Museum
- 25 Restoring an HRO-500
- 28 Repairing a Vega Selena 215 multi band radio
- 30 The restoration of an unloved HMV 907
- 34 Pictures from Wootton Bassett August 14
- 36 The Philips 660A
- 39 Direct Action Tuning
- 40 EKCO exhibition and symposium at Southend Central Museum and Library
- 44 Letter
- 45 Some Observations on a Cossor Melody Maker 501AC Chassis
- 46 BVWS Books
- 47 Advertisements
- 48 Advertisements
- 49 Advertisements, back issues
- 50 News, Advertisements
- 51 The BVWS Spares Department

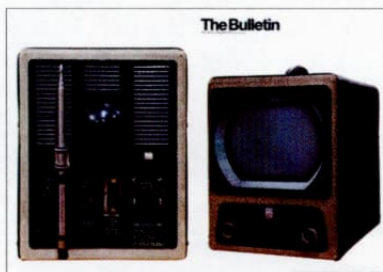
Front and rear cover: Ekcovision type TMB.272 portable television receiver, 1955.

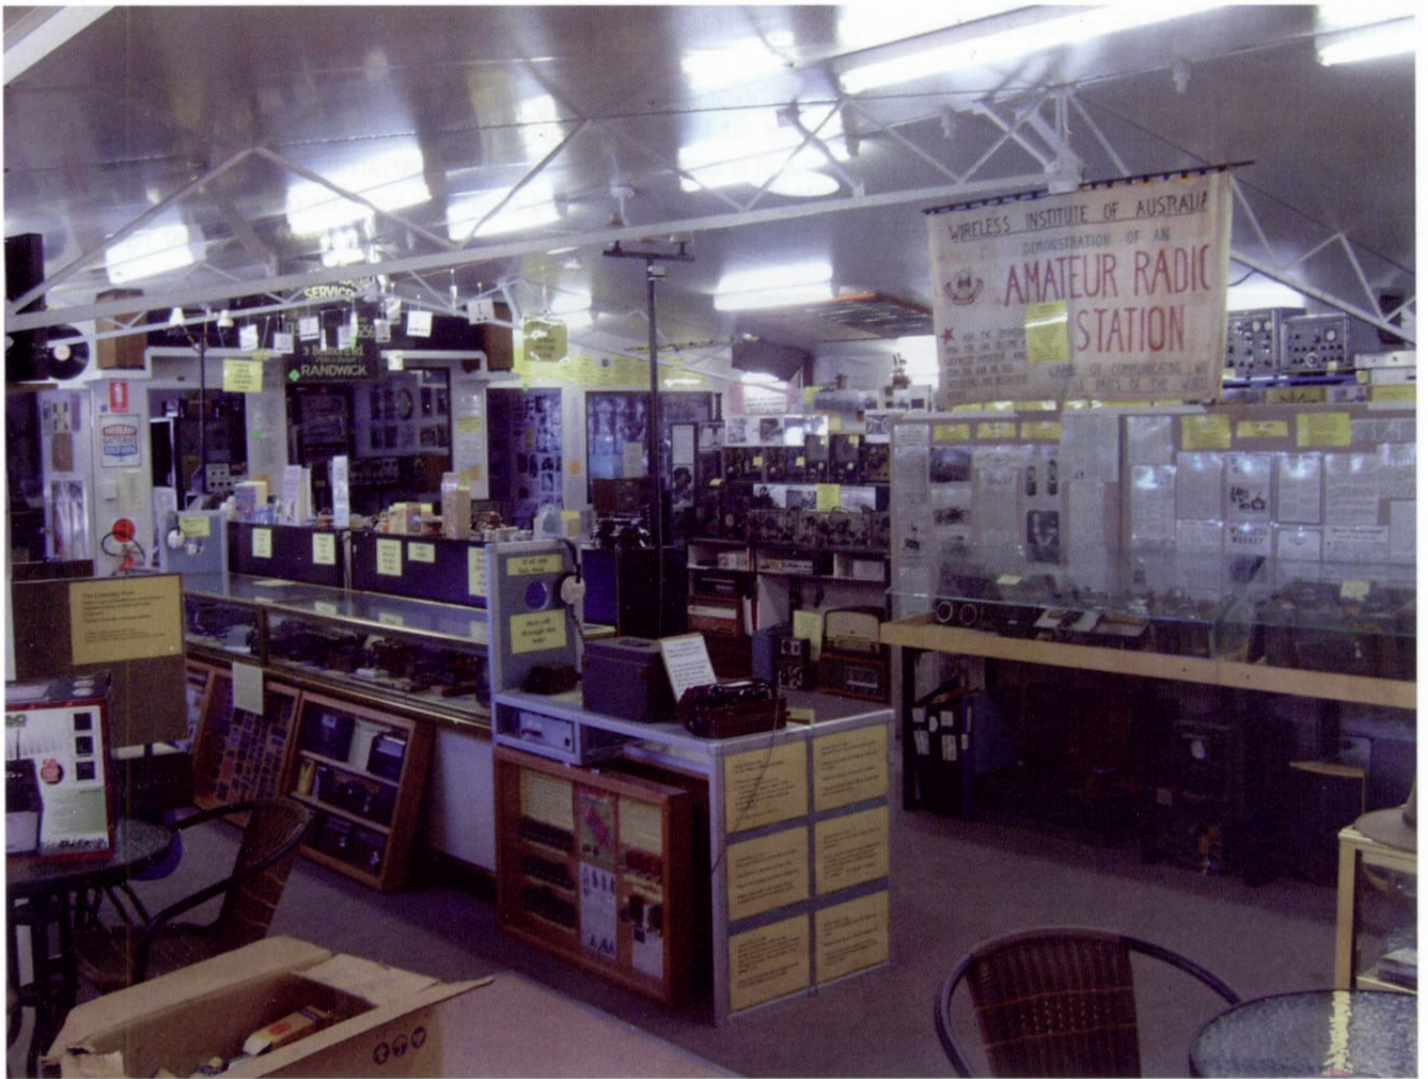
5

5: Booths accommodate an individual's learning requirements, whilst a small theatre is used for a group session. The static displays are all clearly identified in their respective sections. Equipment from most major countries is represented, ranging from domestic to military. There are also exhibits of early telegraph, telephones and test gear, both ancient and modern.

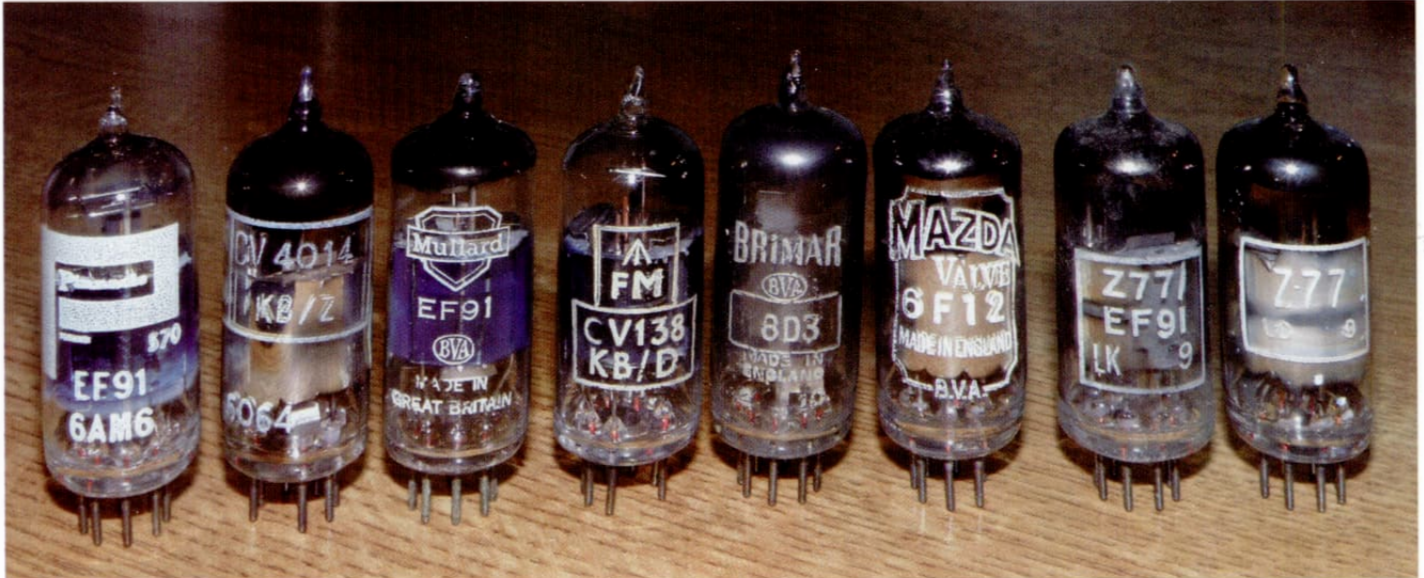
Figure 1: A line-up of a few different 'EF91s'.

Figure 1 shows a line-up of a few different 'EF91s'. When you're looking for the EF91s for this project, any of these valves should do the job, and as you can see valves are often marked with more than one number. I particularly like the bluish colour of the glass around the anodes in the Mullard valve, and the reason for this is interesting.

Inside the EF91 (and similar valves) the anode runs round only part of the cathode/grid structure, and so a significant number of electrons pass through the grids and the gaps in the anode, and into the glass envelope. It was found that this gradually caused gas to be released from the glass, and over the extended lifetime of high reliability valves required by, for example the GPO, it was sufficient to impair the efficiency of the valve and to shorten its life. Therefore, the centre part of the glass envelope was coated (by vacuum deposition) with a chemical. This kept the electrons from the glass and thus reduced the gas released, and thus lengthened the working life. The actual colour of the coating varied with the temperature of the firing, and has no significance.

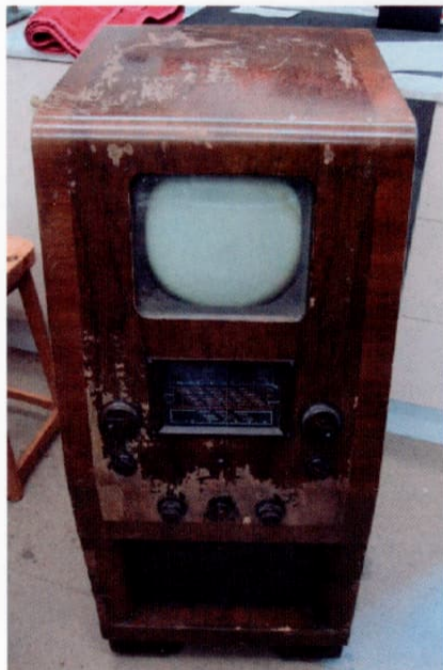
The television as found

Shortly afterwards a call came from the owner to say that he had another television for me to look at, but his time it was in a bad way. When it arrived, I was delighted to see it was an HMV907 pre-war 9" set, but it was clear it had been given a hard life and even suffered an arson attempt, but the HMV was built of better stuff and had survived. Initial inspection showed the set had been stored in the damp for a considerable time, and the veneers to the front around the control knobs had been lifting up and ripped off where loose. This was true of other areas as well. The side of the cabinet had suffered severe burning which had gone right through the veneer and layers of the ply cabinet. This was going to be a long job! My attentions then turned to the internals which, on opening the back hinged cover, appeared to be untouched for many years. It had at some time been fitted with replacement electrolytics, both on the receiver chassis and the tubular smoothers on the power chassis which were dated August 1948. The EHT smoothing capacitor block had also been replaced by two Visconol units. All the paper and electrolytic capacitors would in time be removed and re-stuffed with new components and a new EHT capacitor block and receiver chassis capacitor block would be made to replace the original units.

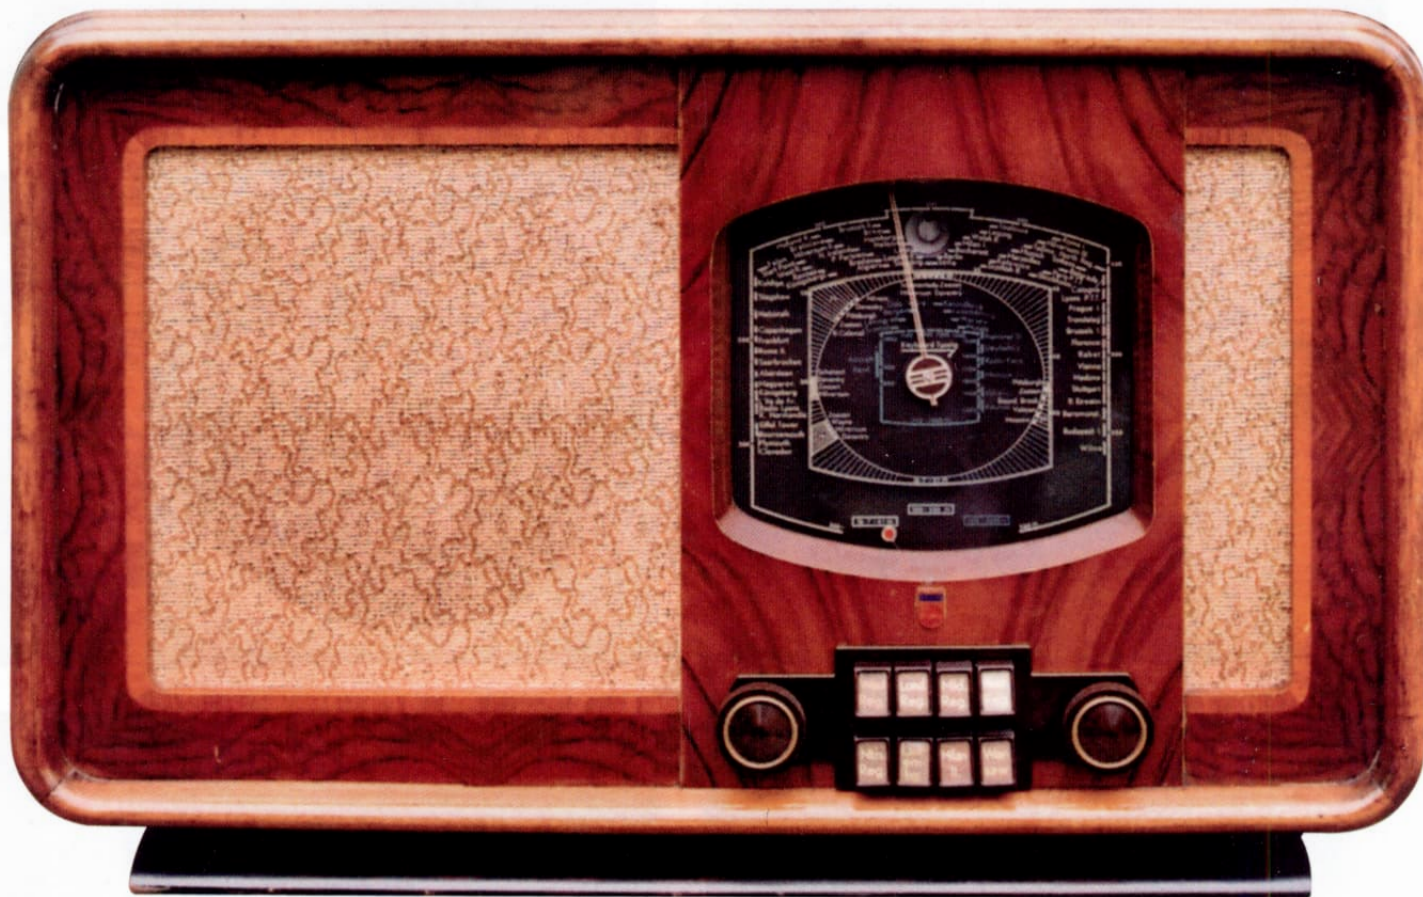
The Philips 660A of 1938 has all the features that one can expect a good Philips from the era to have. It has the quirky but efficient chassis, a notorious drive cord system coupled with a unique tuning device, audio feedback loops and handsome good looks with a sparkling performance. It even manages to incorporate a Bowden cable. 1938 was generally a big year for press button tuning, it became the latest fad. Many different systems were evolved, but the special type of tuning capacitor used by Philips in the 660A meant that it was particularly suited to this type of operation as we shall see. Eight press buttons were provided for preset tuning in addition to there being normal manual tuning across the long, medium and short wavebands. Receiver operation was from AC mains with the familiar carousel type selector catering for a wide range of supply voltages.

Much thought has gone into the cabinet design. It is neat and uncluttered whilst remaining very pleasing to the eye. All of the tuning controls are situated at the front and all of the sound controls are at the side. The lavish veneers, curves, rounded dial and brass inserts to the knobs give it a fresh, continental aura. It was probably designed in Eindhoven. By contrast to the rest of the set, the dial is very busy indeed; in fact no less than 105 stations are marked if one includes the aircraft band! This gives a clue to its capabilities. All manner of stations are marked here. The Scottish region rubs shoulders with Katowice and London becomes neighbours with Linz. At the top centre of the dial, the crowded stations respectfully part to allow the emerald glow of the magic eye to shine through. At the bottom of the dial is a waveband indicator driven by bowden cable.

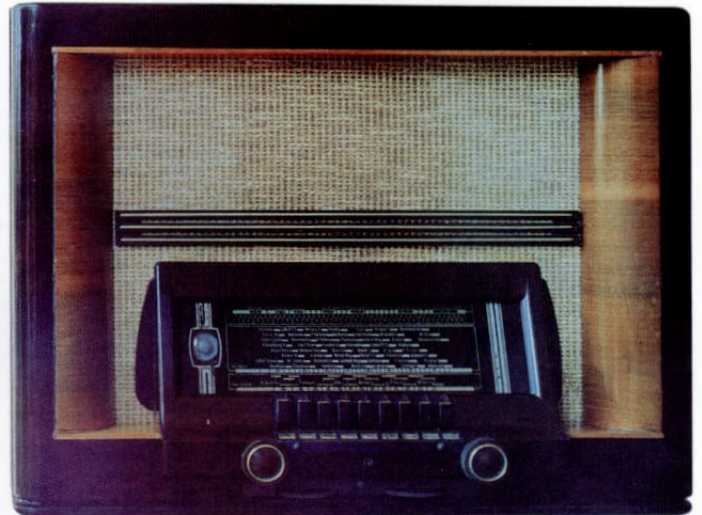
Philips 555A

Philips obviously took all these objections to heart, and the next range of sets, which came out for the 1939 Show, was much more civilised. What they did was to change the press buttons to piano type keys. These turned a shaft which moved the pointer by means of a crafty arrangement of bell cranks, so that it would work at sufficient speed. This shaft also carried a crank, which pushed the

tuning capacitor into position. It was also arranged that this shaft could move the bandswitch if desired. Further, the tuning capacitor foils were tapered, so that the dial drive could be linear.

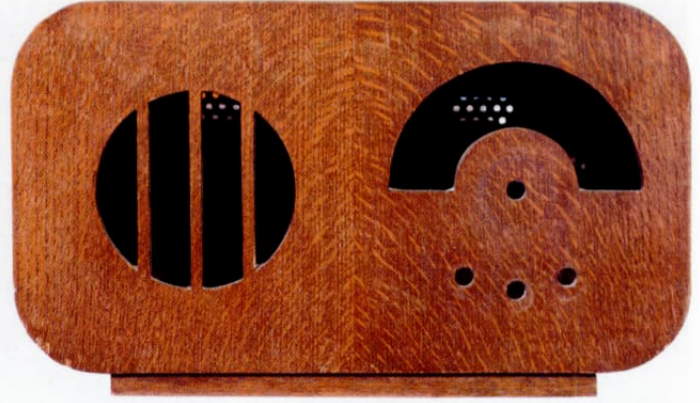
Prototype cabinet for testing fit of Ekco AC85 chassis.
