The Bulletin of the British Vintage Wireless Society

Bulletin of the British Vintage Wireless Society Incorporating 405 Alive Volume 40 No.2 Summer 2015

- 2 The BVWS Spares Department
- 3 From the Chair
- 4 A tale of two hybrids- The Emerson 838
- and the Marconiphone P60B compared
- 11 Pictures from Golborne, 12th April 2015
- 12 An Arvin 444 Mighty-Mite in persimmon
- 17 Photographs from the table top sale at The British Vintage Wireless and Television Museum, West Dulwich
- 18 Making a coil winder
- 29 More variations on a theme
- 32 Repair of an EKCO A320 from 1957
- 35 My Bush TV24 a restoration or rebuild?
- 40 Spring Audiojumble
- 42 A dragon of a Nixie
- 44 Automatic Frequency Control
- 56 Sounds of the Past Open Day, Monks Eleigh, Suffolk
- 58 Advertisements
- 59 BVWS books
- 60 Advertisements
- 61 Advertisements
- 62 News and Meetings
- 63 Advertisement

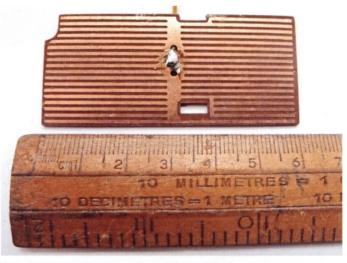
Fig 4. Aerial compartment cover. Ground plane or Shield

The ferrite rod aerial on this set is concealed in the sloping top of the case and is held in its compartment permanently by a piece of paxolin which is heat fused into the plastic case and not meant to be

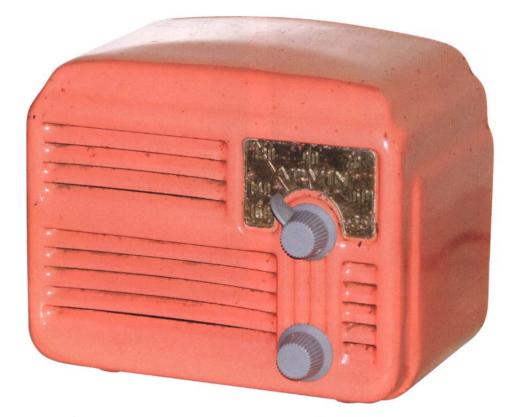
Figure 1: The Arvin 444 in restored condition: the grey knobs are original. Hopefully you can see the raised lettering of 'Arvin' and the dial calibration markings. There also was a model 444-AH with a carrying handle attached to the top of the cabinet.

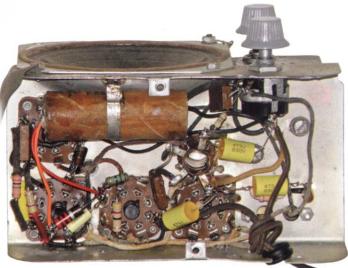
Figure 9: Underside of the restored chassis, showing the cardboard tube of the HT smoothing electrolytic capacitor just below the speaker.

I changed all the wax paper capacitors for modern polyester capacitors, but I wanted to preserve the smoothing electrolytic tube, which can be seen just below the speaker in Figure 9, and which was a feature of the original chassis. This tube contains the 40µF (C5A) and 20µF (C5B) HT smoothing capacitors, and also C5C, the low voltage 20µF cathode resistor bypass capacitor for the audio output valve. The centre of the tube was drilled out with successively bigger drills until all the original capacitor material had been removed. I only fitted replacements for C5A and C5B into the

original tube, and replaced C5C with a modern component which I positioned out of sight. The cardboard tube had a metal band around its centre and was originally soldered to the chassis, and I re-soldered it back into its original position.
