The Bulletin

Vol. 40 no. 3 Autumn 2015 www.bvws.org.uk

- 40 How do they work? Postscript, and repair and calibration of meters
- 44 Pictures from Royal Wootton Bassett
- 46 The Murphy A30C Console radio and its long struggle back to good health

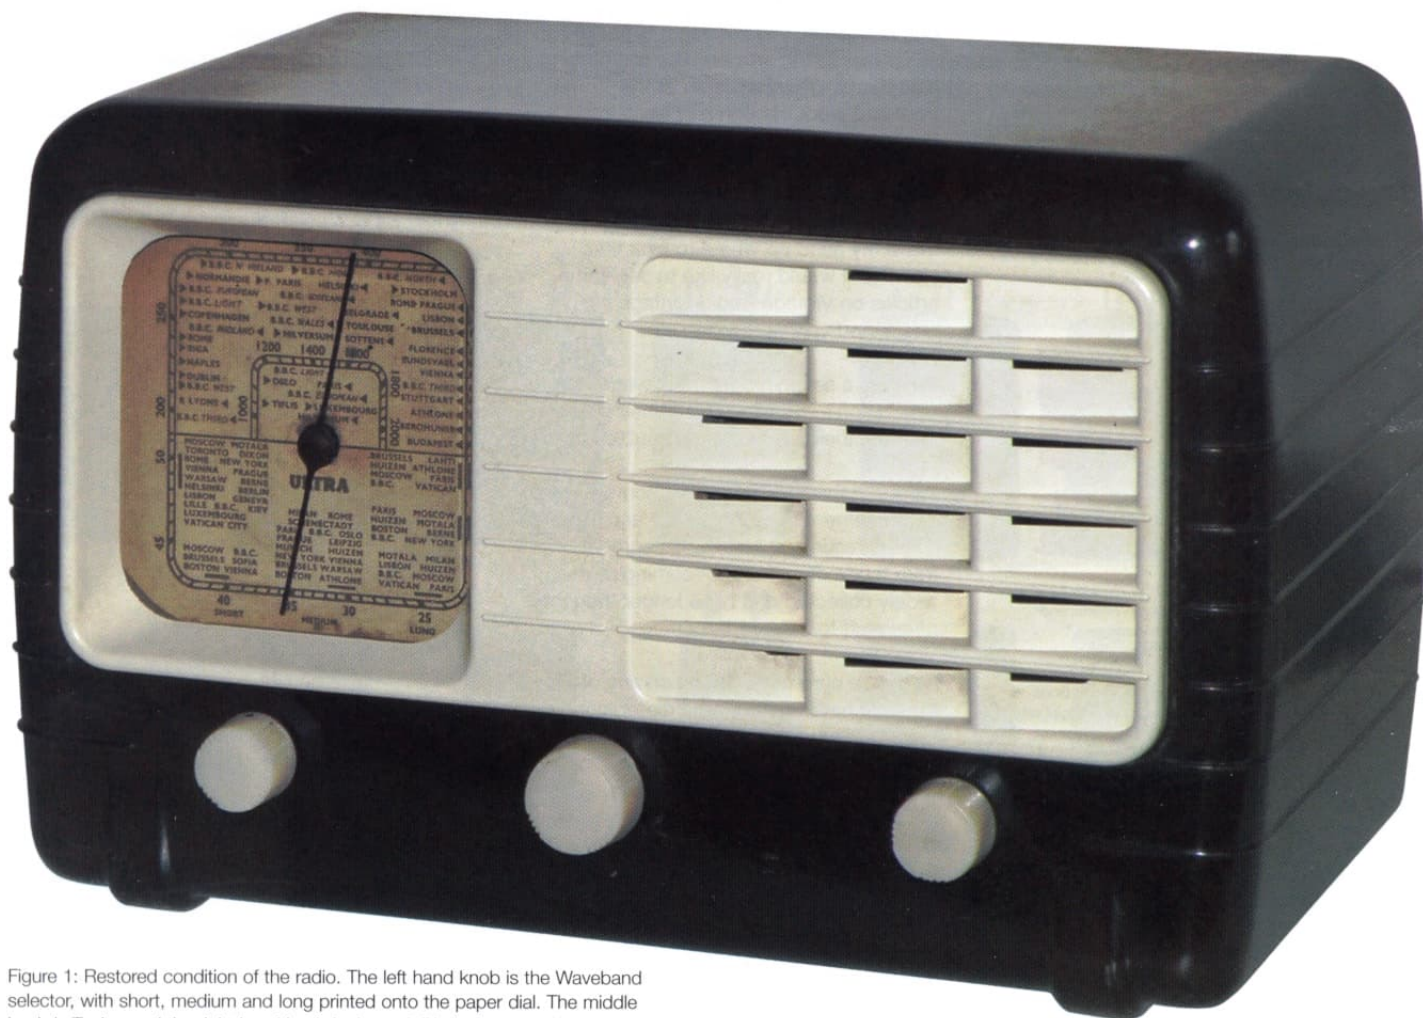
Figure 1: Restored condition of the radio. The left hand knob is the Waveband selector, with short, medium and long printed onto the paper dial. The middle knob is Tuning and the right hand knob is the on/off/volume control.

Figure 1 shows the restored condition of my T401, with a brown and cream cabinet. The radio was also sold in Cuban Red, Ivory and April Green. These colours may well

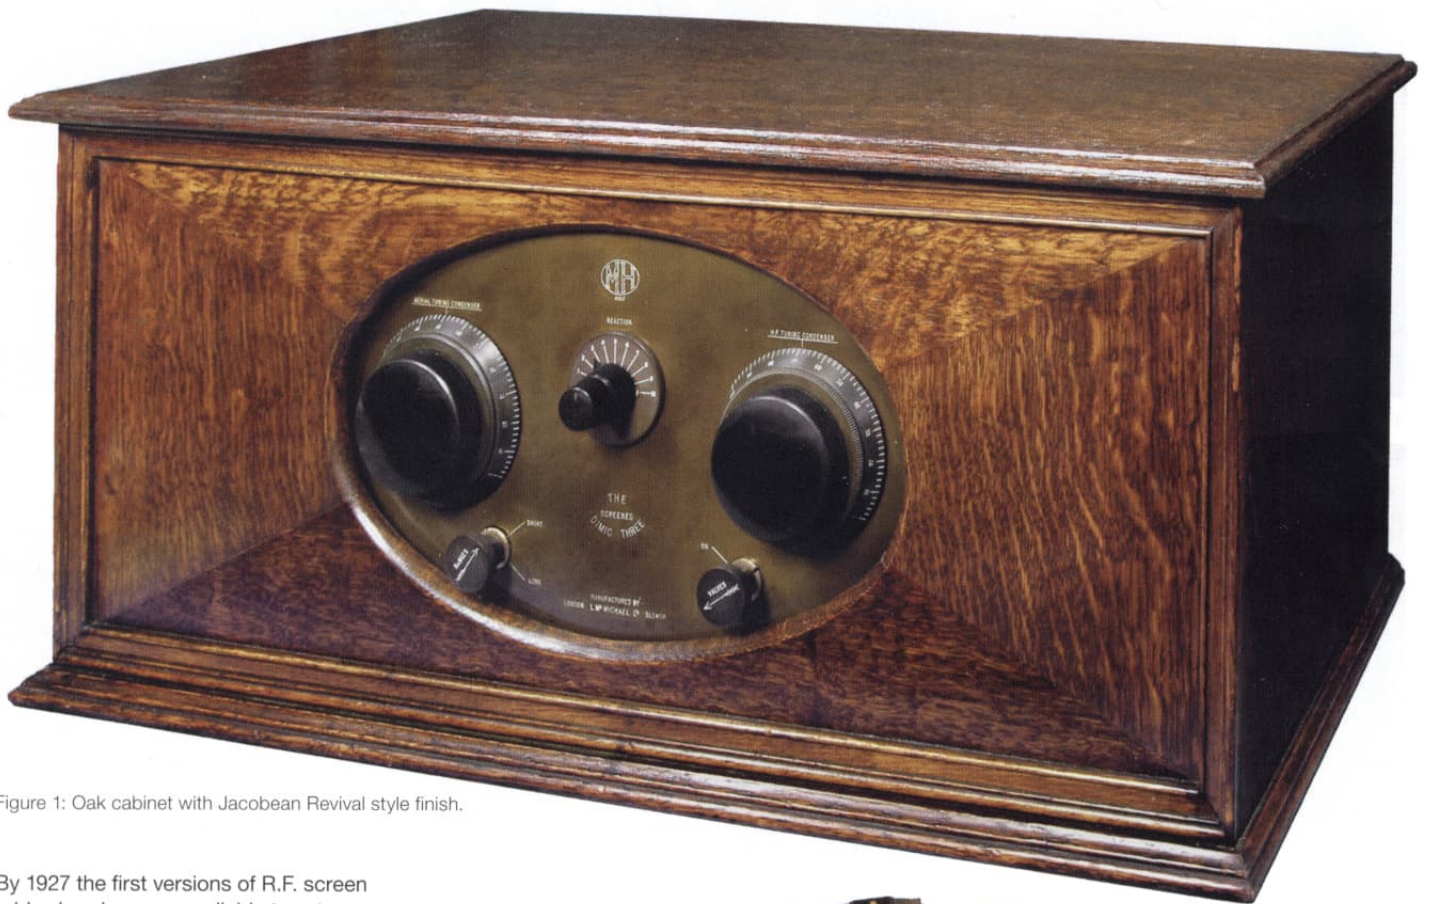
Figure 1: Oak cabinet with Jacobean Revival style finish.

The cabinet is 'flaky cut' oak and the grain is filled but not levelled; somewhat in the style of the Victorian era Jacobean furniture revival; an essentially unknown style here in the USA but found in a number of early U.K. sets.

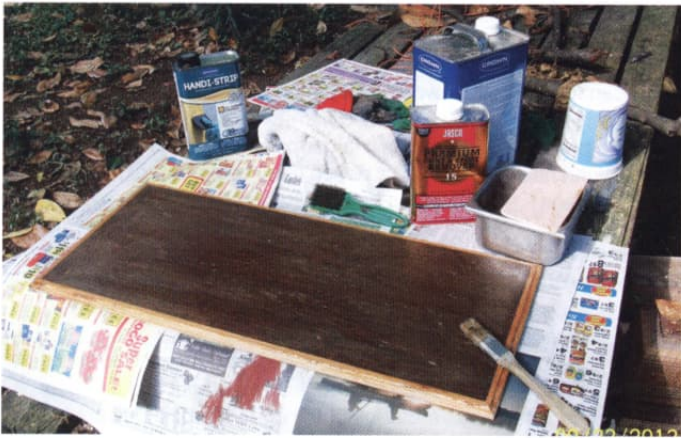
Figure 6: Removing the polyurethane varnish on the salvaged board and staining to match the original cabinet was no small task.

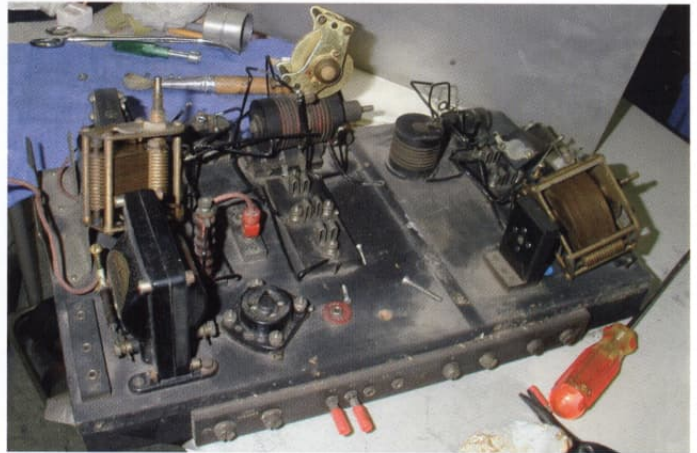
Figure 9: Heavy soil and corrosion on the top side of the chassis demanded all parts be removed for proper cleaning.

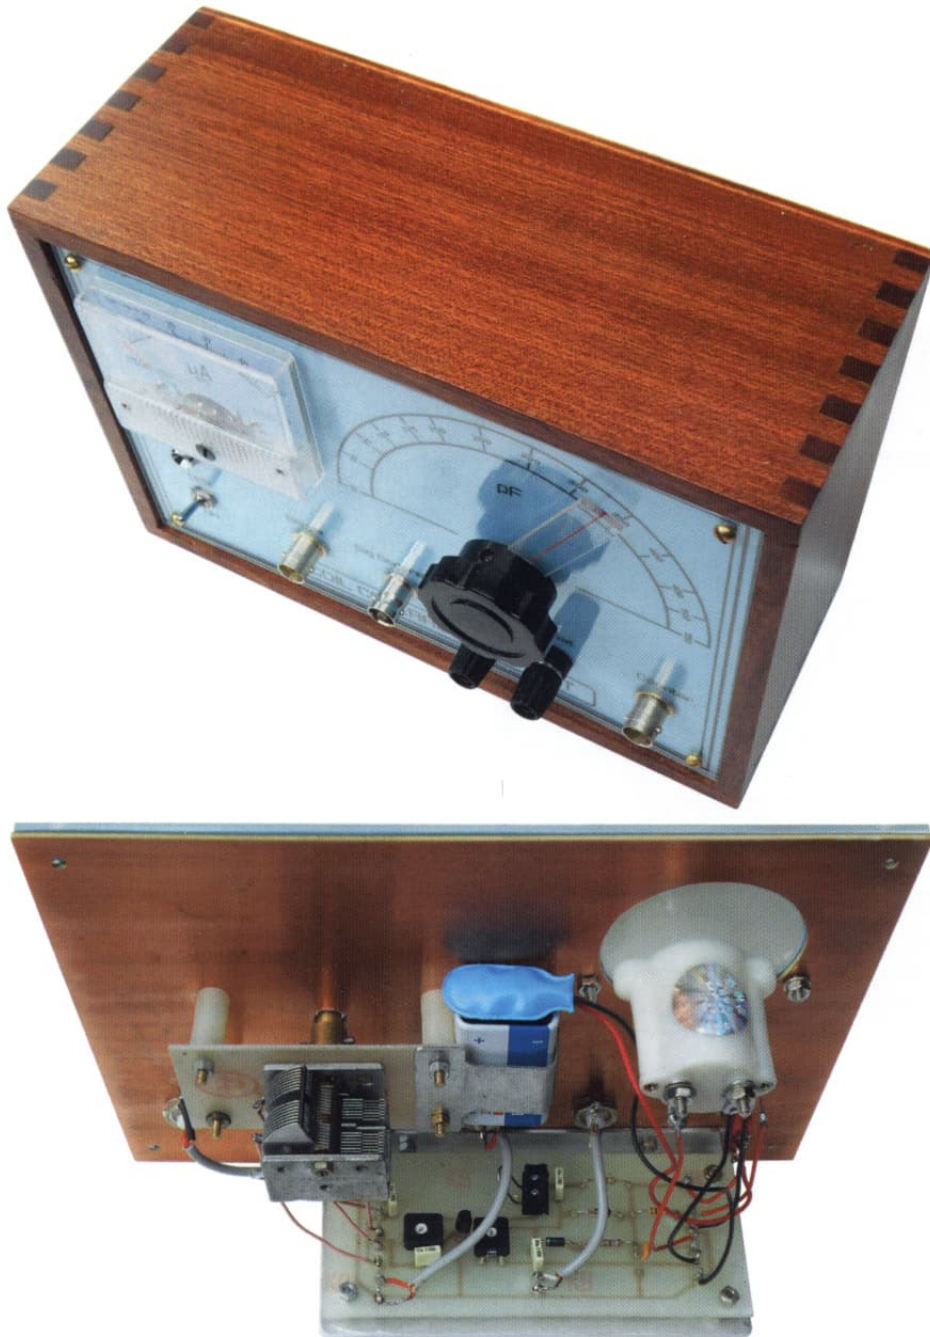
Figure 5: Front panel layout

and test gear knobs. I drew the front panel using MS 'PAINT' then printed it onto card which I encapsulated, then made and fitted a clear acrylic protective panel to cover it.

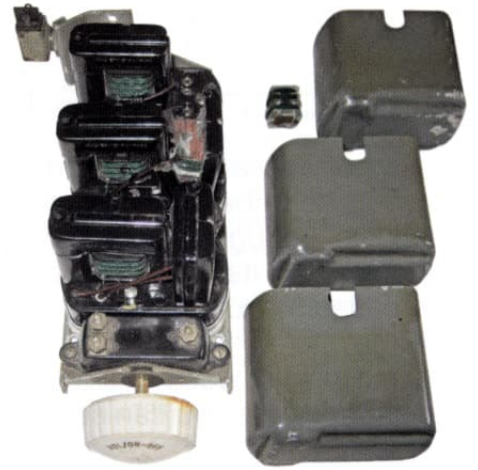
Damp damage to second Colvern coil set

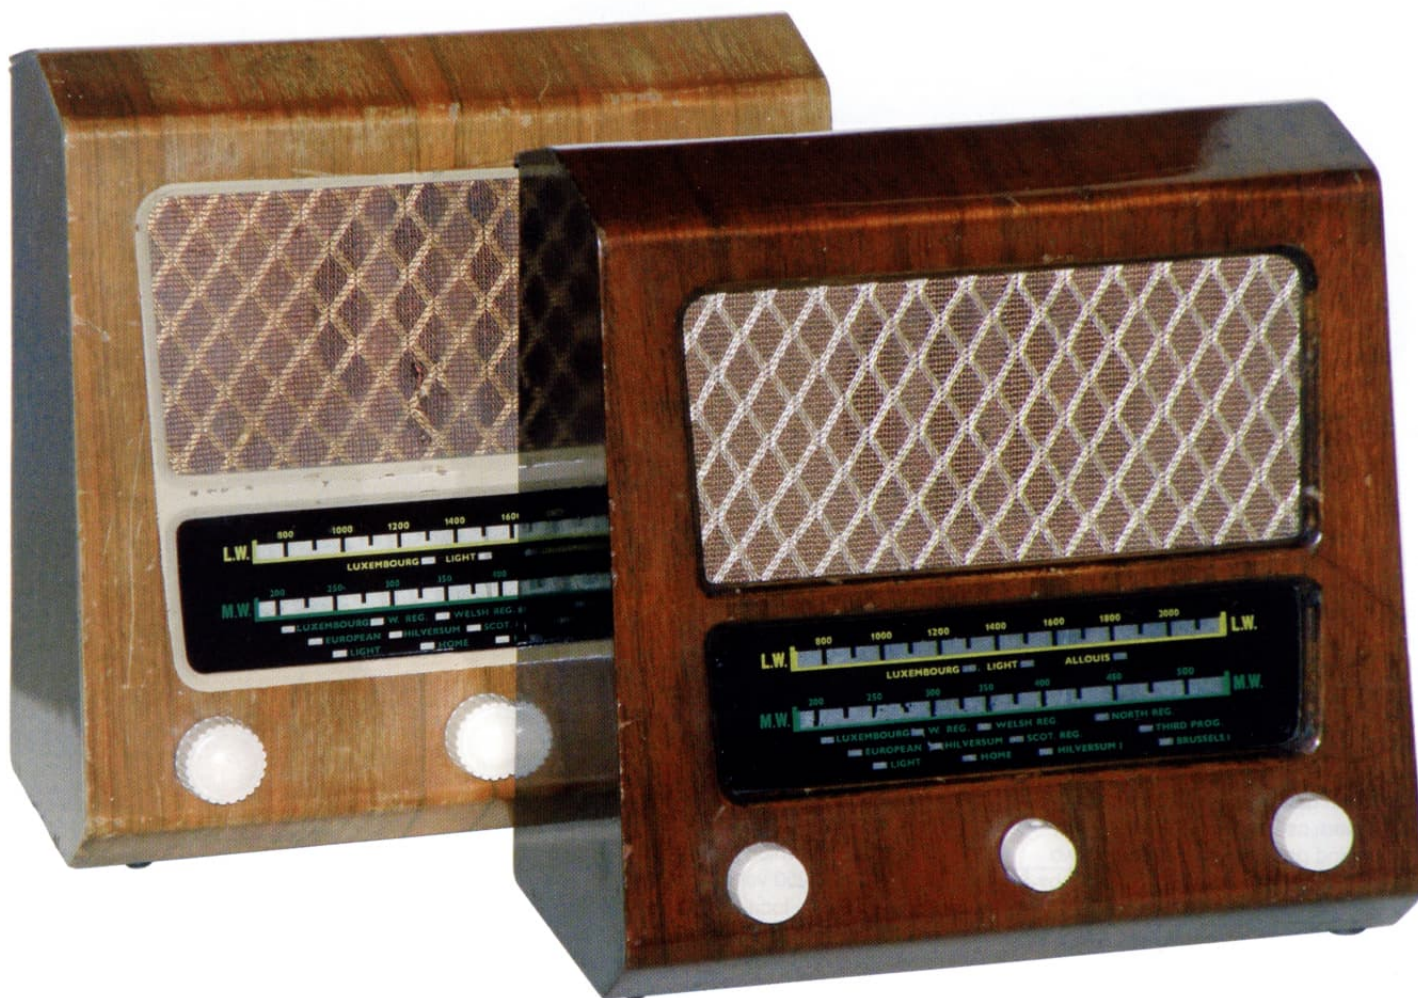
Figure 1: The two radios posed together. As you can see, from the front there's no way of telling which one is which, the dials and control layouts being identical. In fact the superhet is at the front, with the darker cabinet, and the TRF is at the back. The TRF's cabinet's sides are painted, rather than veneered as the superhet's sides are.

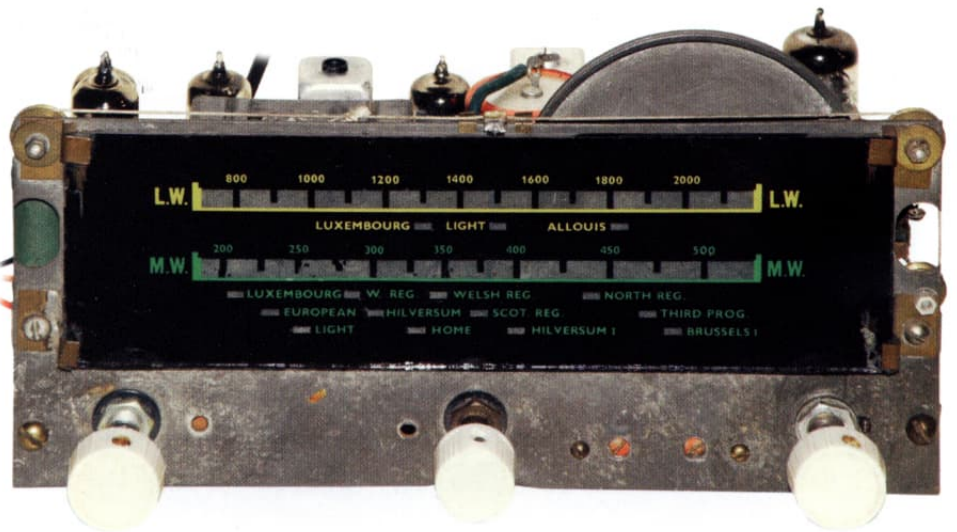
Figure 7: Front view of the superhet chassis. At this stage I hadn't replaced the dial lamp, which fits into the hole to the right of the dial. Left to right, the controls are: volume and on/off (using a double pole on/off switch on the 500k volume control); tuning; and the medium / long wave bandswitch. An identical dial was used for the TRF version of the radio.

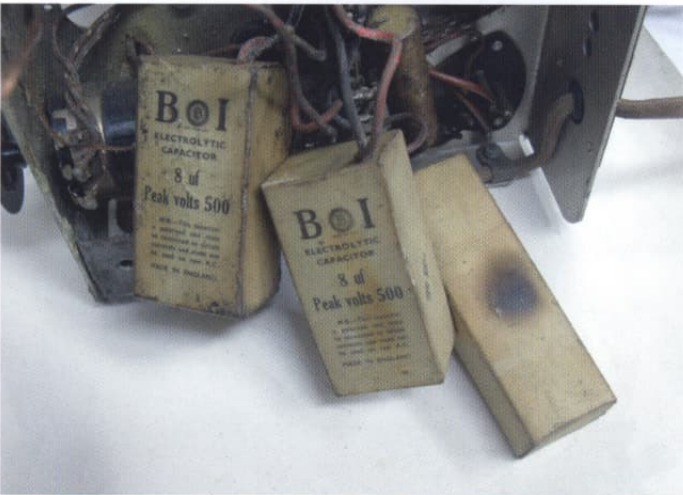
The burn mark

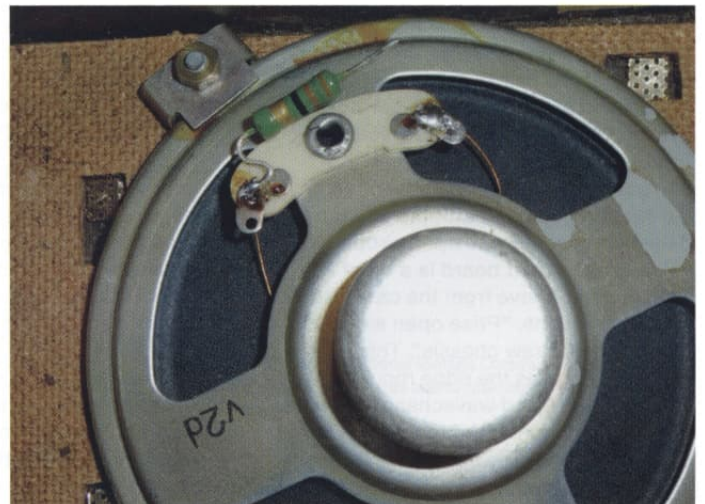
Replacement speaker with series resistor wired direct
