The BVWS Spares Dept

- 2 The BVWS Spares Department
- 3 From the Chair
- 4 An HMV Model 570 Radiogram
- 10 The Loftin White Amplifiers
- 15 My wireless hobby the first 85 years
- 19 Pictures from Golborne
- 20 The Pye Q8 reflex & related models
- 22 September Harpenden
- 24 Restoration of a Philips Aachen Super, D57 AU, MonoKnob from 1938/39
- 40 October Audiojumble
- 42 A Home-Built TRF Using Three EF50s
- 47 Harpenden auction lots
- 48 Negative reaction
- 50 Selecting HT power supply
- replacement capacitors
- 58 Letters
- 59 BVWS books
- 60 Advertisements
- 61 Advertisements
- 62 News and Meetings
- 63 Advertisement

Radiograms are intriguing products and the HMV model 570 is no exception. When casually looking for another quality radiogram this very handsome example turned up at a Royal Wootton Bassett sale. As is often the way with radiograms, the restoration work needed was considerable and continued as motivation and enthusiasm waxed and waned over a number of years.

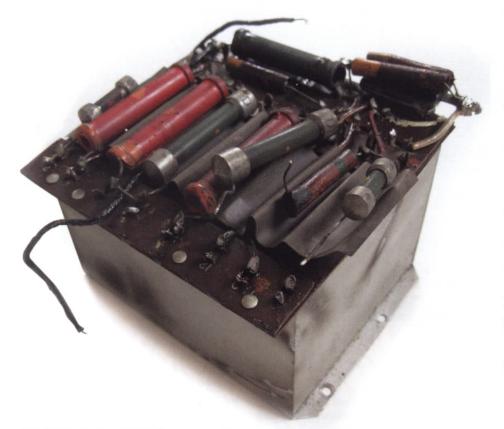
Capacitor box with busy tag board

The Trader Sheet for this receiver illustrates the internal build of the condenser block containing twelve condensers, and this could now be seen where it forms the centre piece of the chassis. It is fairly inaccessible with numerous connections to the rest of the set and many resistors mounted above it on a paxolin tag board. The condenser block would almost certainly need internal attention due to age related failures but just to make sure that I was not embarking on unnecessary work I did a few voltage checks with an external high voltage supply. These checks confirmed that some of the condensers had indeed failed so the block would need to be removed. In the past I had refilled many smaller devices but this one looked quite complex, almost daunting. With so many connections photographs were taken to assist with reassembly. Removal took about an hour of careful unsoldering and disassembly, leaving a large vacant

A new tag strip was made up with replacement capacitors, carefully marking off each against the layout drawing and using coloured wire to minimise errors on reassembly. All this was carefully checked as the rebuild proceeded and on completion the capacitor connections were electrically checked against the Trader circuit diagram. When commencing these checks I used an original HMV circuit and was puzzled that I could not reconcile the capacitor block connections with the Trader circuit used for the rebuild. I decided to return to this later while attention turned to the pick up.

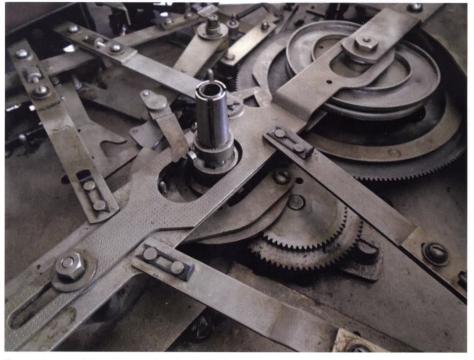
The amazing complexity of the record deck

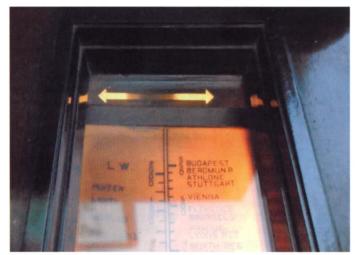
The fluid light in operation

The last item on the chassis to be examined was the fluid light tuning indicator. This moving vane indicator casts a shadow from a lamp in response to the anode current of the IF amplifier valve. I could not see any light coming from it although the illuminating lamp was working. One face of the housing was undone by prising open the fixing tags which separated a small mirror used to reflect light toward the tuning scale. This was covered in a film of fine dust so was cleaned up, in the hope that the translucent scale would transmit enough light for the indicator to become visible. Looking inside the moving vane could be seen to be free and while the indicator was apart it was connected to a DC power supply for test. The vane moved smoothly as the voltage was varied, and with that reassurance it was reassembled and refitted. All that now remained was to install parts in the chassis with new mains connections and connect up the ancillary items. Describing this on paper makes it sound trivial but there was a remote control drive chain, pick up and muting wiring plus the deck and loudspeaker. Testing was performed incrementally

starting with the radio, and the previously dust contaminated fluid light tuning indicator was now very clear and responding to signals. A little more work had the deck playing records and the remaining loose parts were fitted to complete the job. This long running project is fully working although there are a couple of minor items that would benefit from attention when parts are sourced.

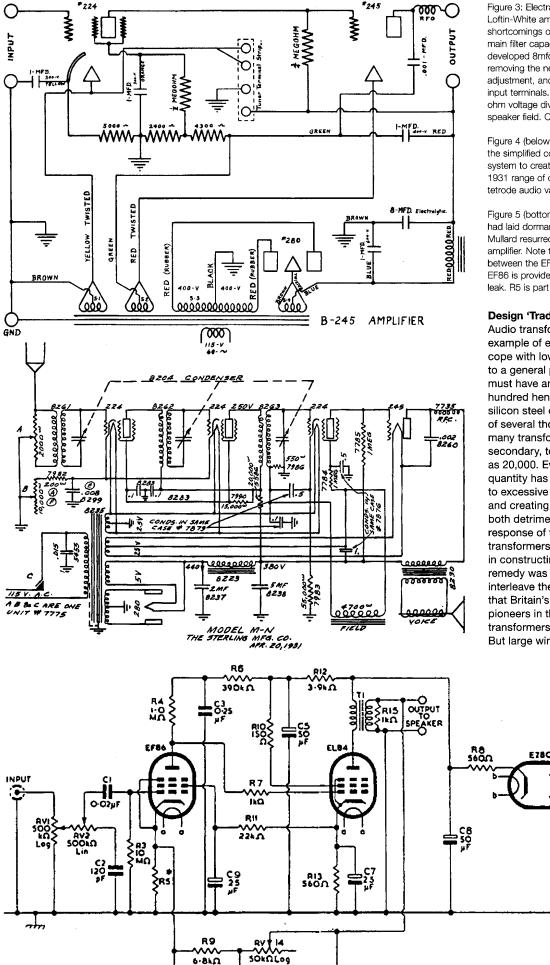
Figure 3: Electrad soon produced an improved Loftin-White amplifier. This overcame the shortcomings of the original by increasing the main filter capacitor with one of the newly developed 8mfd electrolytic filter capacitors thereby removing the need for the tricky hum bucking adjustment, and allowing earthing of one of the input terminals. In some applications, the 4000 ohm voltage divider resistor was replaced by a speaker field. One example is shown in Figure 4.

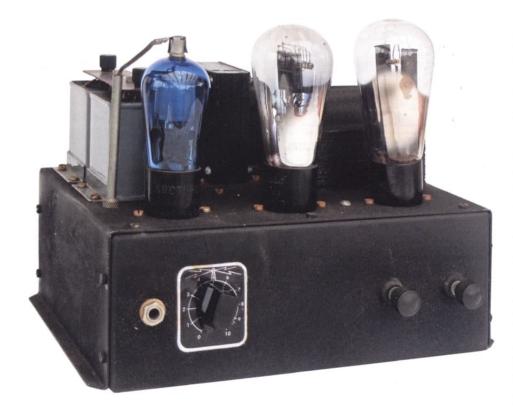
Figure 6: The Loftin-White amplifier shown in Figure 3 as built by the writer. It is very compact when compared with its contemporaries. This example is in frequent use as his workshop amplifier.

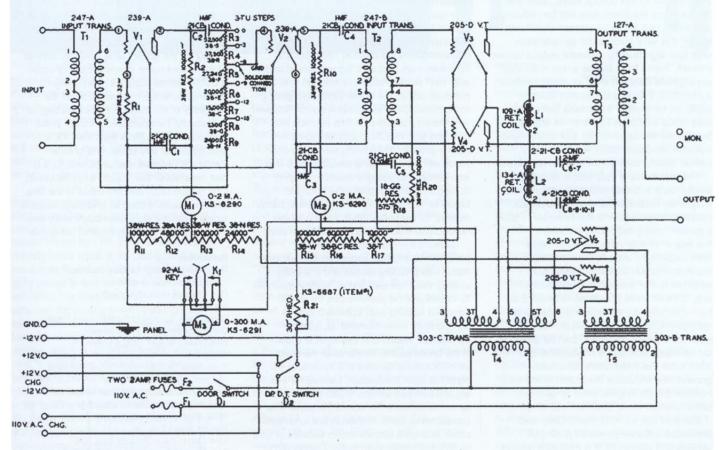
Figure 1A Circuit of Western Electric 46A Cinema Amplifier.

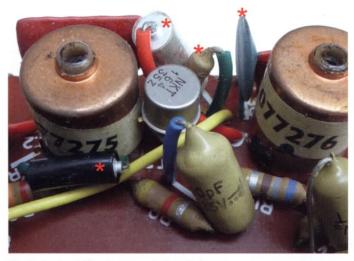
Manufacturer's additional components for reflexing

After a bit of head scratching I realized that this would be OK in an ideal world but components are rarely ideal. It assumes that demodulation only occurs in the diode D1 and that Tr3 amplifies perfectly. Transistors, compared to triode valves, are not particularly linear and to be useable at audio require careful biasing and often the application of negative feedback, whereas to amplify at RF and IF the requirement is maximum stable gain. But remember demodulation itself relies on nonlinearity and with strong signals substantial audio components can be generated in the collector of the last IF transistor. Usually this is not a problem as any demodulated audio will not be developed across the final IF transformer which has low impedance at these frequencies. However place a resistive load in the collector of Tr3 and it will develop a demodulated audio component across it in addition to that produced by D1. What I believe happens is that there are now two audio signals across this resistor at low settings of the volume control and that they become out of phase causing cancellation and distortion. At higher volume control settings the amplified audio fed back from diode D1 predominates

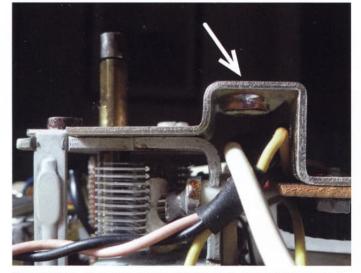
This bracket fixing-point governs how parallell the tuning knob is to the case front

The epicyclic slow motion drives on all these sets can give trouble with slippage. This is exacerbated by a felt friction pad behind the tuning dial, as a slightly worn drive cannot cope with the extra drag. I tend to remove the felt pad and put up with the looser tuning. There is also a spacing washer deep in the outer tuning control which you mustn't lose or the two halves will rub together. In fact there can be difficulty getting the tuning control to sit reasonably flat against the case. This is governed by an angled bracket bolted to the internal tuning capacitor into which the frontal case fixing screw taps and it may be necessary to bend this slightly but firmly and very carefully with pliers.

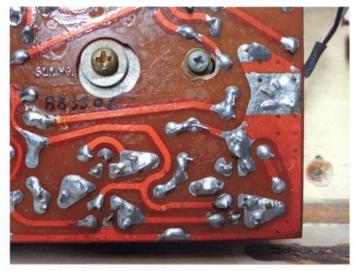
Non reflexed circuit board

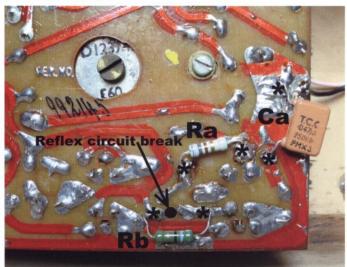
Reflexed board showing break in strip and modification components

I tried a few experiments to see if I could linearize Tr3 sufficiently to reduce unwanted demodulation. Reducing the value of the emitter resistor has the effect of altering the bias and increasing current through the device. I tried the effect of placing 680 across the existing resistor which gives a composite value of 340Ω and also reducing the value of the 82Ω collector resistor by bridging it with 56 $\!\Omega\!.$ This increases the current through the transistor to about 3.5mA rather than the usual 1mA although care is now needed to avoid approaching the maximum safe collector current for a small signal transistor. I have soak tested the stage for many hours and the transistor appears to run cool. The modification was carried out on two Q8's and it did reduce the effect considerably on one and removed it entirely on the other. This presumably reflects variations in gain between the IF transistors of different radios. As the audio was still a bit on the bright side, due to the extra stage, I also added an additional capacitor of 0.047µf between the top of R12 and earth.

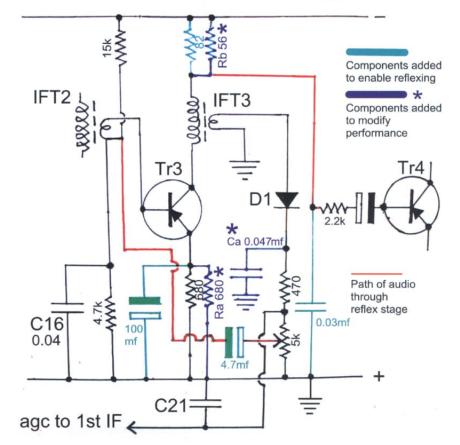
Reflexed IF stage showing manufacturer's alterations and suggested modifications. Neutralizing capacitor not shown

It is questionable if reflexing the circuit in this particular manner towards the end of its production run was an effective way to improve its performance and also whether the pitfalls were fully recognized and the best circuit values were chosen. Although it is now possible to listen to weak stations that were previously inaudible at maximum volume these are noisy so it doesn't improve the basic signal to noise ratio. However with the modifications suggested my two Q8's are now much more pleasant and full sounding and closer to the sound, at low volume, of the original Ekco PT378. This is not a guaranteed remedy for the woes of all reflexed radios in this series, since the 2nd IF stage may still overload in very strong signal areas, however for anyone who has experienced similar problems, short of returning the circuit to its original form, it is a modification worth trying.

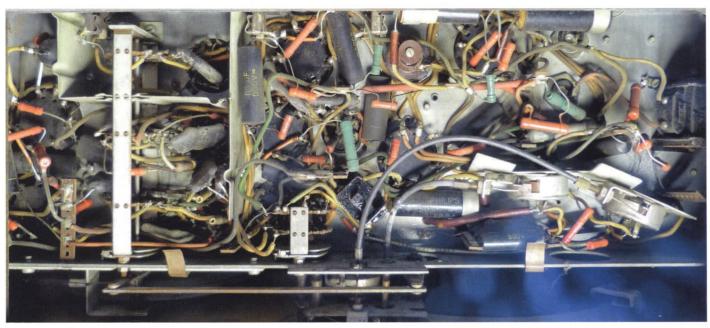
The underside of the chassis before restoration

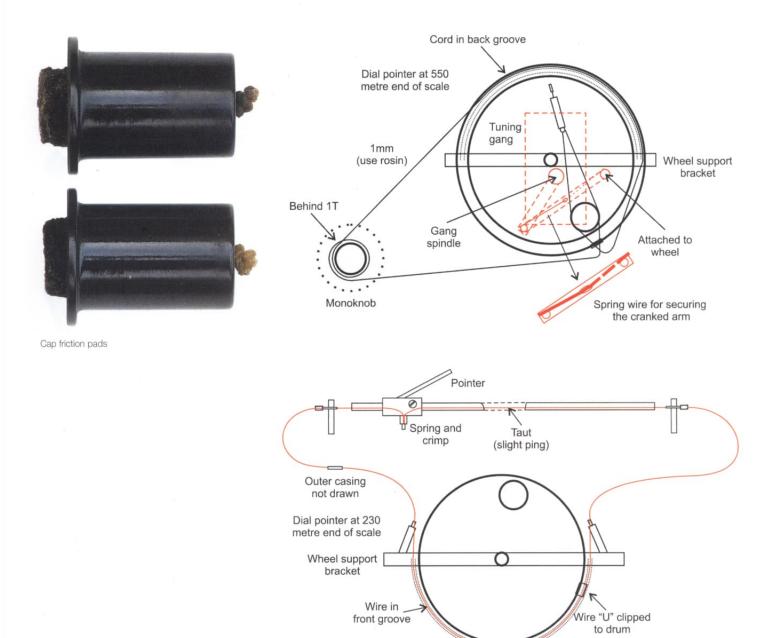
Total wire length loop to loop 1250 mm. One side 759 mm through 467 mm outer cable. Other 495 mm through 217 mm outer cable. Wire lengths are from the loop ends to the pointer spring and crimp.

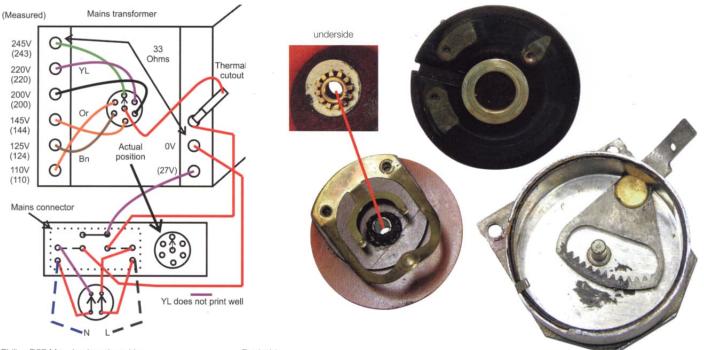
Philips D57 Monoknob mains wiring

The wiring around the transformer was puzzling with its attached double pole mains switch (interesting to see that Philips had safety in mind all those years ago), voltage selector and multi-pin mains lead connector. I made a drawing of this and the transformer has a 27V bottom tap that connects to unused pins of the multi-connector. This is possibly used with one of the two additional vibrator packs in DC operation. There are apparently two types: 110 to 145V and 200

The mains switch was open on both poles but with some cleaning and DeOxit it seemed reliable. Later I resisted the urge to wire the poles in parallel and use them to switch a hidden double pole mains relay for actual on / off.

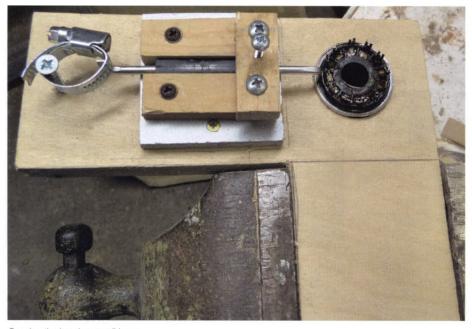
Opening the bandpass coil base

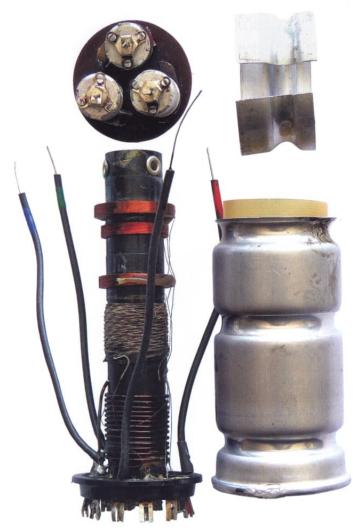
Coil rewound with parts for reassembly

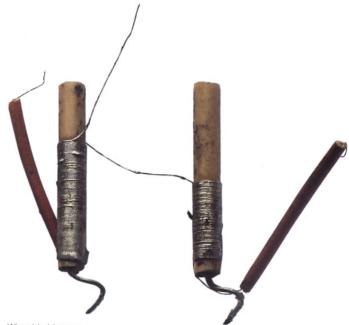
Wire strip trimmers

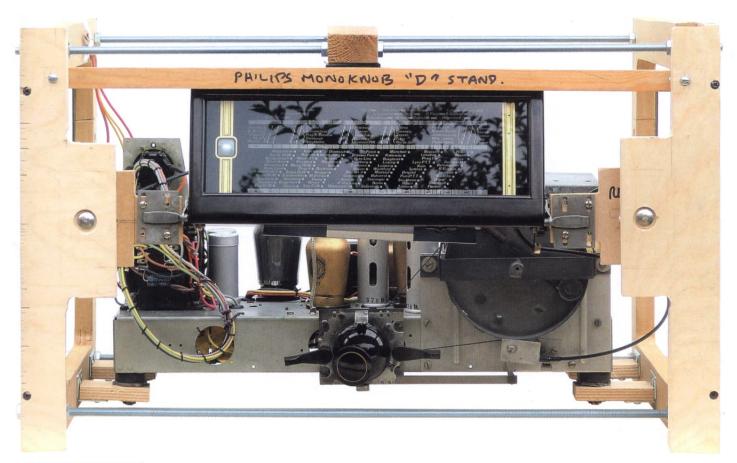
Finished chassis in work-stand

The chassis was cleaned and some rust specks treated before spraying with shellac and a matt lacquer to dull the shine.

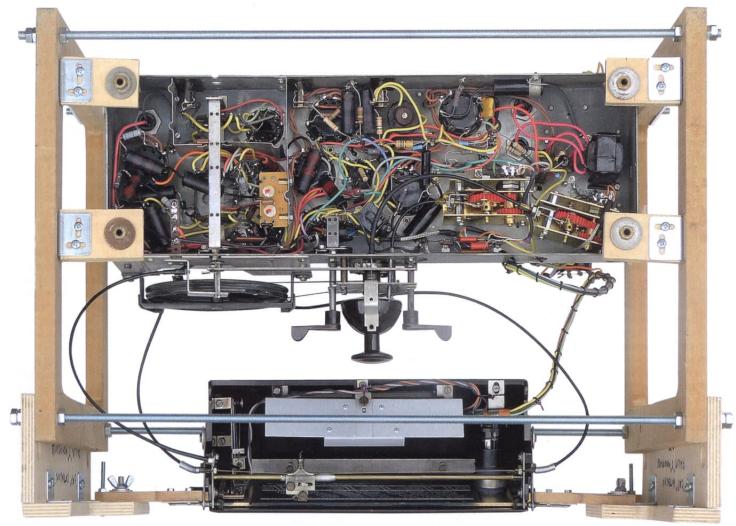
Underside of finished chassis in work-stand

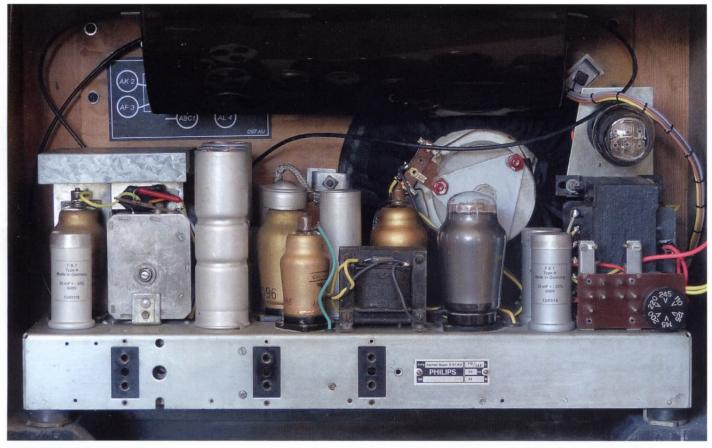
That cableform needs re-routing

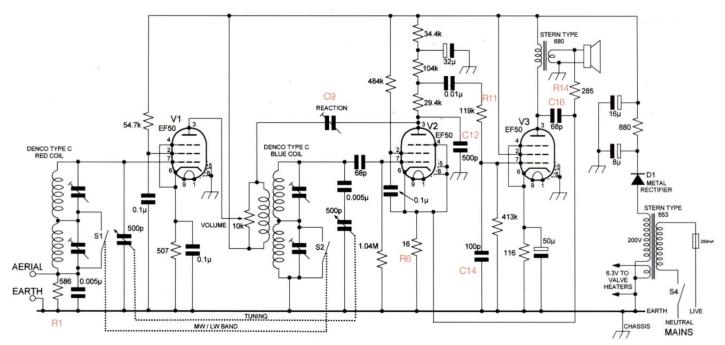
Figure 6: Schematic of my EF50 radio. The resistor values shown are as measured on the components fitted, and hopefully their nominal values can be deduced.

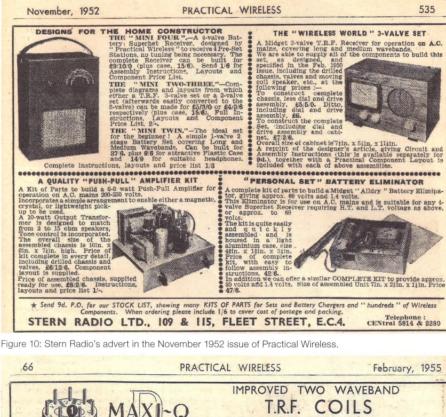
Figure 11: Denco's TRF design in an advert in the February 1955 issue of Practical Wireless.

Denco published its own TRF design as an advert in the February 1955 issue of Practical Wireless, see Figure 11. The coils used were coded C2 (blue - aerial) and C3 (green - detector coupling, plus reaction) and were replacements for the C coils used in the February 1950 Wireless World design.

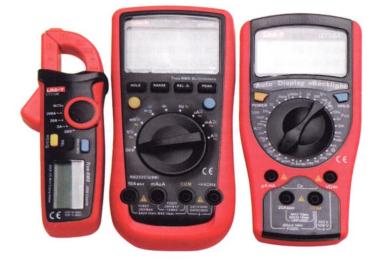
Figure 17: Line-up of the true RMS UNI-T meters I used to make the measurements. To the left is the UT210B clamp ammeter; in the centre is the UT61E; and on the right is the UT50A. The UT50A costs about \pounds 20 on eBay, and if I were to buy only one of these meters, this would be one I'd choose.

Although I found the UNI-T true RMS meters to be very suitable to make the measurements, I make no recommendations to you, and other manufacturers' instruments are available. See Figure 17 for a line-up of the UNI-T meters I used.
