The Bulletin

Vol. 41 no. 1 Spring 2016 www.bvws.org.uk

BVWS 40th Anniversary

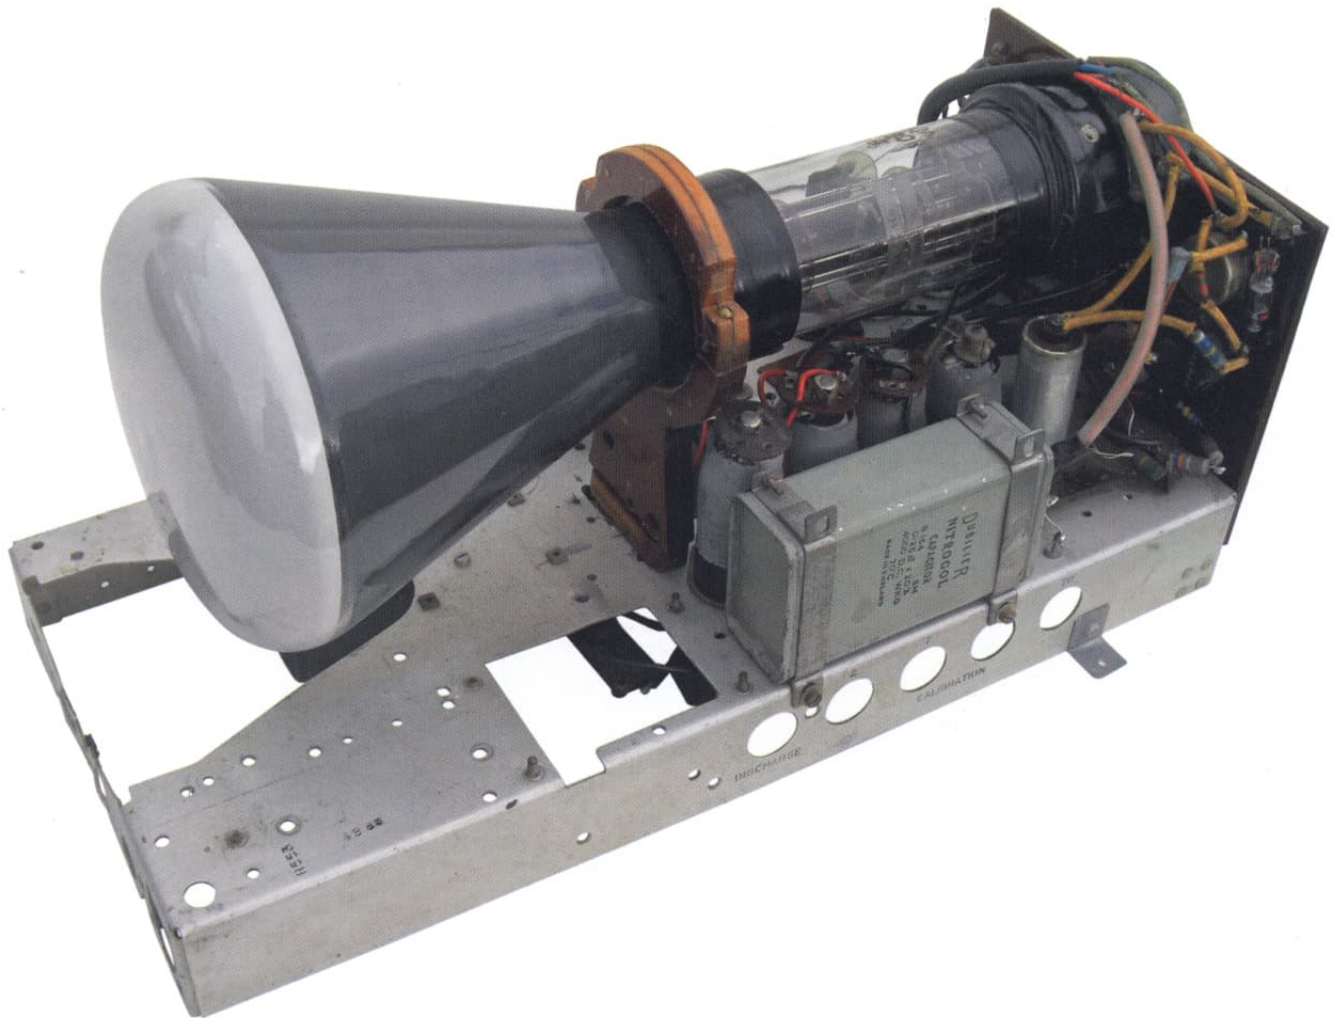
Upper chassis front view

There's a relay RL1 energised from the sound output valve cathode, and this enables the upper chassis HT and EHT when the sound

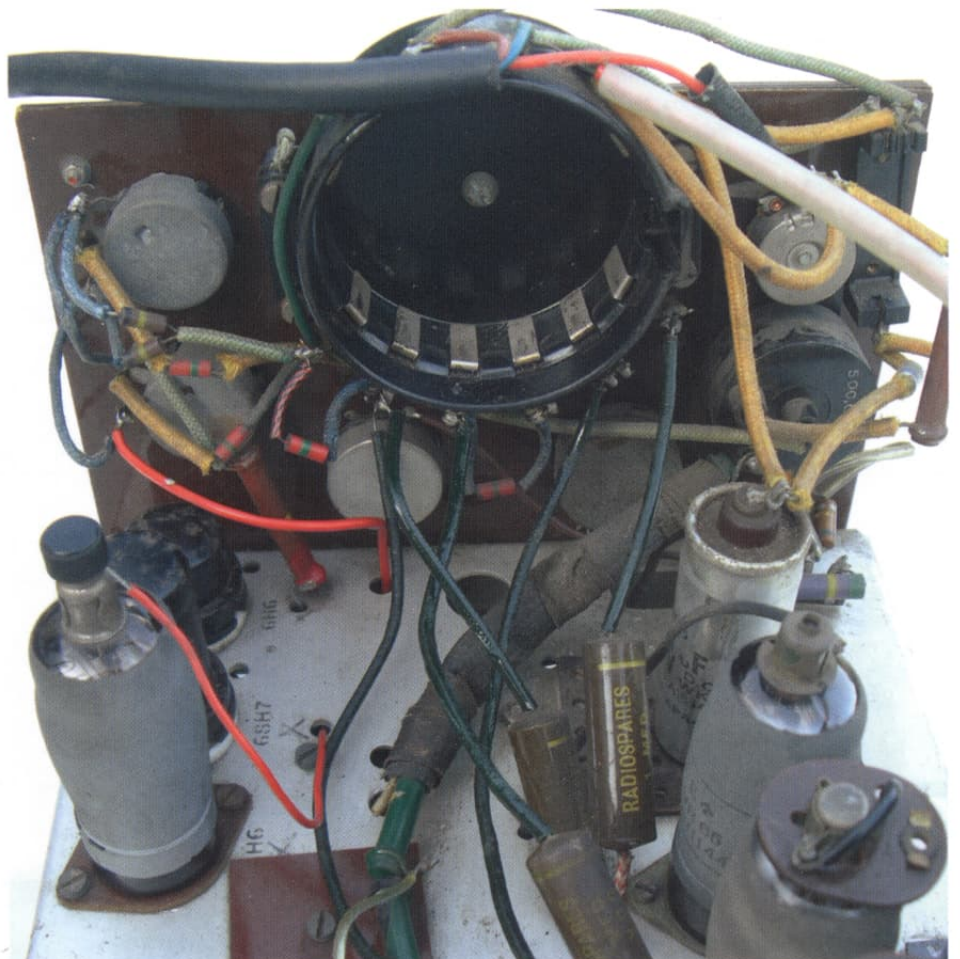
Upper chassis rear panel

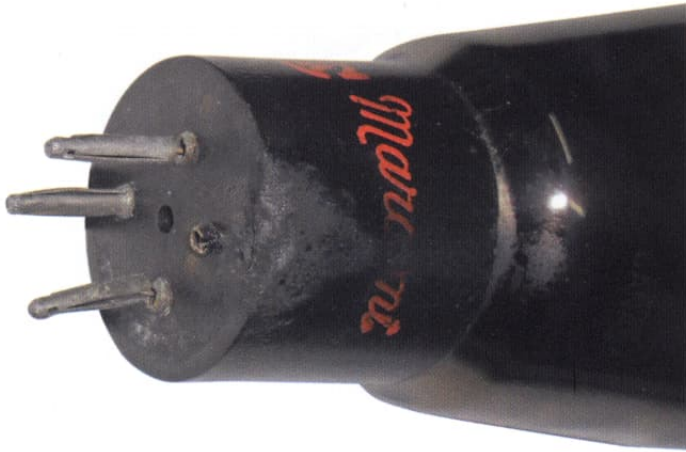
Burned-out EHT rectifier
