# The Bulletin

Vol. 41 no. 2 Summer 2016 [www.bvws.org.uk](http://www.bvws.org.uk) BVWS 40th Anniversary

# An Alba 472 with an identity crisis by Stef Niewiadomski

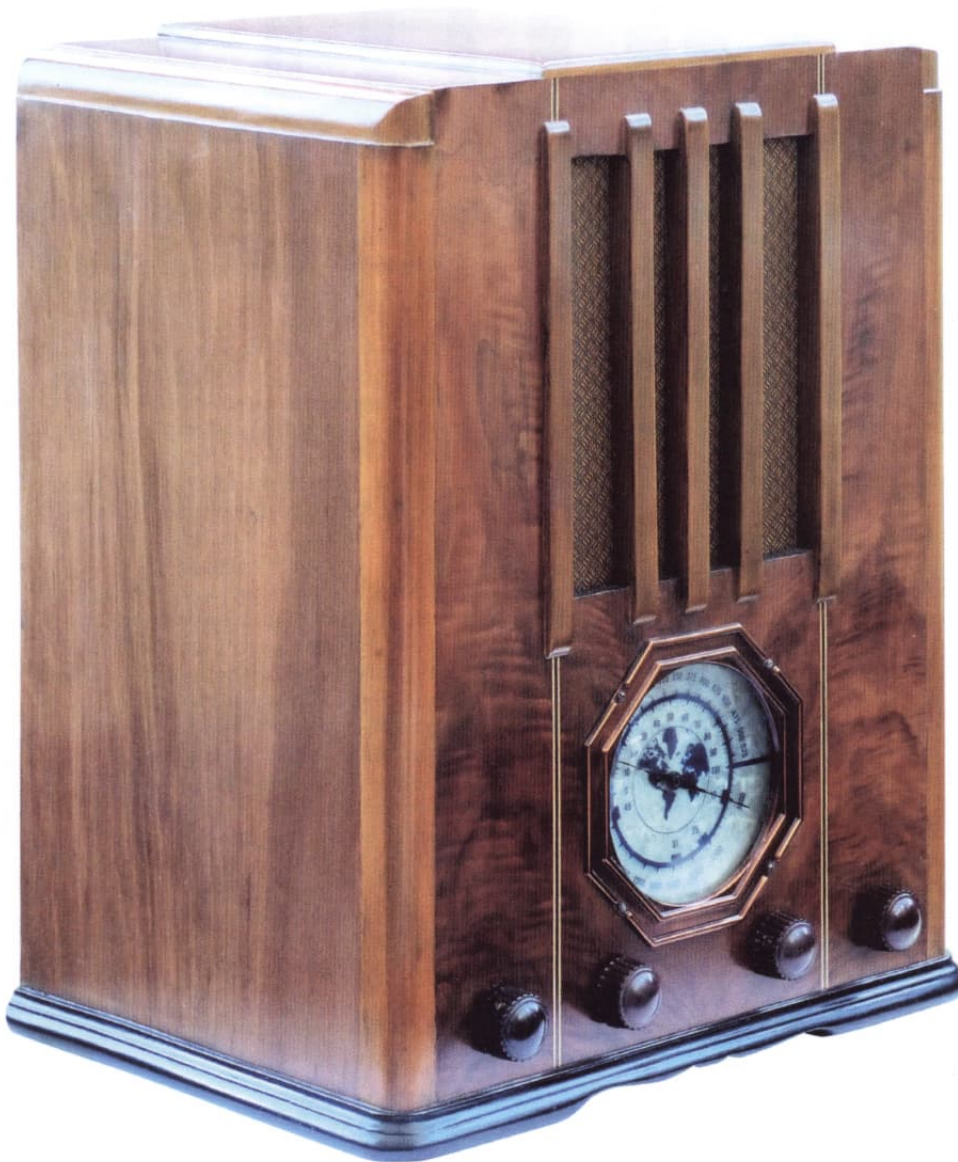
The refinished radio, second attempt

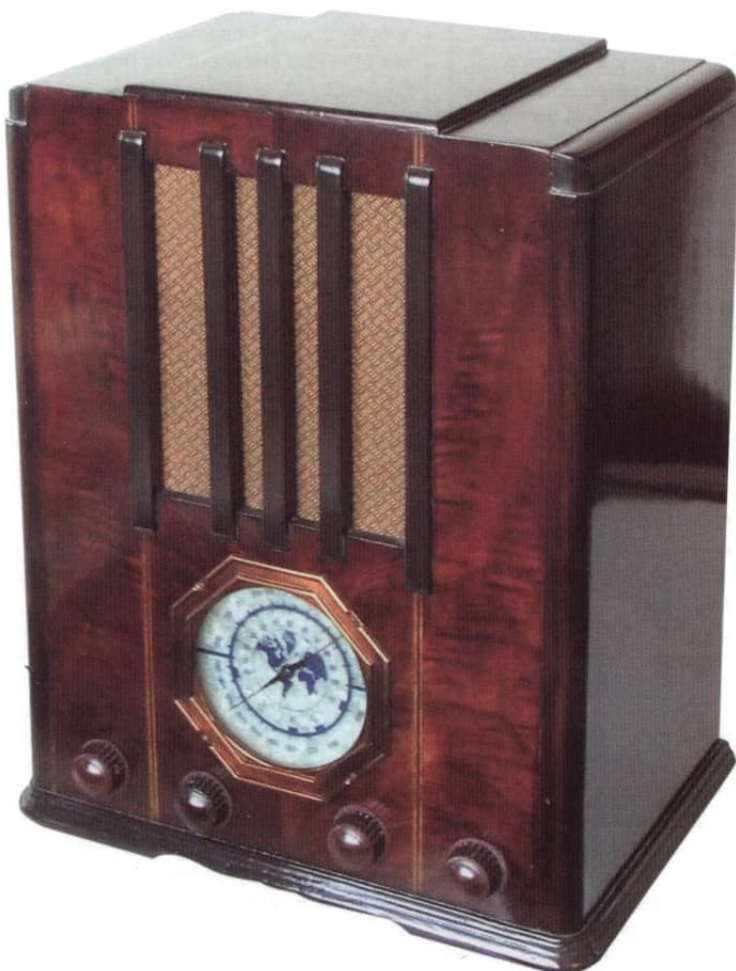
The refinished radio, first attempt

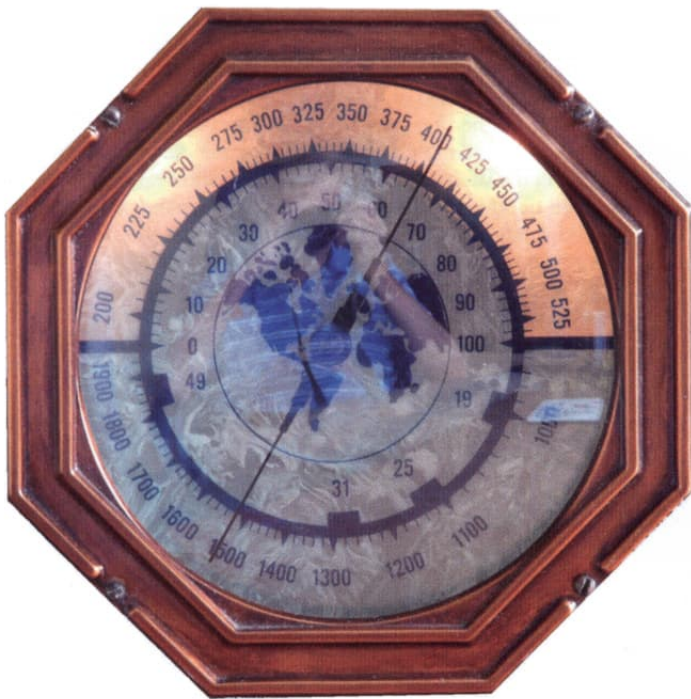
The dial

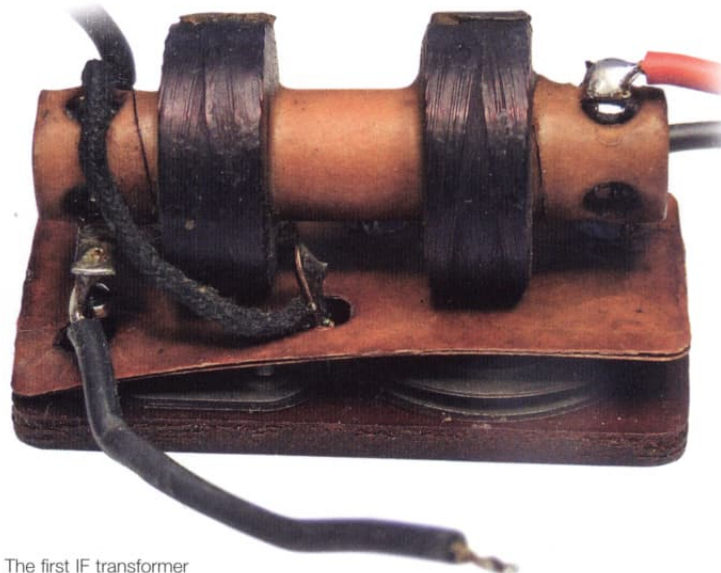
The performance is about what I expected, lots of gain and very selective although unpleasant to listen to and awful on modern 'pop' stations that use high levels of modulation. It had the worst case of sideband cutting that I have come across. An attempt was made to offset the windings of the first IF transformer to achieve a wider IF bandwidth. However, to me it was better, and safer for

The first IF transformer

the future, to return it to peak tuning and lower the Q of the single winding of the second IF transformer. This was physically easy to do with a shunt 47K ohm resistor. This increased the bandwidth from 4.5 kHz to about 7.5 kHz, at half height, which improved the music quality from my MW transmitter and made listening to Absolute Radio reasonable, assuming anyone likes that kind of music. The best 'real' station with least interference was R4 on LW. Comparing the AVC line voltage of this station, with an oscilloscope and X10 probe, with and without the resistor, indicated a loss of gain of less than 5 dB. Doing the same on MW, for the station received from the transmitter gave a similar loss; of course the audio increased slightly as the clipping had been reduced.

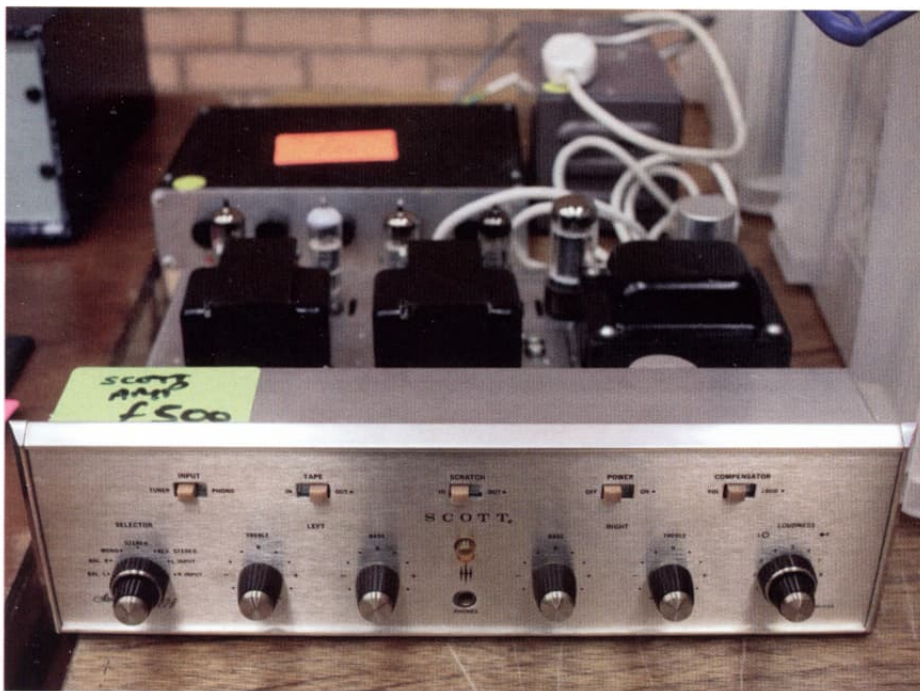
1960's Scott 4 x ECL86 stereo amplifier (note the dud valve)

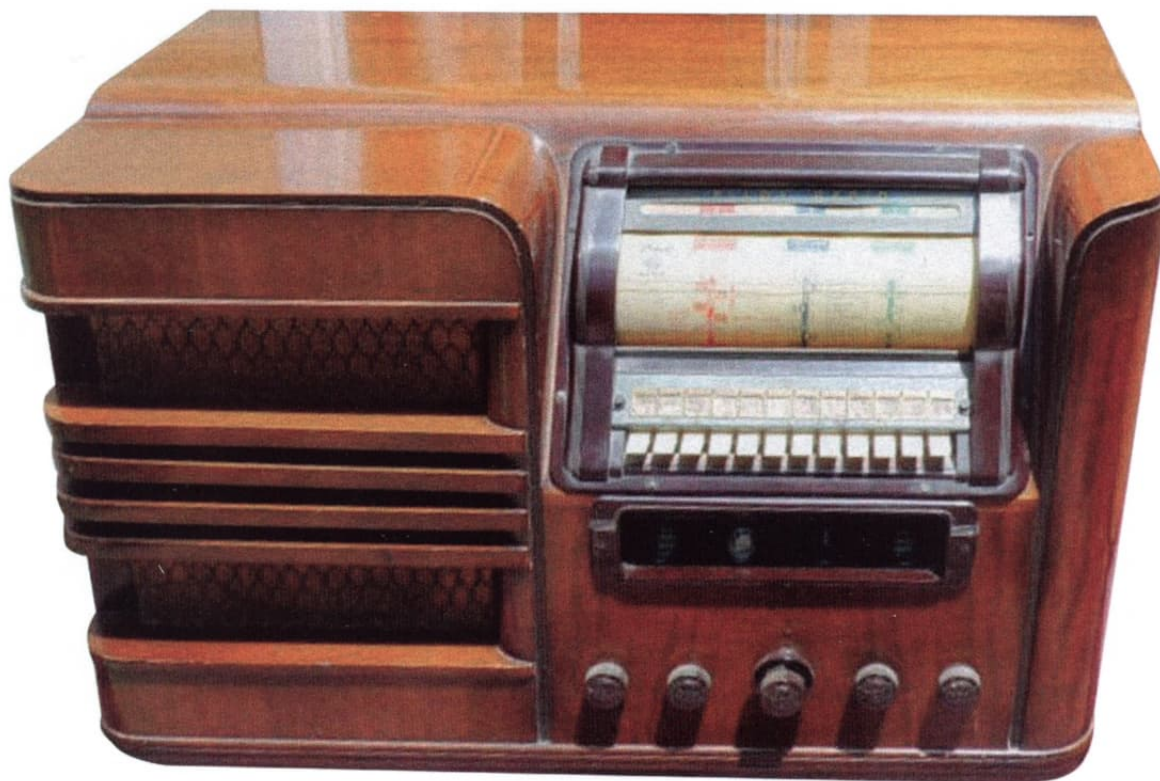
This rare and unusual radio is the mantel version of the Pilot H594. It would make a striking centre piece for any display.

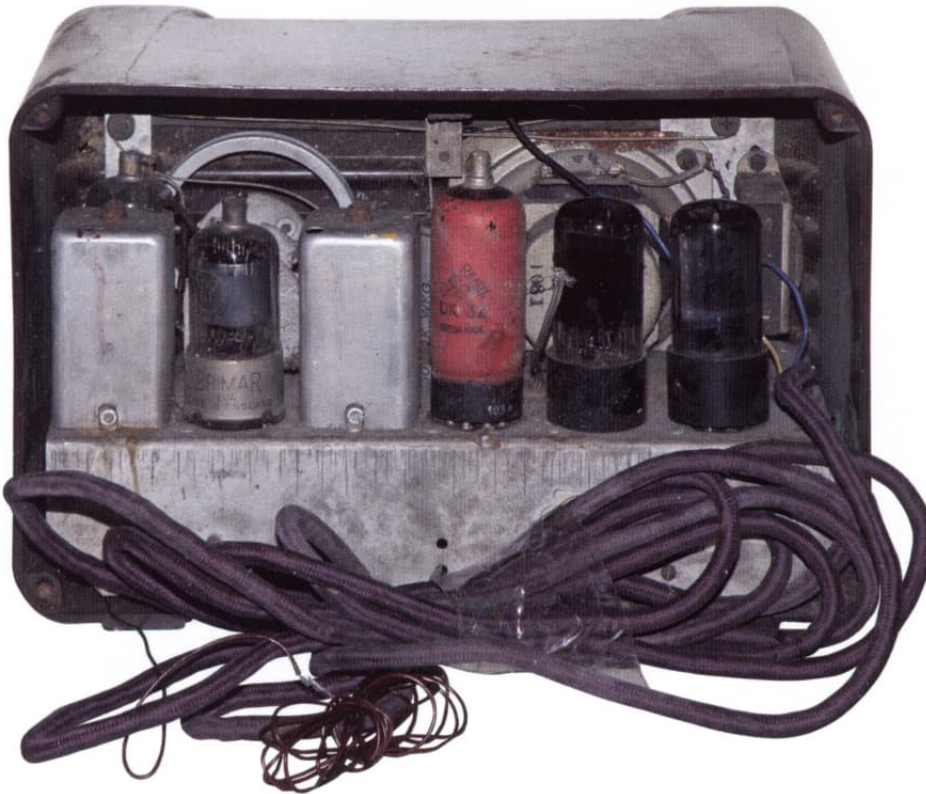
Figure 1: Rear view of the Masteradio radio, with its original mains line cord. The red DK32 in the centre of the view is a cuckoo in the nest.

A long line cord was fitted, with no mains plug, and a throw-out aerial was present. Five octal valves were fitted, but rather worryingly, a red coloured Ever Ready DK32, which was clearly not the original valve, sat in the middle of the chassis. The four other valves looked like they were probably the correct ones. Money changed hands, and the radio was mine. Figure 1 shows the rear view of the radio in the condition I bought it.

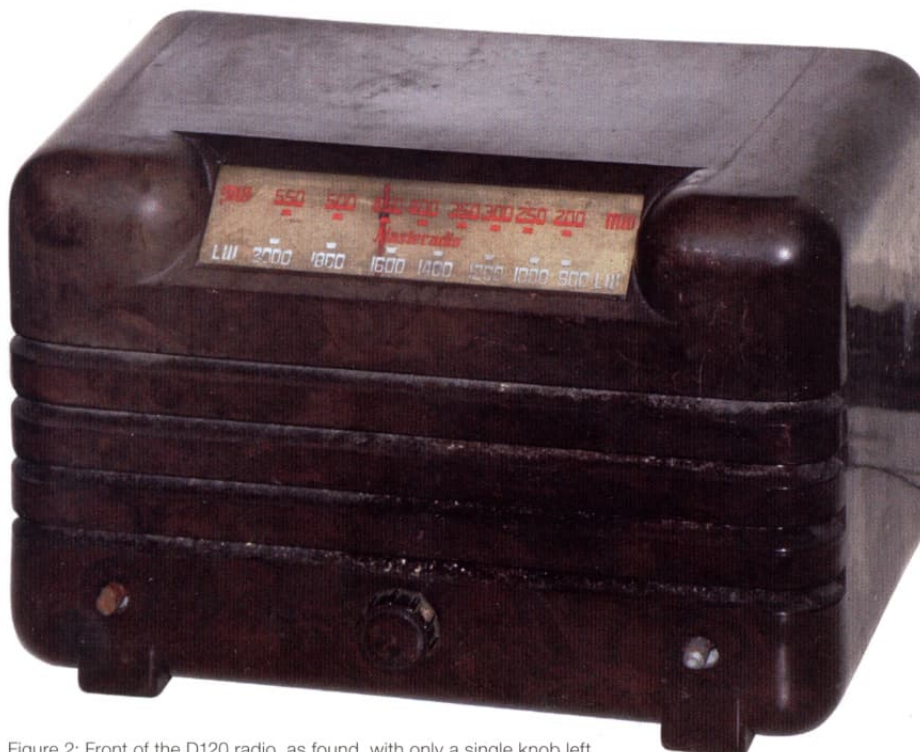
Figure 2: Front of the D120 radio, as found, with only a single knob left.

shows a front view of the radio, as found.

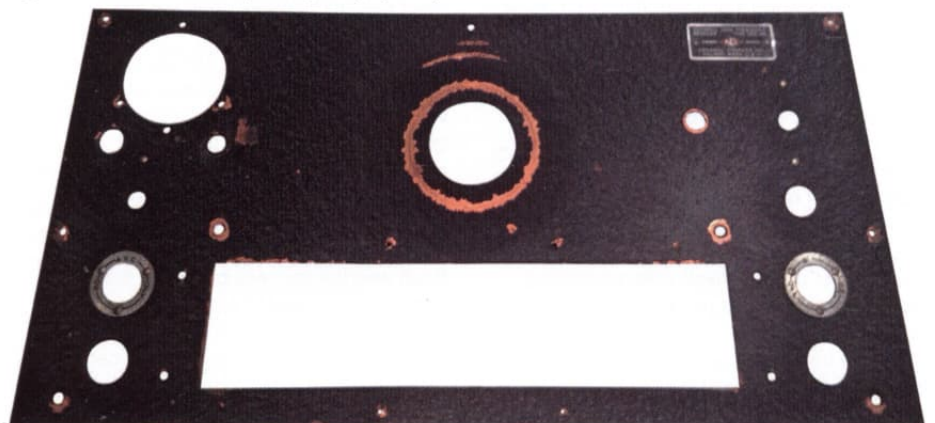
Fig 6. Damaged paintwork (front panel)

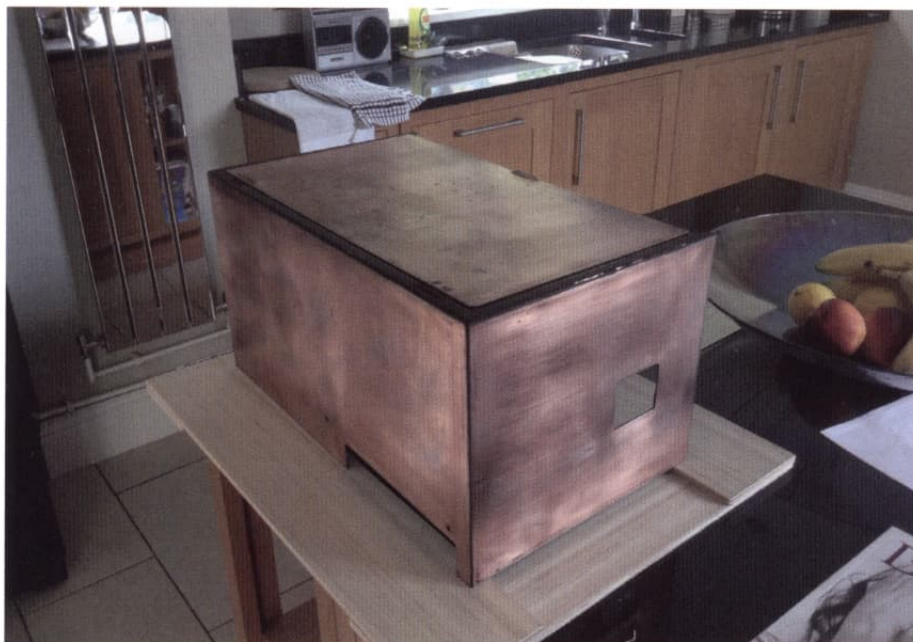
Fig 7. Case stripped for re-painting

I removed and set aside the knobs and valves, then removed the front panel and case. The full extent of the damaged paintwork was now apparent (Fig 6). The paint has a wrinkle black finish and I was wondering how to deal with this when Terry Martini-Yates published his article in the Winter 2014 Bulletin about restoration of a BSR amplifier in which he described the process of re-painting with VHT paint. I bought a spray can of black VHT from Amazon and experimented on a piece of gash steel following Terry's instructions. The result was outstanding. With confidence that I could achieve a good result, I set about stripping the old paint. I found that soaking in methylated spirits and scrubbing with 80 grade paper was effective. The few stubborn final patches succumbed to nitromores leaving the copper plating exposed, clean and ready to accept new paint (Fig 7). Painting the case, which comprised a right and left side, rear panel and hinged top panel was straightforward. I used pvc tape to mask the hinges to avoid sticking them together with paint. The front panel wasn't so easy. There are a number of dome head rivets that hold the model number plate, AVC and B+ switch legends and a couple which provide a pointer to the numbering on control knobs. I didn't want to remove any of these because I thought it unlikely I could find matching replacement rivets. Instead, I applied pvc tape to mask these items, carefully cut round with a modelling knife before applying paint. The re-painted case and front panel were every bit as impressive as my practice piece (Fig 8).

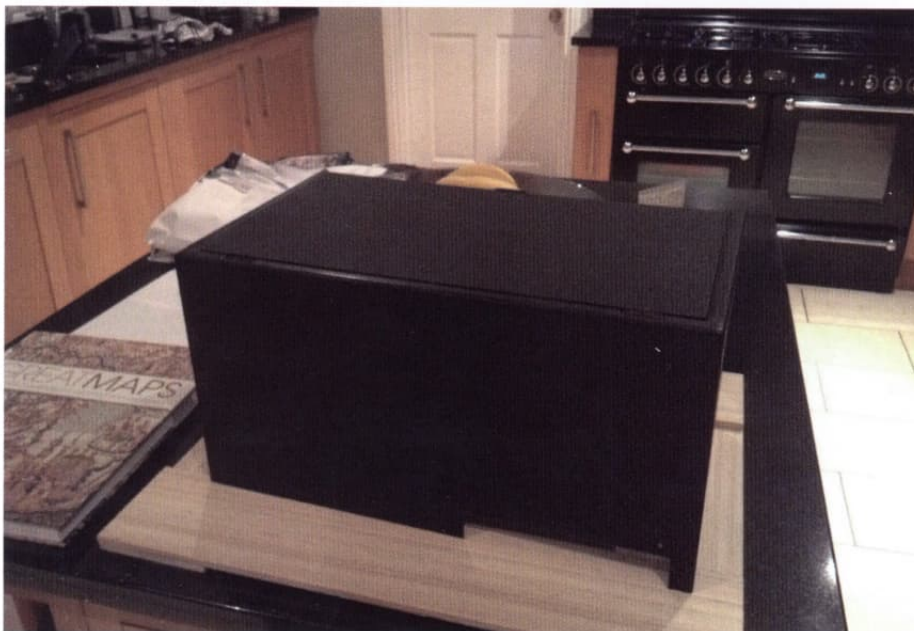
Fig 8. Re-painted case

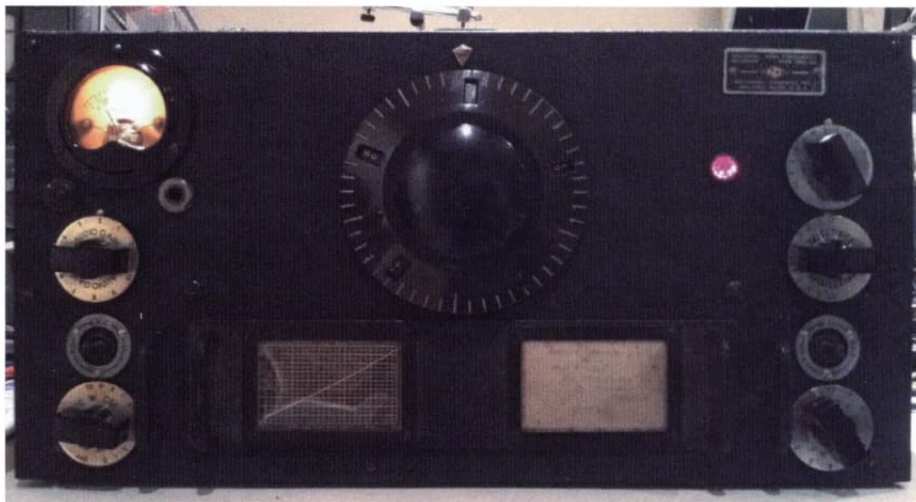
Fig 10. Restored receiver (front view)

I then replaced the front panel and case. Before replacing the knobs I carefully cleaned them with Brasso. The same treatment returned the S meter to its original condition. Before replacing the vernier tuning dial, I removed and cleaned the rear plate which was sticky with grease and dust. I toyed with the idea of scraping out and renewing the paint on the graticule lines but decided the best treatment was to leave as original. (Fig 9 and 10 show the re-assembled receiver).

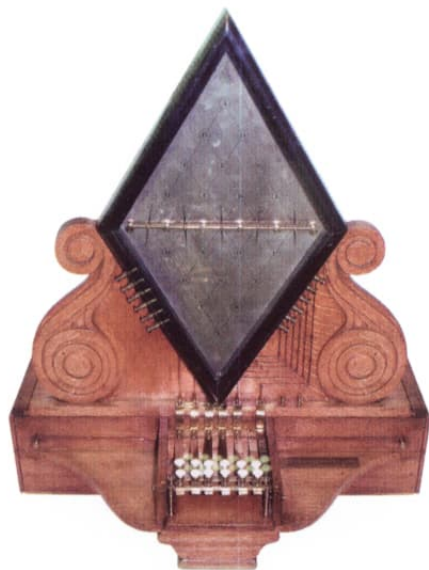
Fig. 2: Cooke & Wheatstone's five-needle telegraph of 1837 (Science Museum London)

joined forces and patented the result of their joint labours as the five-needle telegraph (Fig. 2) and added various alarm devices.

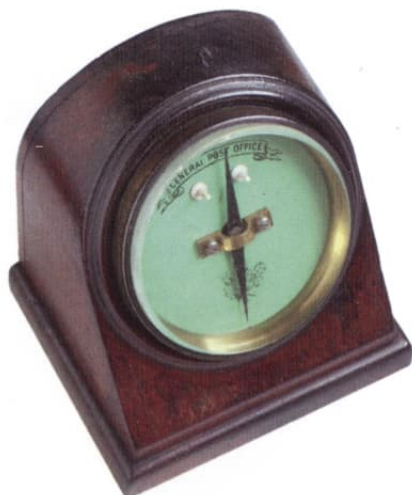
Fig. 3a: General Post Office single needle telegraph receiver

Expansion to the system was made using first, a two-needle instrument, then the single-needle system which formed the basis of the railway block system and later also, using a mirror galvanometer for submarine telegraphy. Morse had patented his telegraph system in the USA in late 1837 using his code of dots and dashes using the simplest signals for the most frequent letters (e.g. a single dot for 'E' and single dash for 'T'). In the single-needle and cable code versions of Morse a dot is represented by a left deflection and a dash by a right (Fig. 3a&b). It was soon found that railway use occupied but little time so that spare periods could be utilised for paid messages.

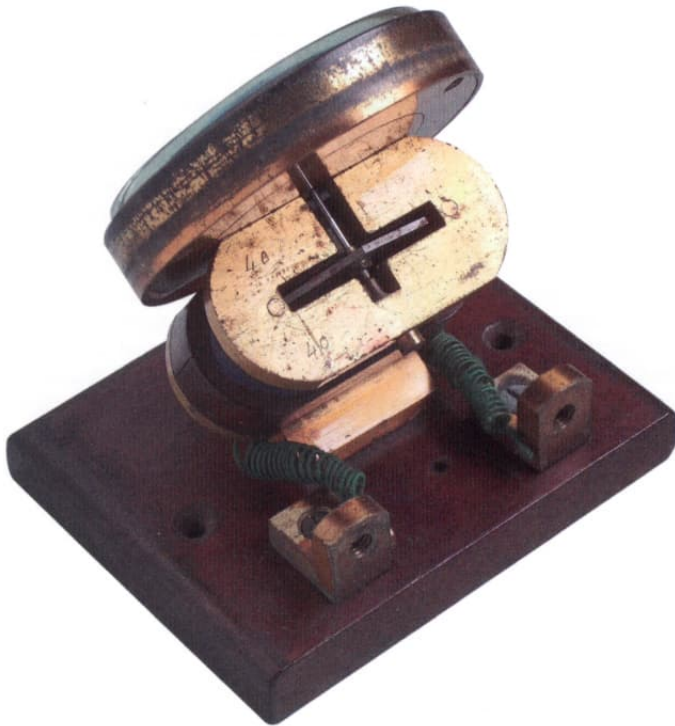
Fig. 3b: General Post Office single needle telegraph receiver

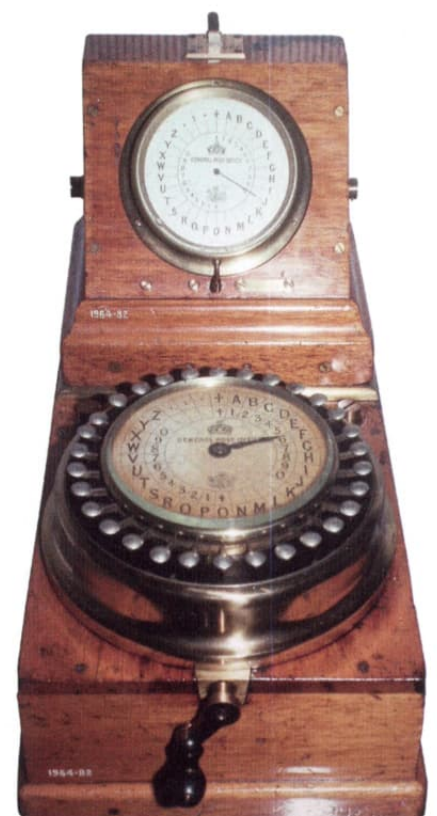
Fig. 5: General Post Office ABC telegraph sender & receiver (Science Museum London)

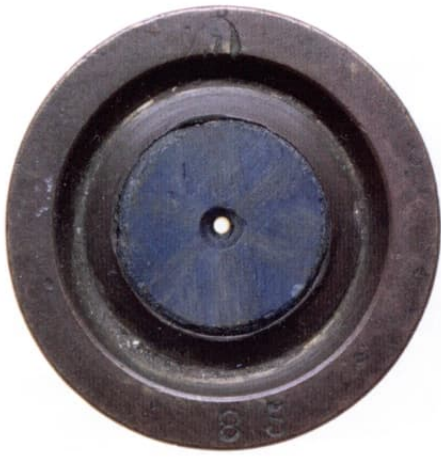
Fig. 6: Feldspar wire drawing die, 30mm diameter

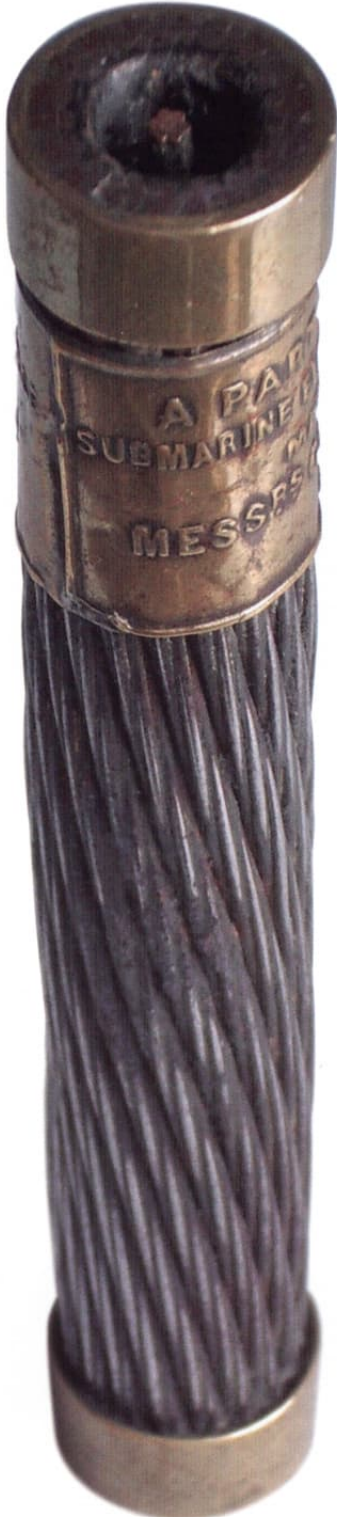
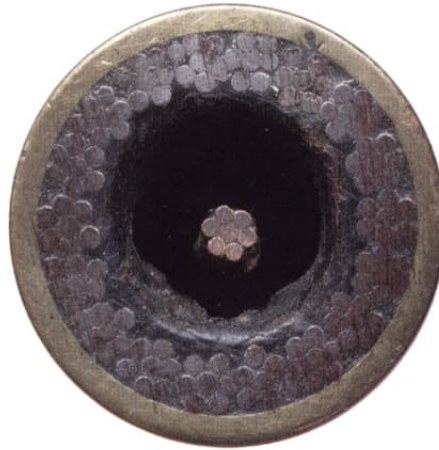
Fig. 8a: 1857/8 transatlantic cable by Glass Elliot & Co. (left hand lay, western half)

Fig. 8b: 1857/8 transatlantic cable by Glass Elliot & Co. (left hand lay, western half) 17mm diameter

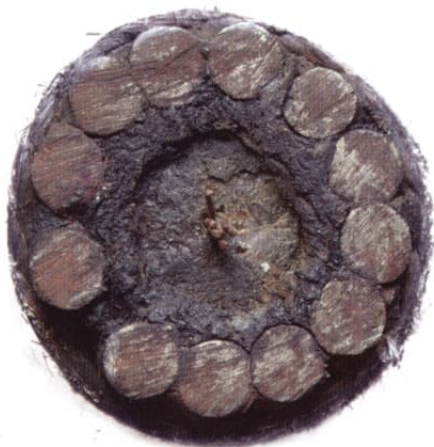
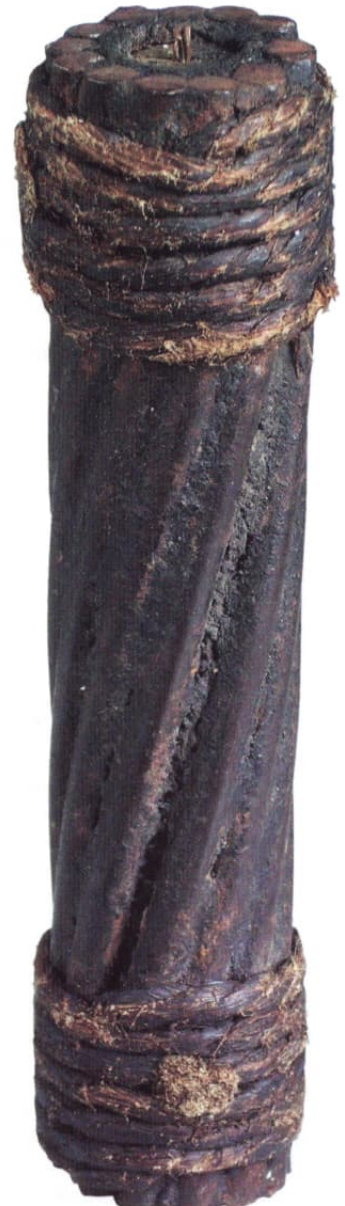
Fig. 9b: 1857/8 shore end cable by RS Newell & Co (right hand lay, Irish end) 41mm diameter

Fig. 9a: 1857/8 shore end cable by RS Newell & Co (right hand lay, Irish end)

The shore ends of the cable need to be much heavier and stronger to avoid damage both from tidal and ocean currents abrading the cable against rocks, and from being caught and broken by ships anchors. This takes the cable into deep water either in one stage or sometimes with an intermediate section. An example of the shore end Atlantic cable laid in 1857 at the Irish end is shown in Fig. 9 which would have been made RS Newell.

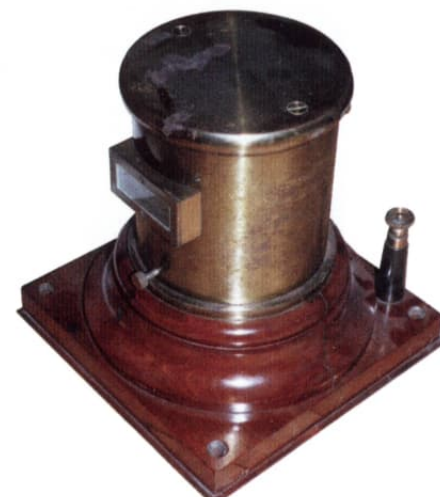
Fig. 12: Iron clad version of marine galvanometer by Elliott Bros (Science Museum London)

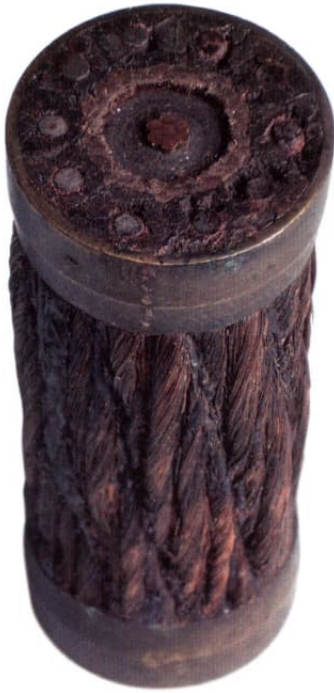
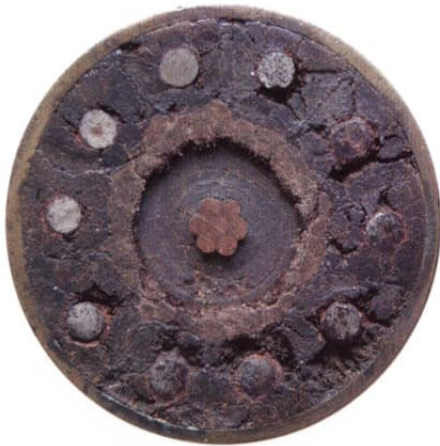
Fig. 13a: 1865 transatlantic cable

Fig. 13b: 1865 transatlantic cable. 29mm diameter

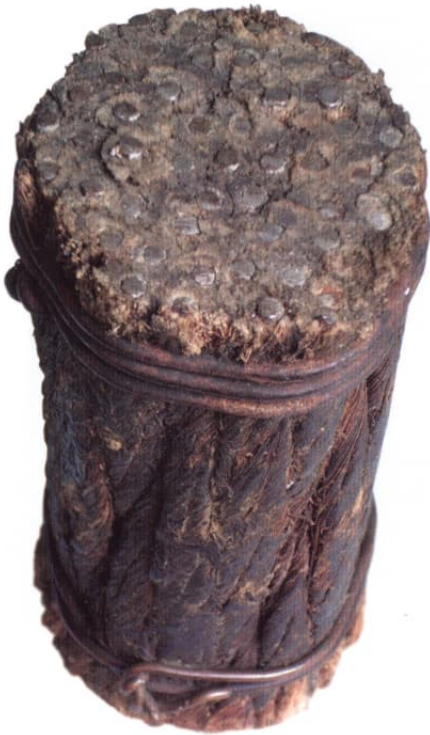
Fig. 16: 49 strand grappling cable for 1866 recovery of 1865 cable. 48mm diameter

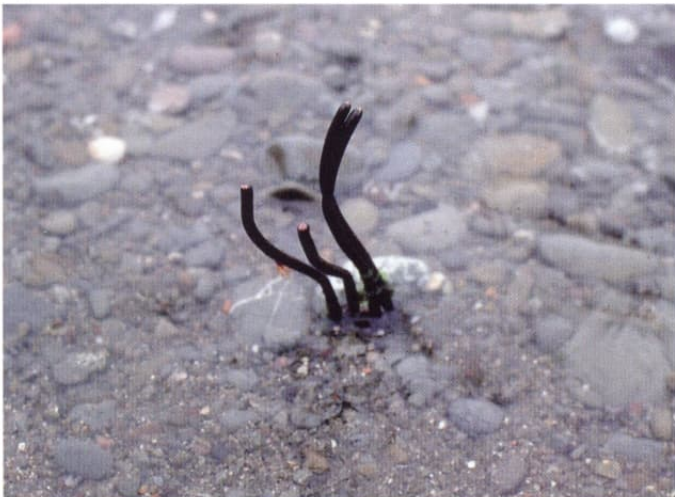
Fig. 19: Portpatrick four channel cable emerging from the sea

Before we crossed from Stranraer we visited Portpatrick and found the cable hut (Fig. 17), the yellow diamond shaped warning to shipping of the cable, and an exposed section of cable (Fig. 18). Two sections of four-core cable were also found, one with the four gutta percha covered conductors rising directly out of the water (Fig. 19) and the other further up the beach (Fig. 20a). The end of the latter was cut off and reconstructed with string replacing the original decomposed hemp or manila (Fig. 20b). These appeared to be part of the same cable and different from the more heavily armoured section in Fig. 18 which was left intact. It is not known when these cables were laid, but the first ones to Donaghadee and Whitehead of 1853 and 1854 were both six-core cables.

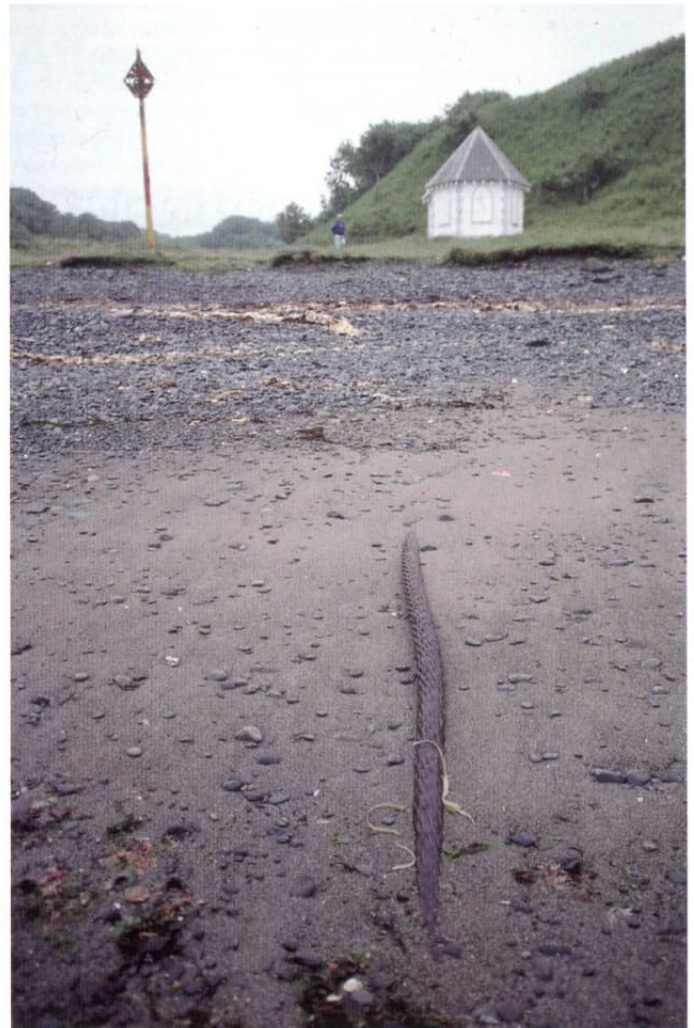
Fig. 18: Exposed cable, diamond cable marker & cable station

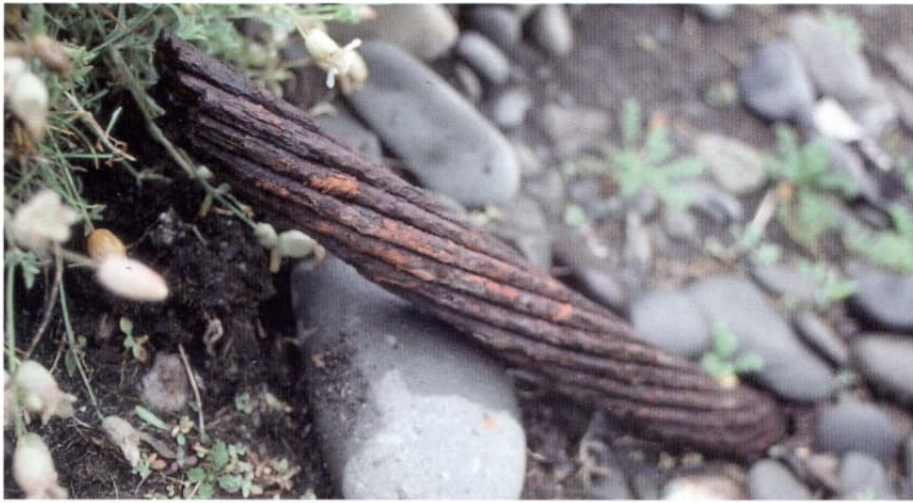
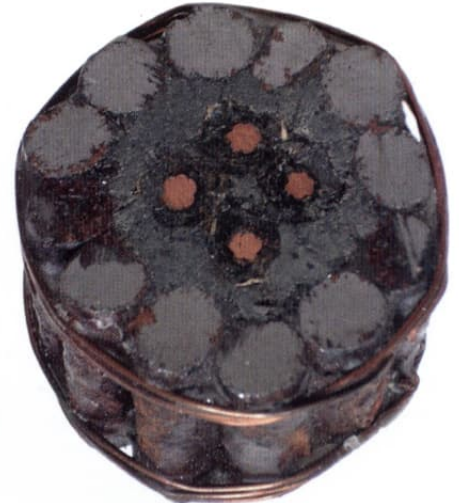
Fig. 20a: Portpatrick four channel cable emerging from beach (presumably same cable as Fig. 19)

Fig. 20b: Reconstructed section of Fig. 20a 38mm dia

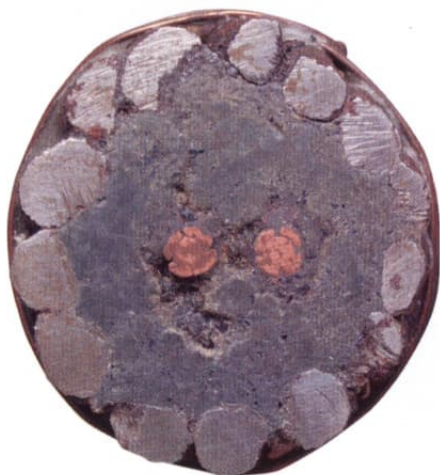
Fig. 27: Reconstructed cable section from Knightstown harbour with five sector conductors. 37mm dia.

Further south in Kerry we found White Strand, Ballycarberry Bay (Fig. 26), where the cable had been landed from the *Niagara* in 1857, and presumably where the later cables terminating on Valencia Island were linked to the mainland, but found no trace of cable. In Knightstown harbour we found a 2-core cable, probably the shore end of a much later Atlantic cable. The second conductor may have been for a sea earth, taken some distance out to sea, to avoid the electrical ground interference near the coast. It has an interesting construction (Fig.

27) with a single solid 2.3mm copper core wrapped by four copper strips bringing it up to 2.9mm, and armoured with 14 iron wires rusted to about 7mm. Fig. 28 shows the large transatlantic cable station in Knightstown.

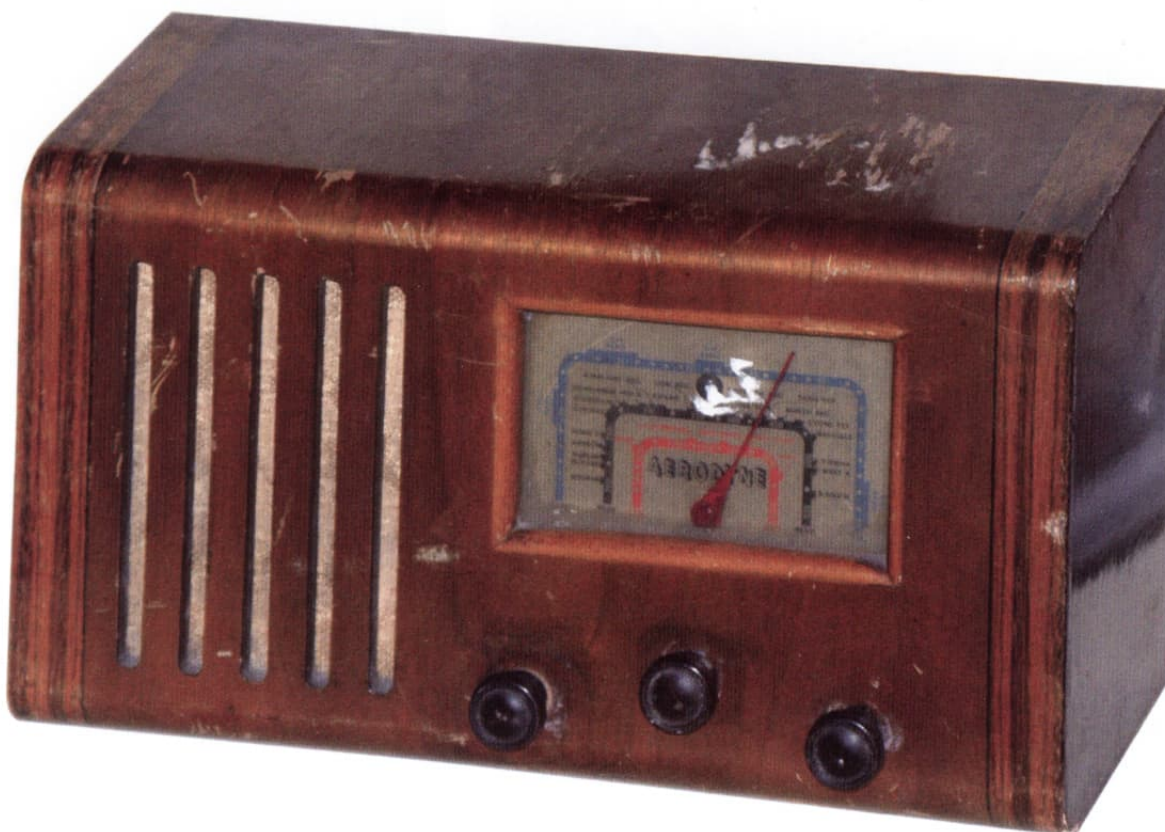
Figure 1:  
Pre-restoration view  
of my tired looking  
Aerodyne-branded  
(at least from the  
front) radio. The dial  
markings look out  
of focus, but this is  
because of the thick  
layer of dust on the  
inside of the dial glass.

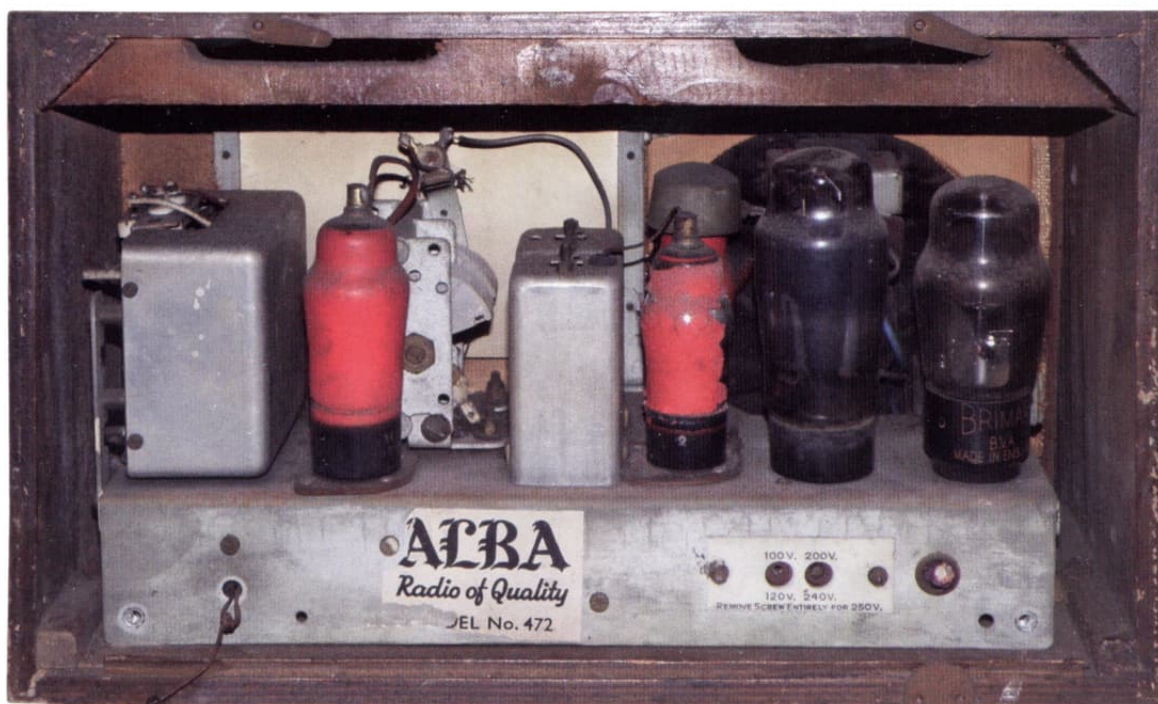
Figure 2: Rear chassis view before restoration, clearly showing the Alba model 472 identity of the radio. The rolled-up throw-out aerial can be seen emanating from the left side of the chassis.

Once I'd got the radio home, I could investigate its parentage in more detail. Looking at the pictures on the Swiss Radiomuseum website and in Jonathan Hill's *Radio! Radio!*, A J Balcombe Ltd's Alba 472 and the Aerodyne 302 cabinets are of similar size, and the positioning of the control knobs, tuning dials and speaker grilles hint at the same chassis being used for the two radios. However the Alba version should have the name 'Alba', and the Aerodyne should have 'Aerodyne', printed on its dial. Also the Aerodyne dial should have a single dial bulb, more-or-less centrally located (as on my radio), whereas, according to its service sheet, the Alba radio should have two dial lights mounted further back on the chassis, illuminating a translucent dial from behind. So a clearly labelled Alba 472 chassis (like mine, see Figure 2) should not have an Aerodyne-branded dial with its single bulb.

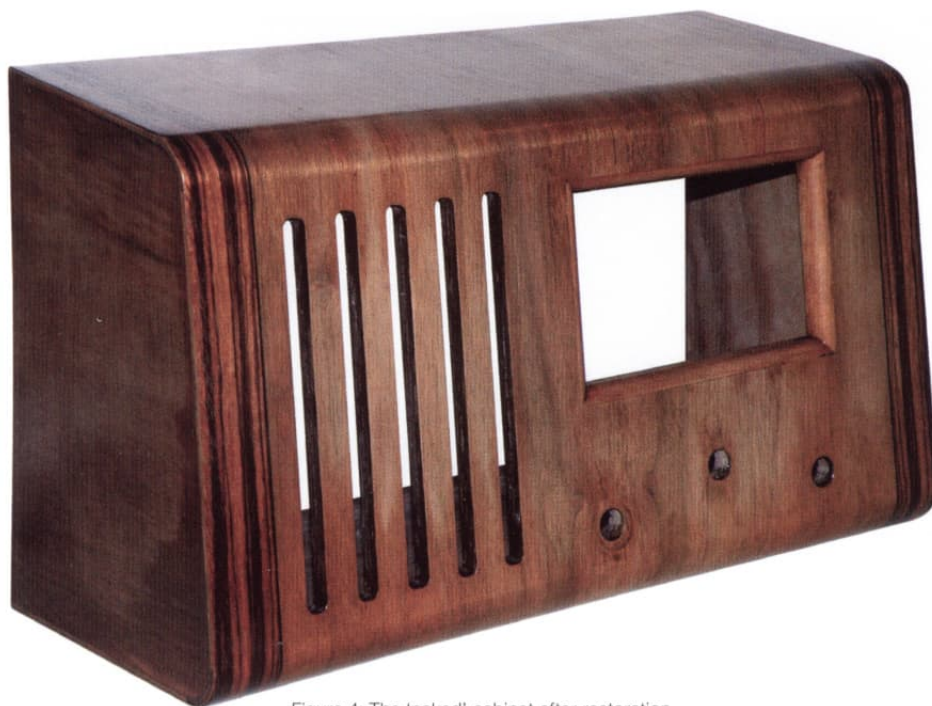
Figure 4: The 'naked' cabinet after restoration.

then polished it with furniture polish. The edges of the five speaker slots were touched up with brown paint to bring them back to original condition. I fitted four new rubber feet to lift the cabinet above table level, to allow air to circulate into the chassis from below. I was very pleased with the result. Figure 4 shows the cabinet after restoration and before the dial glass, speaker cloth and the chassis had been re-inserted.

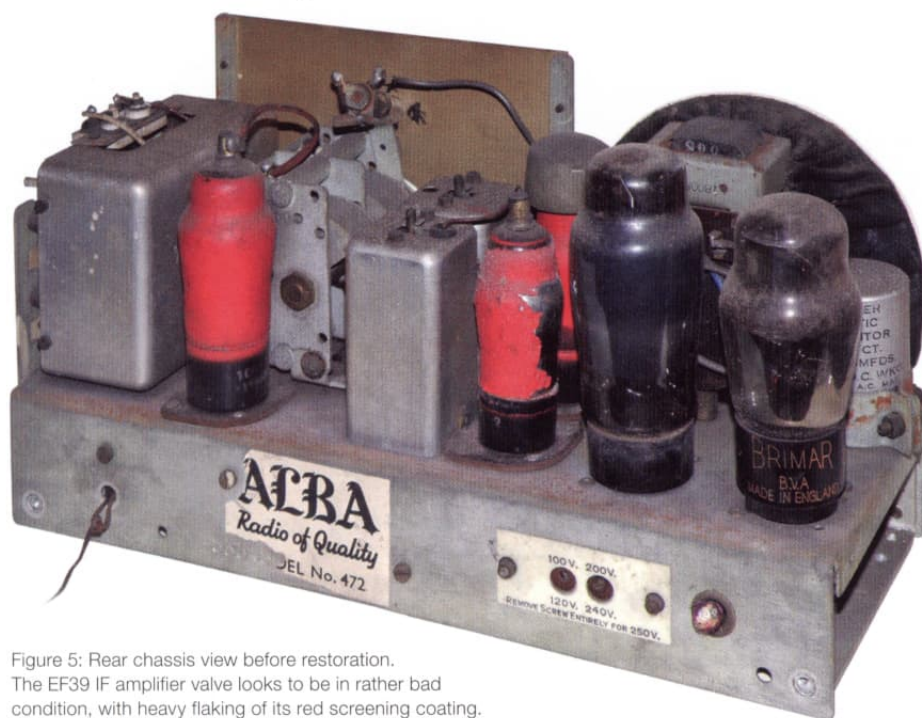
Figure 5: Rear chassis view before restoration. The EF39 IF amplifier valve looks to be in rather bad condition, with heavy flaking of its red screening coating.

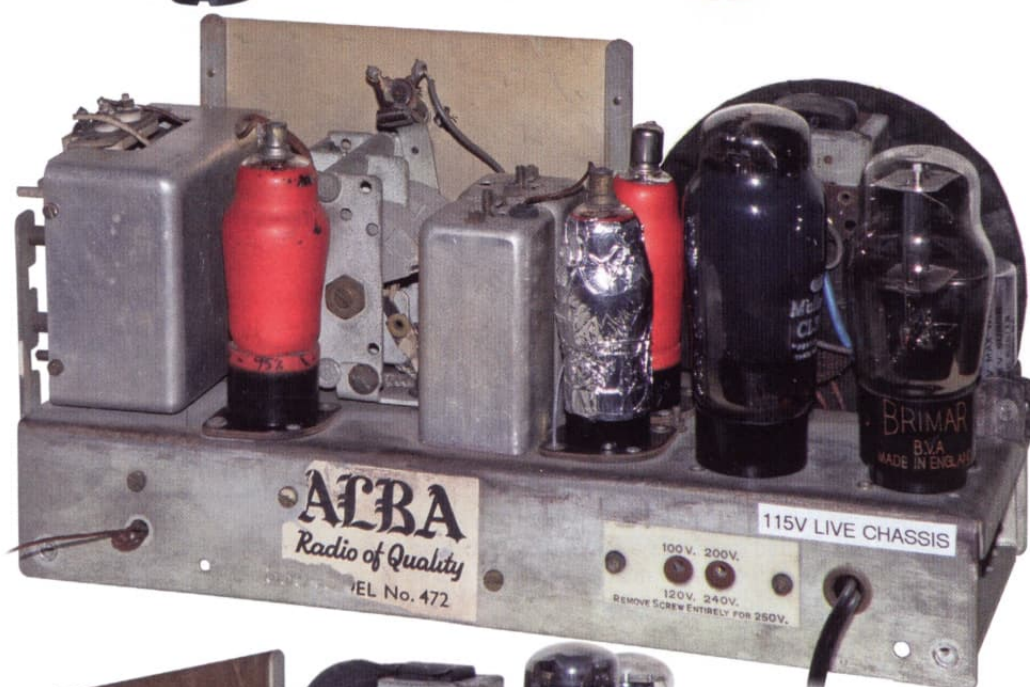
Left: Figure 7: Rear of the chassis after restoration. The EF39 IF amplifier valve is the original, wrapped in grounded aluminium foil to restore its screening.

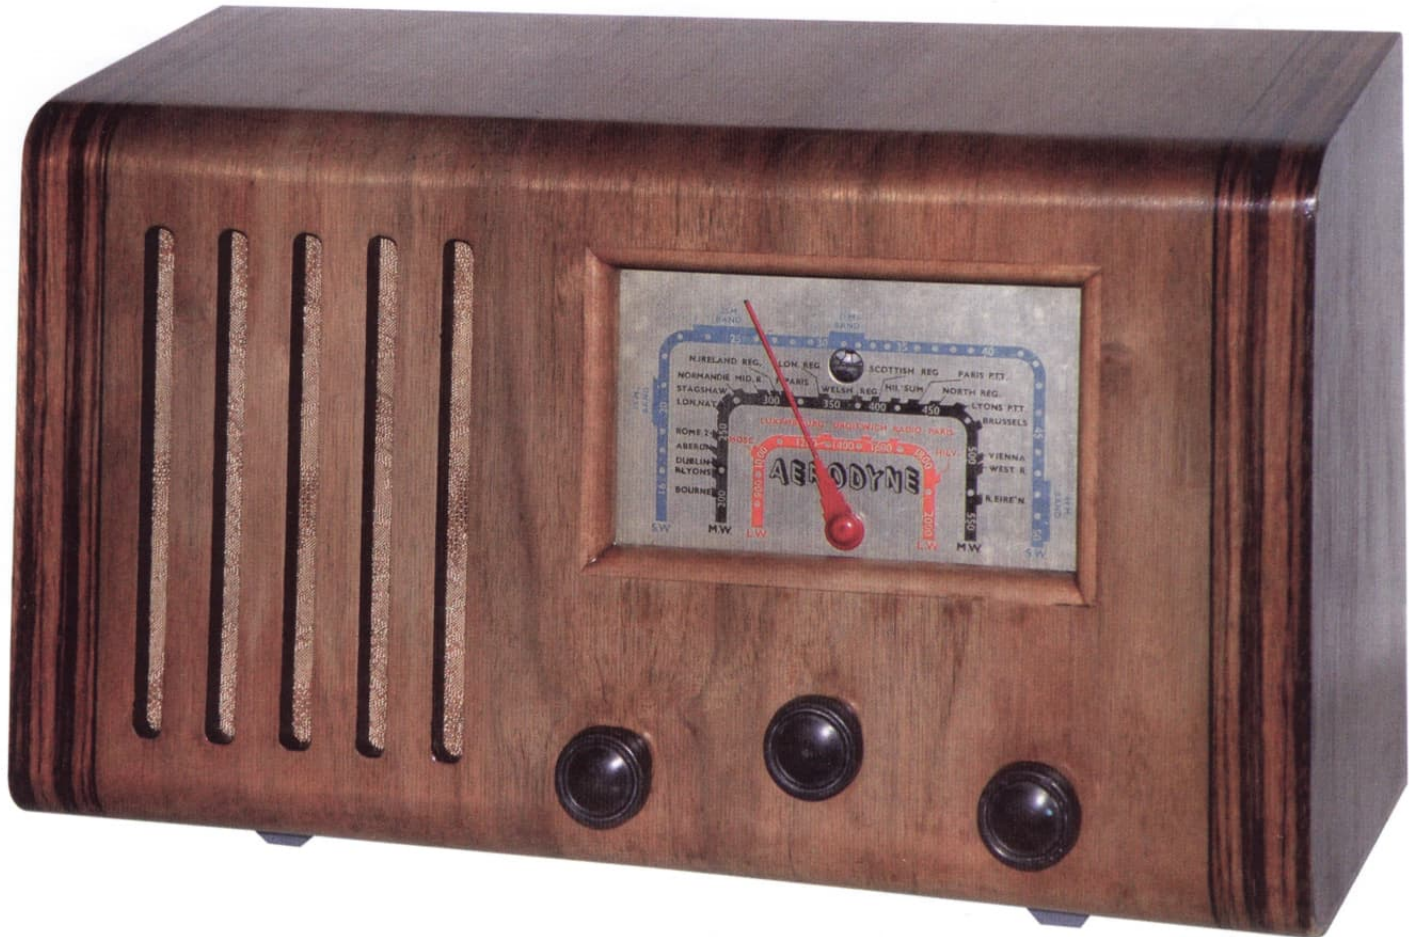
Figure 10: Restored condition of my Alba 472 with an Aerodyne dial. The knobs are original, though I think they let the side down slightly now that the cabinet colour has been lightened.

The cleaned dial glass was re-attached to the cabinet, as was the speaker cloth and its cardboard surround. The chassis could now be slid back into the cabinet and attached via its four fixing screws, and the knobs re-fixed. Because the cabinet's feet were missing, I covered the exposed chassis fixing screws with insulation tape so that they could not be touched. Figure 10 shows the restored condition of the radio. The knobs are original, though I think they look rather dated even for the mid-1940s, and let the side down slightly.

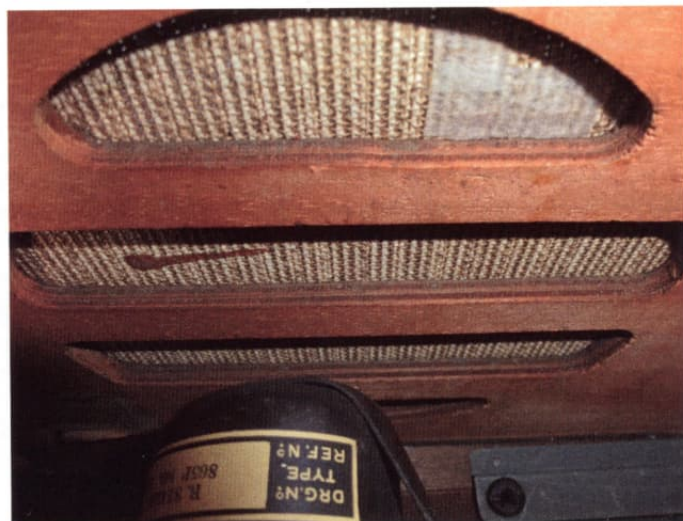
Internal fabric repair to rear cabinet vent (top, right of picture)

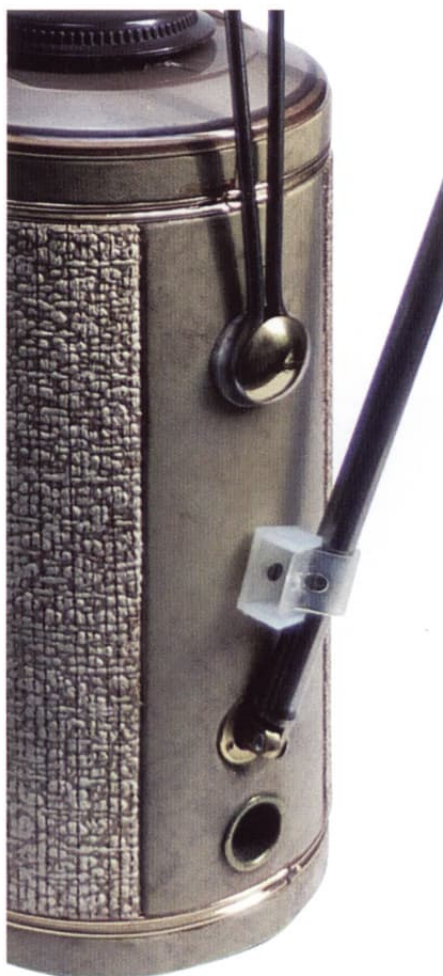
Modified antenna

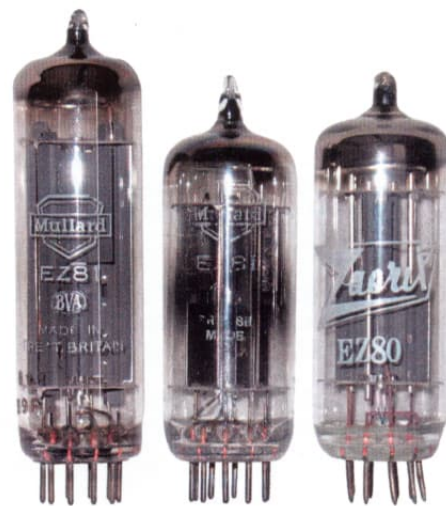
The Mullard EZ81, GEC Z709/EZ81, and Zaeux EZ80
