The Bulletin

Vol. 41 no. 3 Autumn 2016 www.bvws.org.uk BVWS 40th Anniversary

- 2 Advertisement
- 3 From the Chair
- 4 Fixing my Bush TV22
- 11 BVWS members display historic apparatus at Chelmsford
- 12 Repairing Record Autochangers
- 14 PICGEN: a 405 line pattern generator that produces sixteen test patterns two of which are Test cards

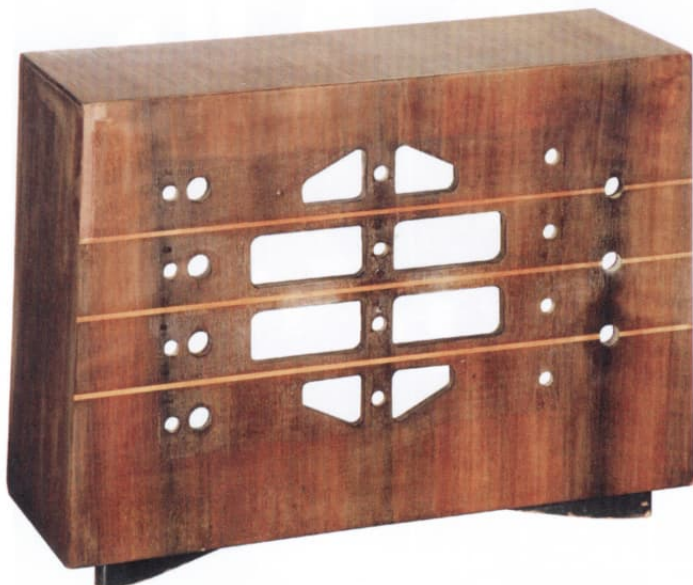
Figure 6: The stripped down cabinet, with the repair to the veneer in the top left hand corner, awaiting varnishing. I've been careful not to rub down the surface too much, to retain the 65 years old patina. The central openings allow the sound from the 8-inch Goodmans speaker to escape.

The wooden cabinet was generally in good condition: the varnish layer had lots of scratches and dings, but most of these did not extend into the veneer itself. All the veneer was attached apart from a small section at the top left hand corner of the front which had gone missing. I removed the plastic sections which effectively formed the speaker grille and the four station indicator panels, and the speaker itself. As well as being attached with screws from the inside, these plastic sections were lightly attached to the front panel with a few dabs of glue, presumably to stop them from rattling in sympathy with the audio output, but this glue was easy to scrape off and didn't damage the veneer.

Figure 6 shows the stripped down cabinet, with the repair to the veneer in the top left hand corner, awaiting varnishing.

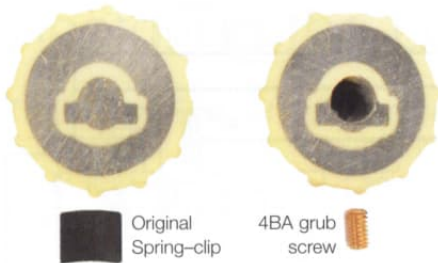
Fig 4: Spring-clip removed, knob filled, drilled out to 6mm, and a 4BA grub screw fitted in the side.

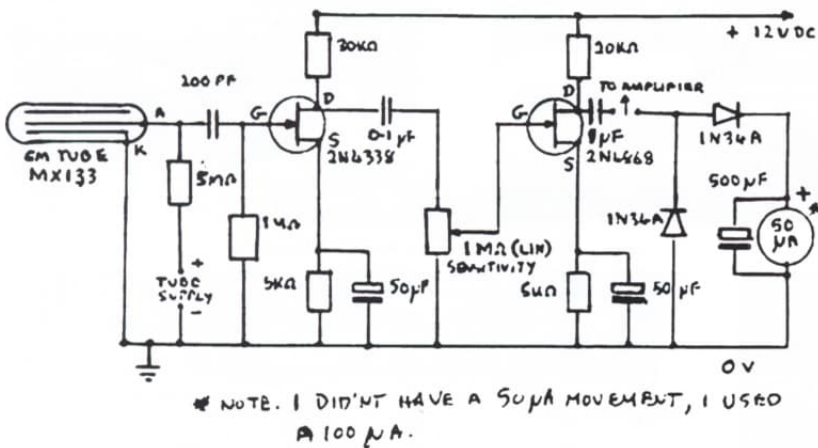
Fig.1: The circuit as found in the book.
