BRITISH VINTAGE WIRELESS SOCIETY  
≡ BULLETIN ≡  
VOL 42 • SPRING 2017

## McMichael Twin Supervox 20 years in repair...

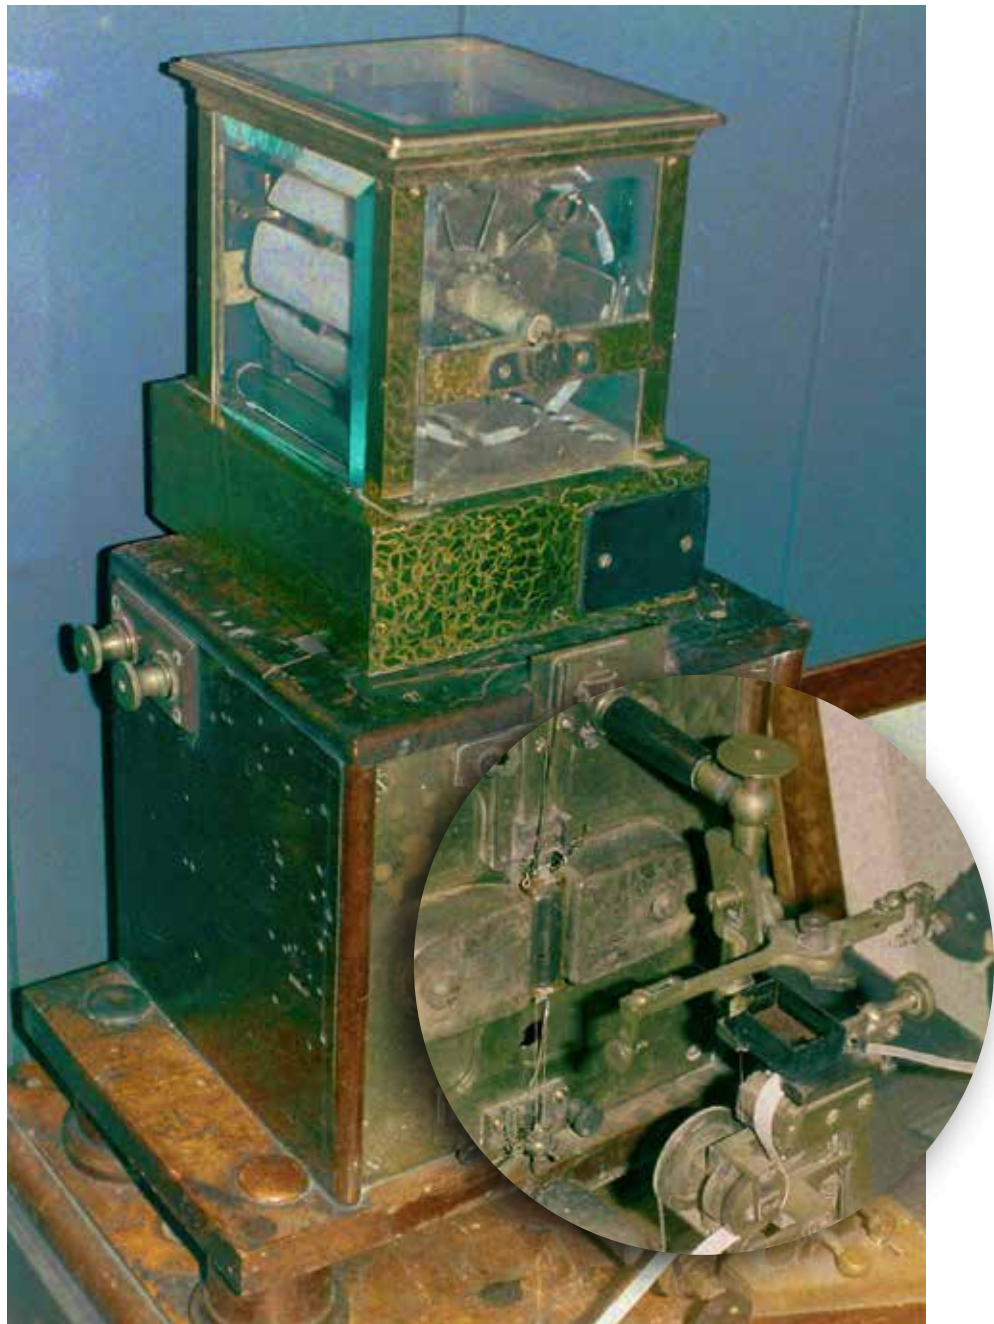
The whole siphon assembly is insulated from the rest of the instrument and connected to an electrostatic generator within the "mousemill" motor, the glazed brass device on top. A cylindrical array of brass and magnetic sectors is rotated by an armature below to drive both the paper and an electrostatic generator. The latter attracts the ink to the paper making a dot. Thus as the paper is drawn through a trace of fine dots is produced with lateral deflections produced by the positive or negative current applied to the moving coil. This was an expensive and bulky piece of equipment and many cable companies were slow to take it up but it later became almost universal over many years. It was soon found that electrostatic devices are unreliable in humid atmospheres so the electrostatic generator was replaced by a vibrator attached by a thread to the pen on later models. Several manufacturers produced their own version of the instrument, Fig. 12 showing an example by Muirhead and Fig. 13 one by Tinsley. Fig. 14 (top) shows an example of a siphon recording of the letters 'a' to 'h' with corresponding perforated tape version below. The equivalent Morse symbols

Fig. 11a William Thomson's (Lord Kelvin's) siphon recorder (Porthcurno)

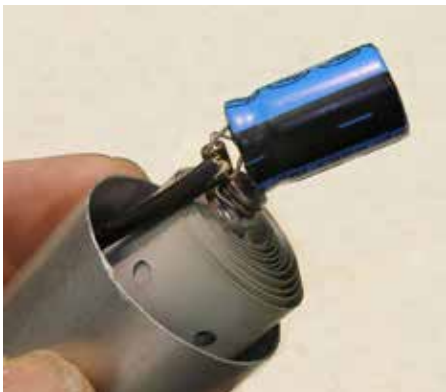
Fig. 20 – Mounting replacement electrolytic to the top of the central aluminum post.

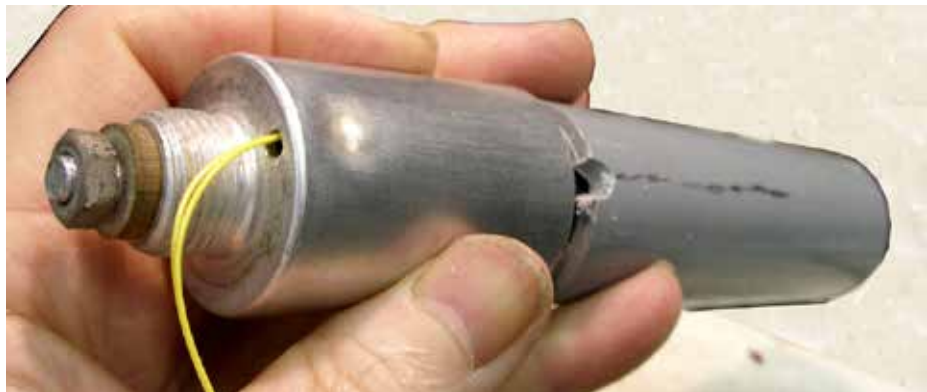
Fig. 21 – Condenser – Wire brought out of base and PVC pipe used to insulate old positive spiral plate.

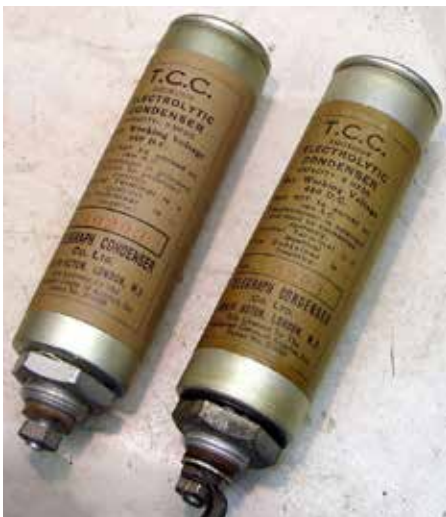
Fig. 22 – Condenser – Comparison of original and rebuilt & modified replacement.

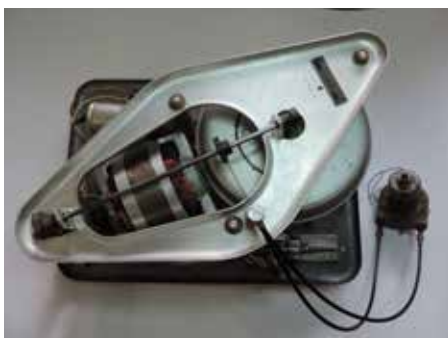
The underside of the deck showing the general transport arrangements, with the Bowden cable controlling the rotation of the cams that are positioned at either side of the deck depending on the positioning of the deck control. The main control mechanism can be seen on the far right which also houses the lock solenoid.

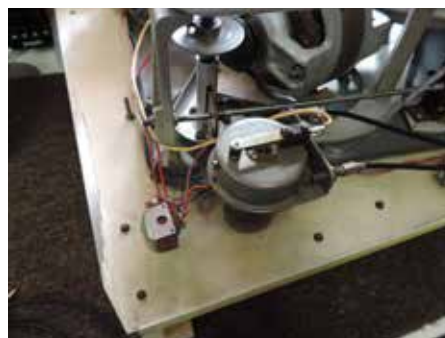
Close up of the lock solenoid assembly and the motor supply contact.

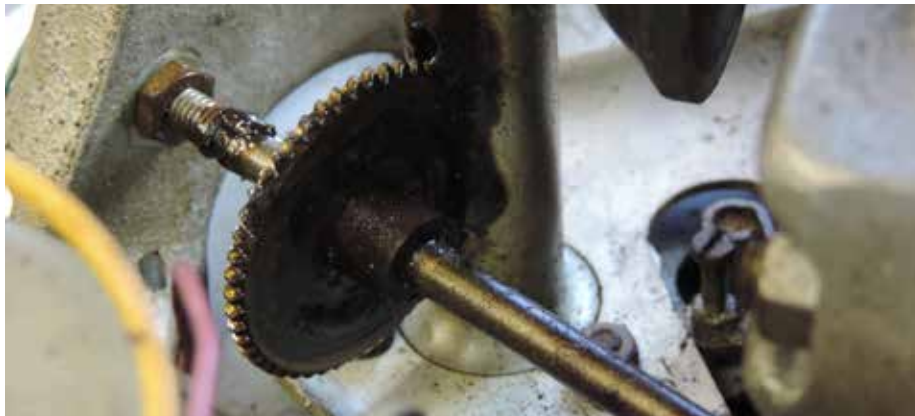
The underside of the worm drive assembly that couples the spool carrier hub to the drive. The muck seen here was almost solid.

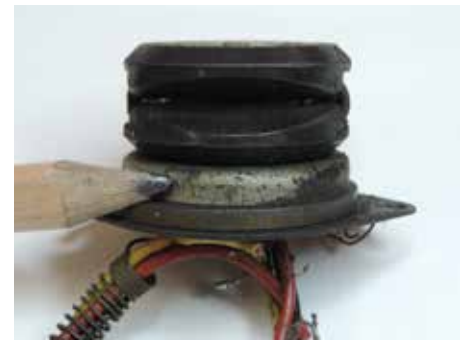
The recording head completely dismantled. The general dirt and dust that was found can be seen prior to cleaning. The slot can be seen where the wire travels across the head which is a combined type and incorporates the bias, erase and record/replay windings.

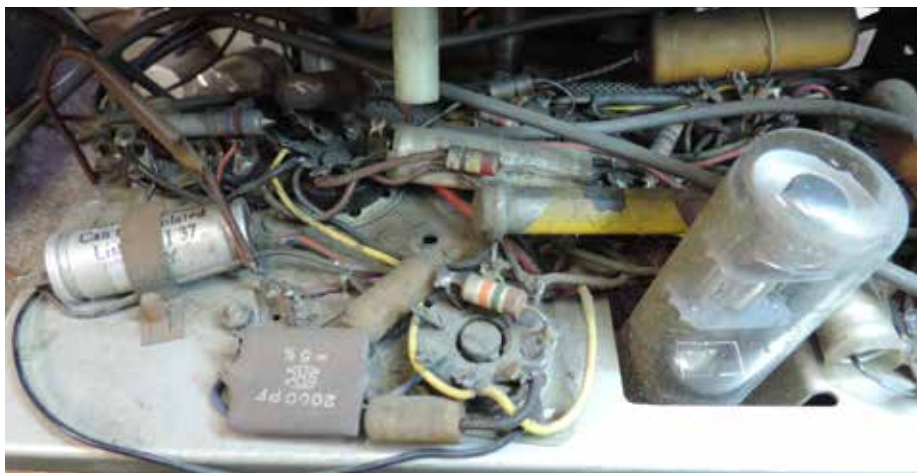
The unrestored amplifier as found. Just look at all those waxies!

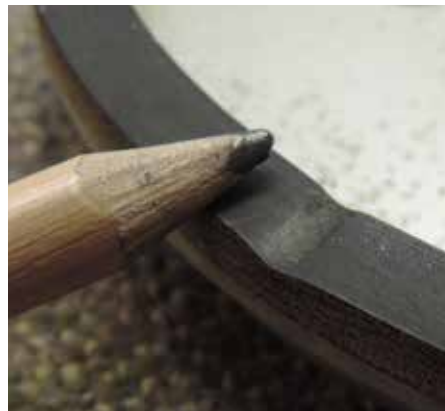
The damage caused to the flywheel rubber rim can be seen here and just goes to show how much damage can be caused by carelessly leaving the deck in the play position for a period of time.

The turntable flywheel was examined and it was discovered that there was a small flat embedded in the rubber surface which had been formed because the machine had been left in the play position. The only treatment for this was a very fine sanding of the rubber surface until most of the flat had been removed. This action called for very careful attention as too much sanding could have

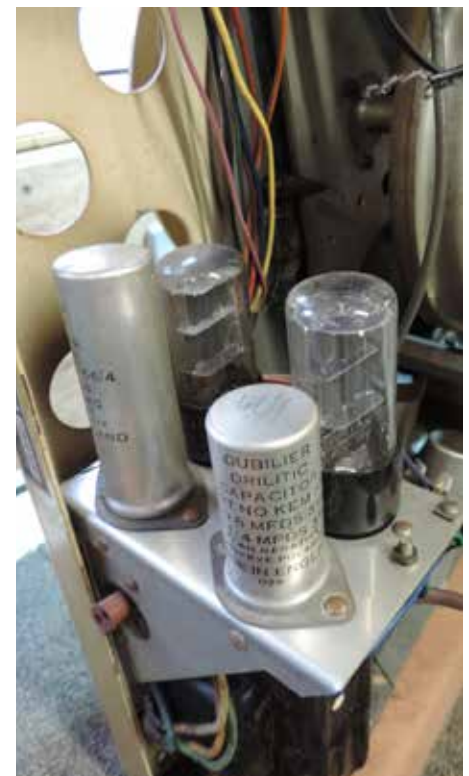
The power supply unit as found. The two 6X5G rectifiers and associated smoothing can be seen here.

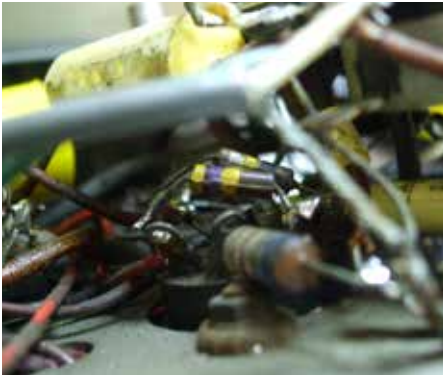
A gut feeling about these two resistors found on V1, proved to be right. Both had nearly doubled in value.

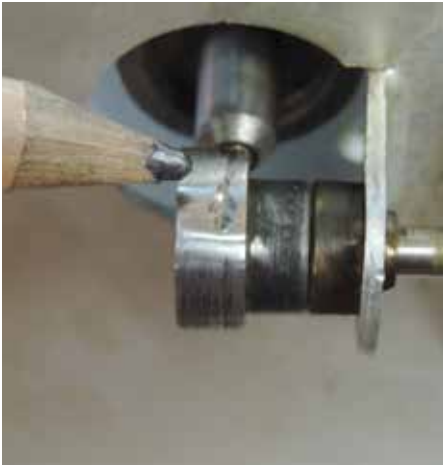
The extensive damage on the play cam can be seen in this picture.

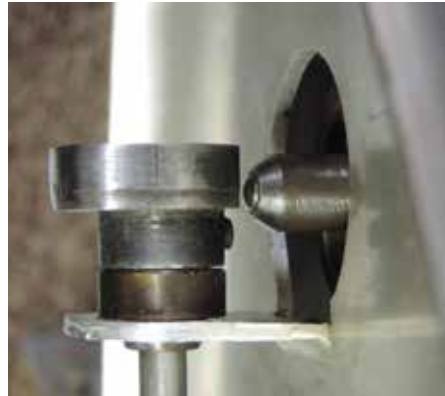
With the turntable drum dropped into the play position the general mis-alignment with the top of the cam can be seen. The bearing should be resting on top of the cam so that turntable drum is lifted clear of the deck plate in play or rewind mode.

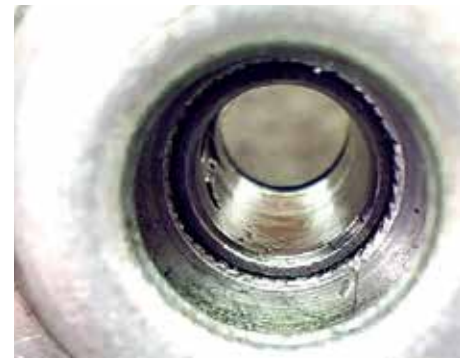
Although difficult to spot at first, the image captured here via an endoscope camera shows sections of wear seen inside the motor bearing housing, and was part of the cause of the stiffness found with-in the motor in general.
