BRITISH VINTAGE WIRELESS SOCIETY
=BULLETIN=

VOL 42 • AUTUMN 2017

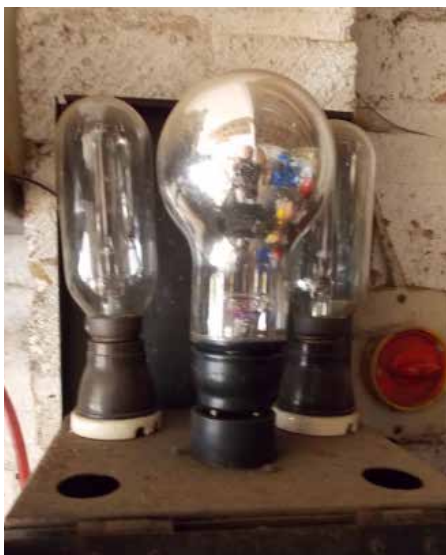
Fig 1 Interior of charger showing low voltage "Tungar" rectifier valve.

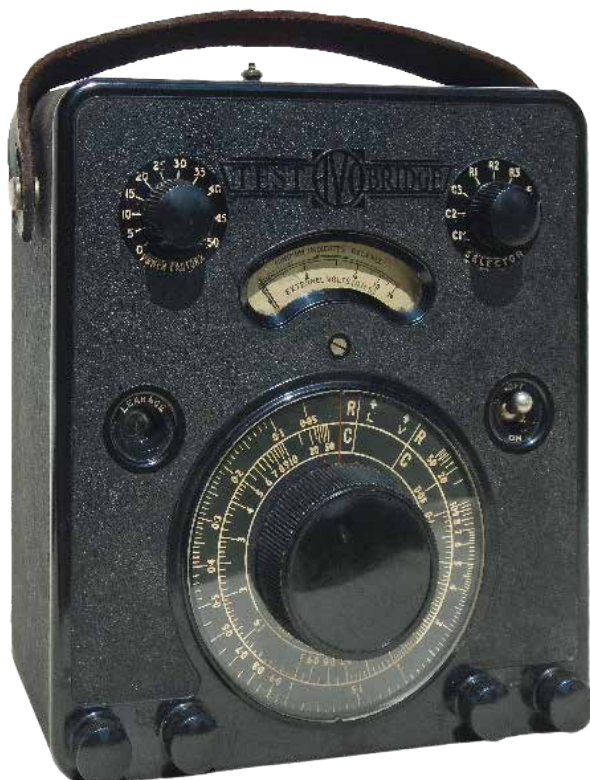
A. AVO Test Bridge three quarter view

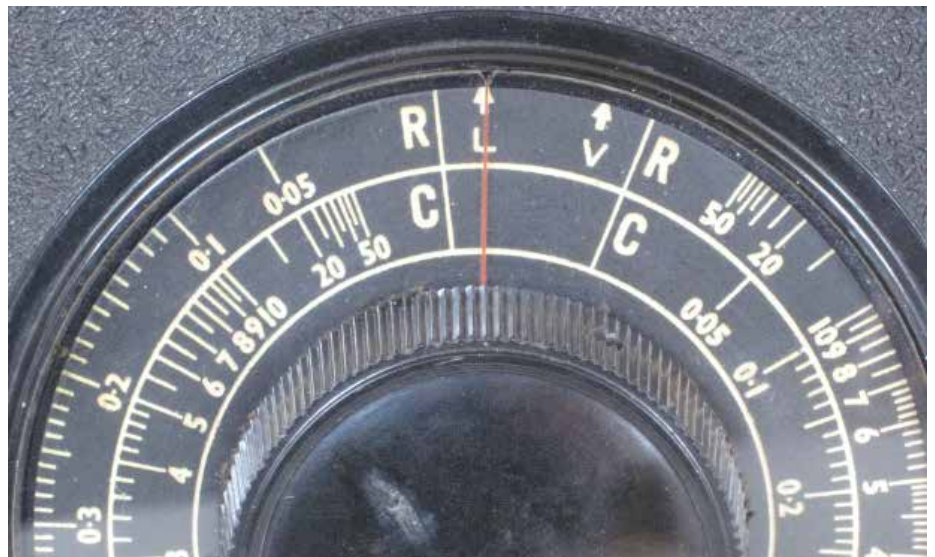
D. AVO Test Bridge close in scale

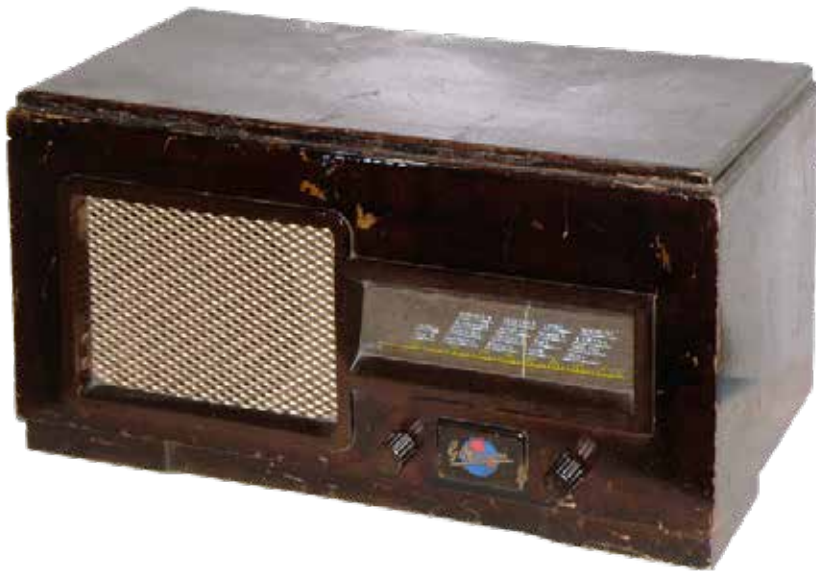
Figure 1: The 'as received' condition of the mystery radio.

Once it arrived I could start to investigate exactly what this strange radio was. See Figure 1 for the 'as received' condition, as viewed from the front. A 'G Marconi' badge is mounted between the two knobs, which is why the previous owner had deduced the manufacturer of the radio to be Marconi.

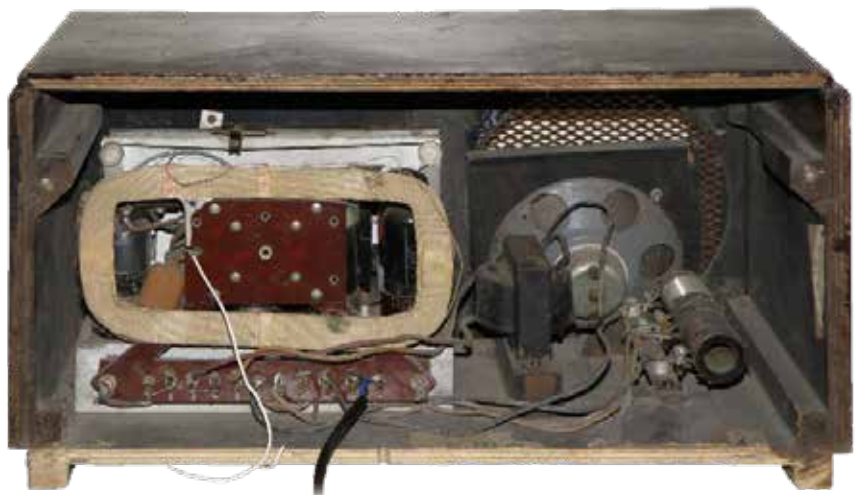
Figure 2: Rear view of the radio, again in 'as received' condition. The 11-way tag strip is stepped away from the chassis by a couple of 1-inch long spacers. The white wire dangling out of the back seems to have been an external aerial connection, but the 'official' connection is to the socket in the middle of the paxolin panel in the frame aerial.

Figure 2 shows a rear view of the radio, again in 'as received' condition. The frame aerial of the radio chassis can be seen to the left, then what seems to be the audio

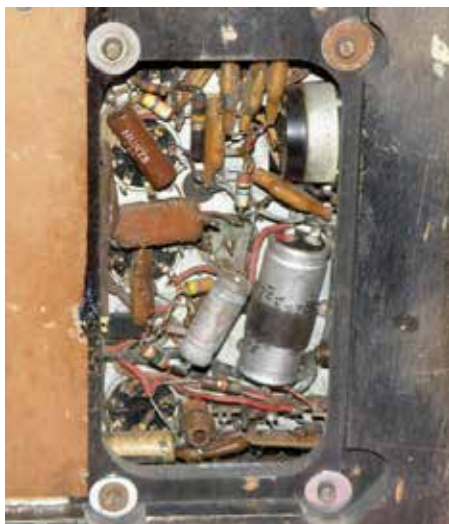
Figure 3: Through the keyhole - bottom view of the radio, with the inspection panel removed, showing the exposed bottom of the chassis in original condition. All the components seem to be original ex-factory. The cut-out also seems to be original, being much neater than I would expect from an amateur. The exposed, and potentially dangerous, chassis fixing screws can also be seen.

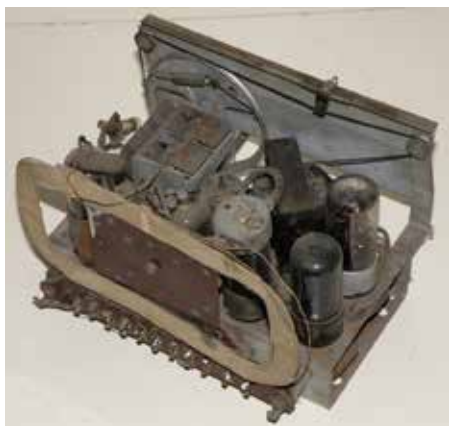
Figure 4: Top rear view of the chassis, showing the large choke at the centre. You should be able to see the small size of the tubular-canned IFTs when compared to the valves, as shown by the one next to the tuning capacitor.

The chassis looked very much like an American five valve AC/DC radio from just before the war, see Figures 4 and 5. It was fitted with a 12K8GT frequency changer; a 12K7GT IF amplifier; a 12Q7GT AGC/ audio detector and triode audio amplifier; and a 35L6GT audio amplifier beam tetrode (all Brimar) line-up, but the rectifier was a Marconi-Osram U76 (more or less like a 35Z4GT, but with a different heater voltage and current rating). The chassis had the serial number 039192 stamped into it, but no indication as to who the manufacturer was. I took a few photos of the chassis and posted them, along with the valve line-up, on the UK Vintage Radio Repair and Restoration forum. I quickly received a couple of helpful replies indicating that the chassis looked very much like that from the Marconiphone T11DA

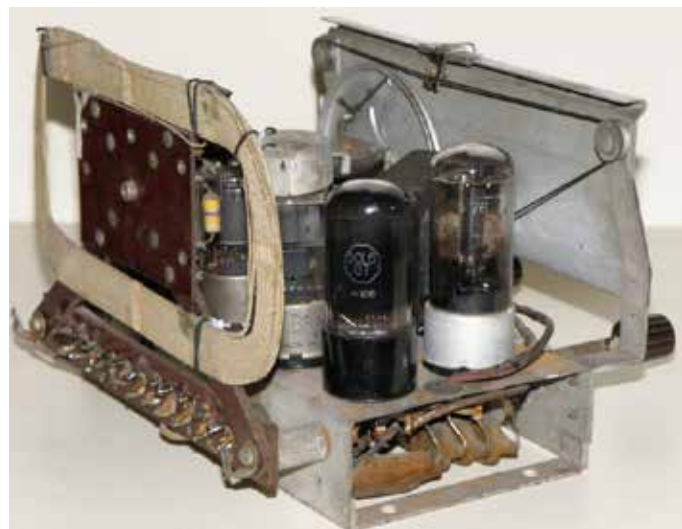
Figure 10: Left hand side of the chassis, showing the frame aerial, and the audio output valve (with a 50L6GT fitted instead of the original 35L6GT) and the original U76 rectifier.

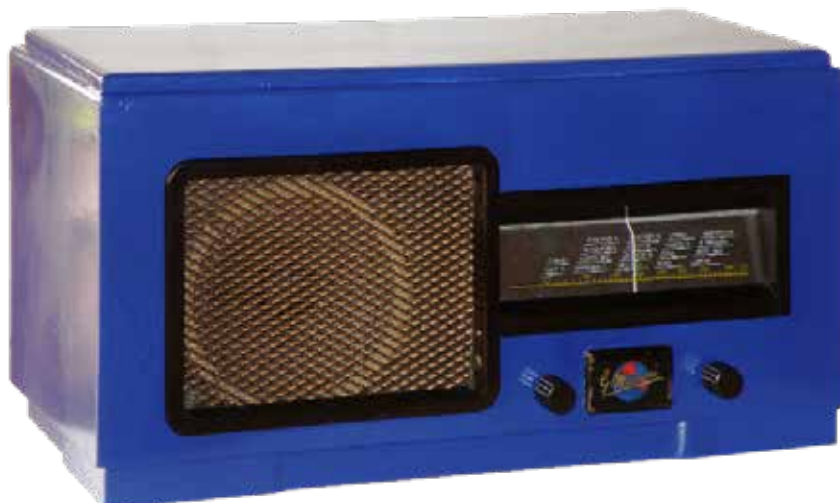
Figure 12: Front view of the restored radio, in its bright new coat of blue paint. The original 'G Marconi' badge has been left in place.

Restoration of the mainly Brimar-valved chassis was relatively simple, and I spent more time on the cabinet, rubbing down the old dark stained and varnished coating, treating it for woodworm, and painting it a bright blue colour. I preserved the 'G Marconi' badge, which had come from inside the lid of the donor radiogram, and was now mounted between the two control knobs, so that any future owner could immediately identify the original manufacturer.

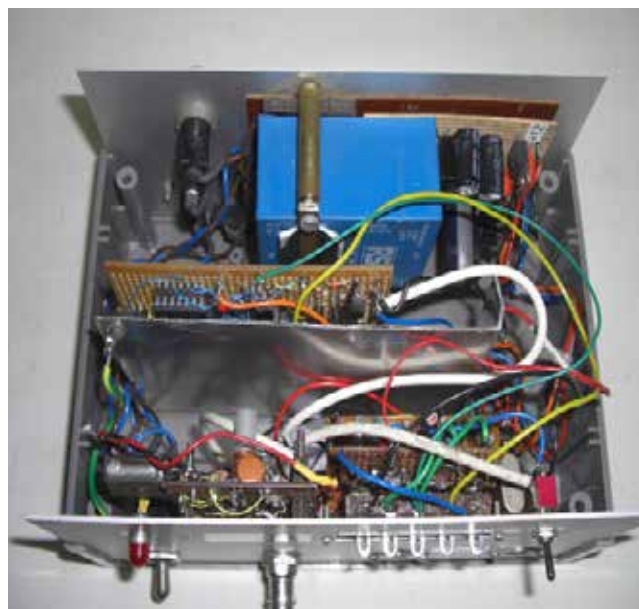
Inside the test card generator box

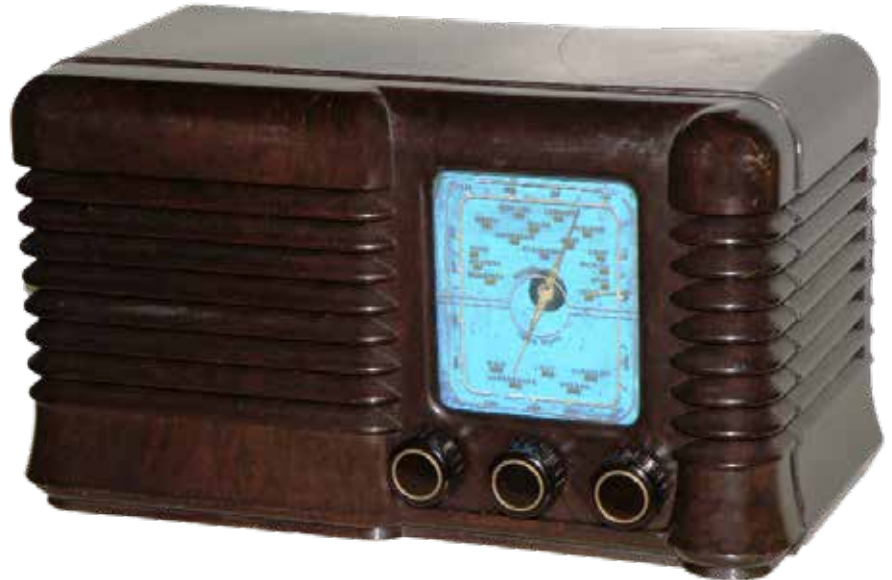
Figure 1: The radio in its restored state. Its intact set of three knobs was what attracted me to the radio, and it barely escaped scrapping to harvest them.

The chassis was made of thin aluminium which of course had not rusted, which was not true of the rear section of the tuning capacitor. The tuning mechanism seemed to work, and the output transformer was still there. A quick check with a meter showed that its windings were of the right resistance, as was the coil on the 5-inch loudspeaker. The Bakelite cabinet had a crack in its top, and although the dual-band dial glass (with no manufacturer's markings) was rattling around and loose, it was intact. The blue-painted dial plate was rusty, but promised an attractive backing to the dial when cleaned up and painted. Overall, the radio was a mess, but restorable, and I decided to save it from the scrapheap. In the end the effort was worth it, see Figure 1 for a photo of the restored radio.

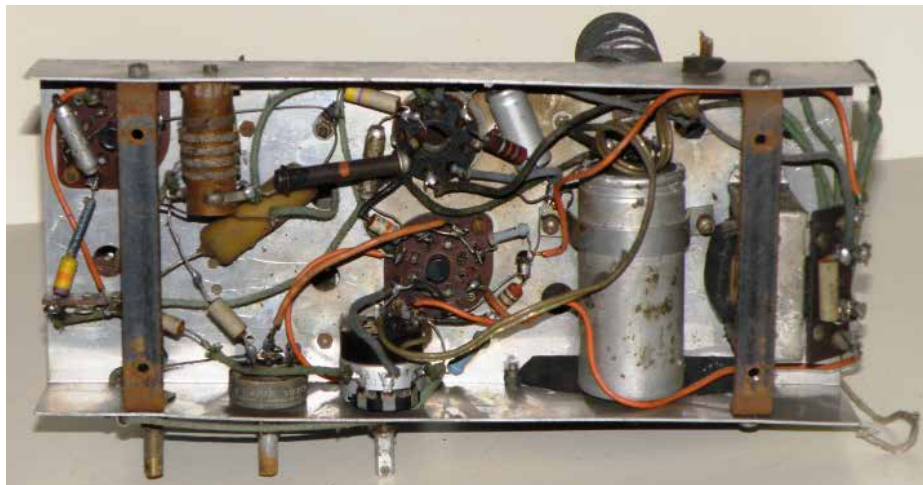
Figure 5: Under chassis view before restoration.

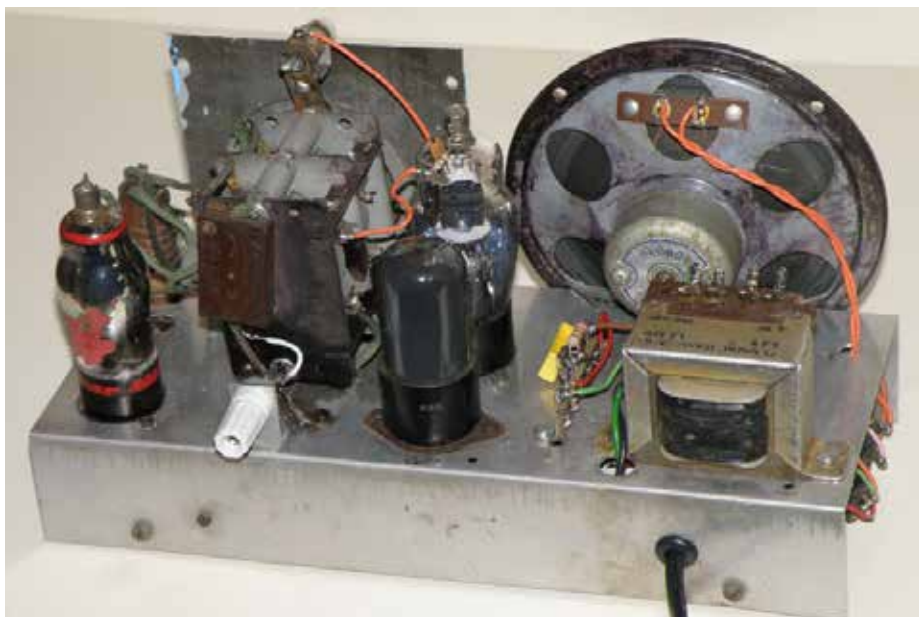
Figure 8: Rear view of the chassis after restoration. I hadn't replaced the screening can around the detector valve at this stage, and it didn't seem to suffer any instability. The new tag strip accommodating the new diode and series resistor, and the class X2 capacitor can be seen next to the new heater transformer. The original EF39, still without most of its red coating, works well enough to be left in the radio.

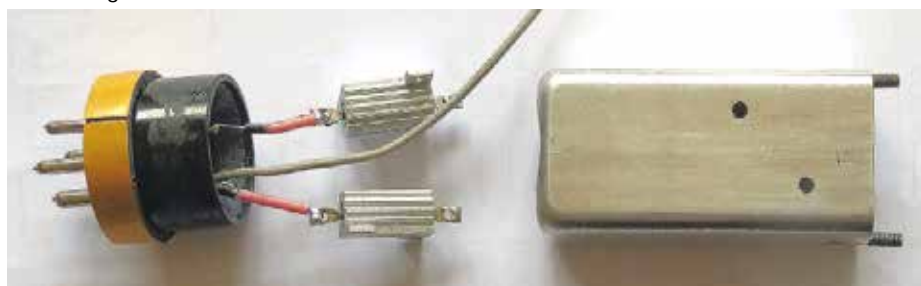
SS rectifier components

It's worth noting the plural when mentioning the electrolytics as the diodes will supply full voltage instantly and with no load, until the rest of the tubes warm up, that includes the smoothing capacitor often chosen with a lower

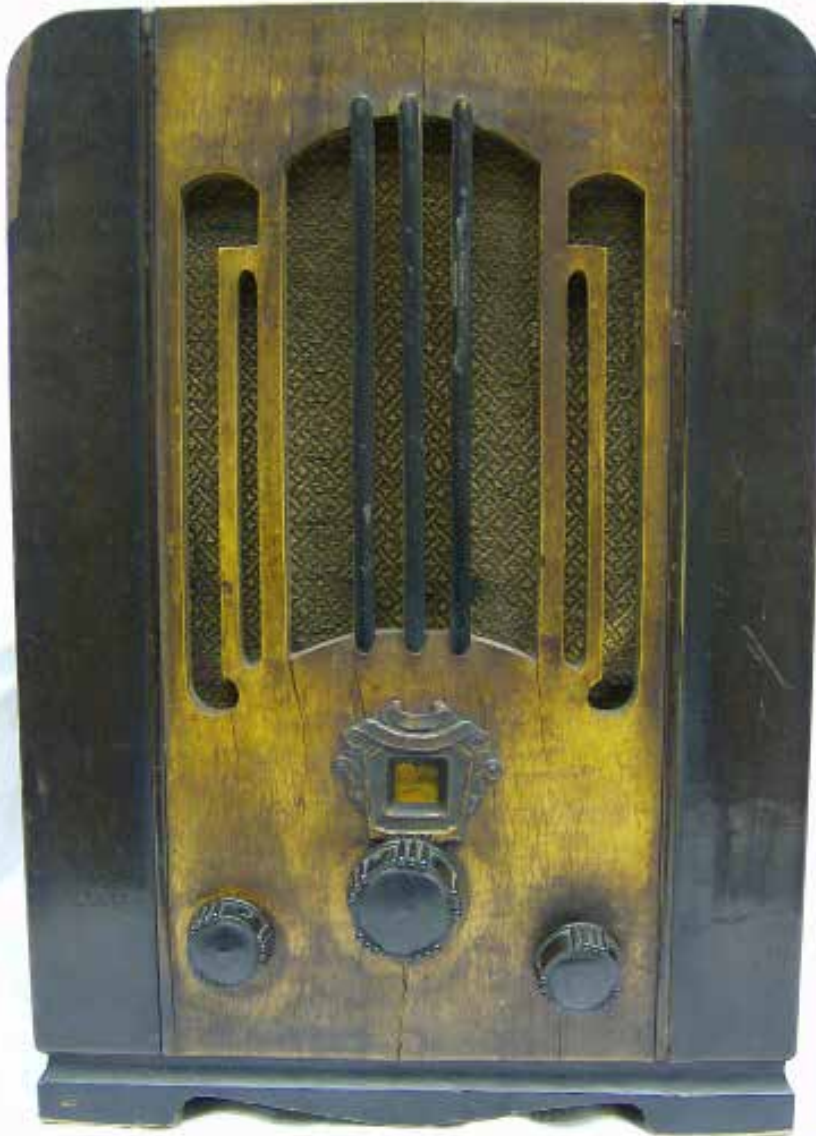
Figure 1 The radio before restoration.

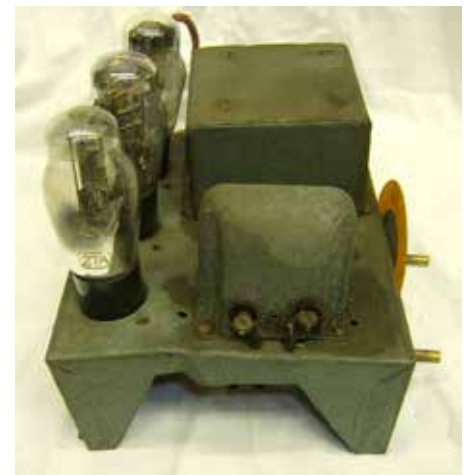
Figure 2 Unrestored chassis showing bent chassis.

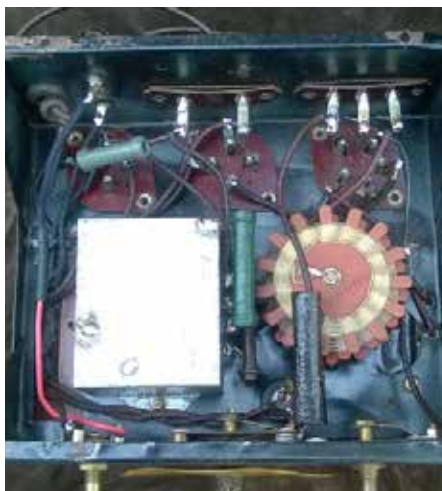
Figure 11 Underside of restored chassis.

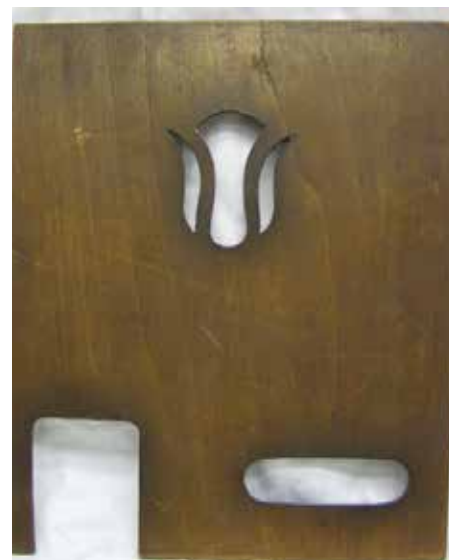
Figure 13 Detail of radio back cover.
