BRITISH VINTAGE WIRELESS SOCIETY  
= BULLETIN =

VOL 42 • WINTER 2017

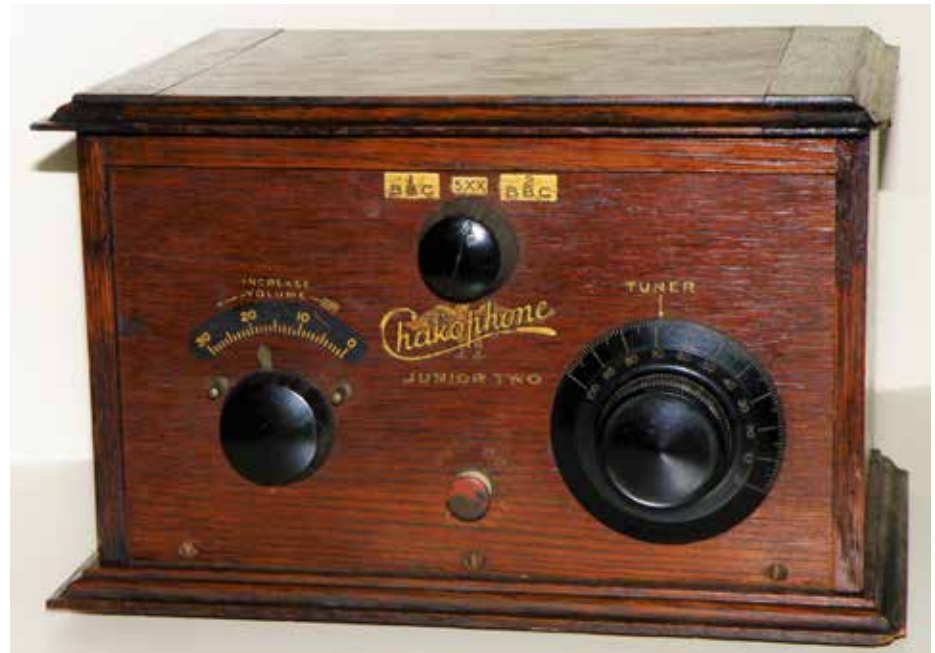
Figure 1: Front view of the radio, showing the excellent condition of the front panel. The lettering is pretty much complete, apart from the worn Pull On and Push Off decals above and below the on-off switch.

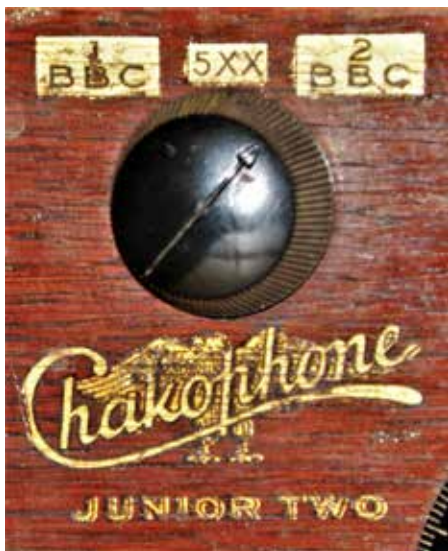
Figure 2: Close-up of the waveband switch and the 'Chakophone' branding on the front panel. Note the eagle behind the Chakophone lettering, presumably referencing the Eagle Engineering Company.

varied over the years is that selecting the 5XX position on my Junior Two would position the listener firmly in the Long Wave, and 5XX or its later incarnations would be found close to its original position on the tuner dial.

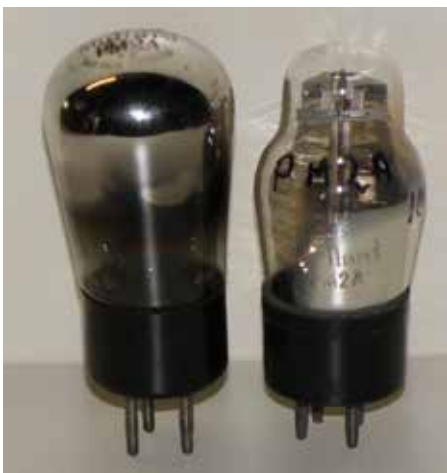
Figure 5: The two shapes of the PM2A as manufactured by Mullard. The left hand valve is the original balloon shape and on the right is the later, 1930s envelope style.

The balloon shape of the PM2A is well known, but what is less well known is that in the 1930s Mullard produced a version with a shape like the octal-based G envelopes then being manufactured. See Figure 5 for these two shapes of the PM2A, the right hand one was kindly supplied to me by Mike Lewis.

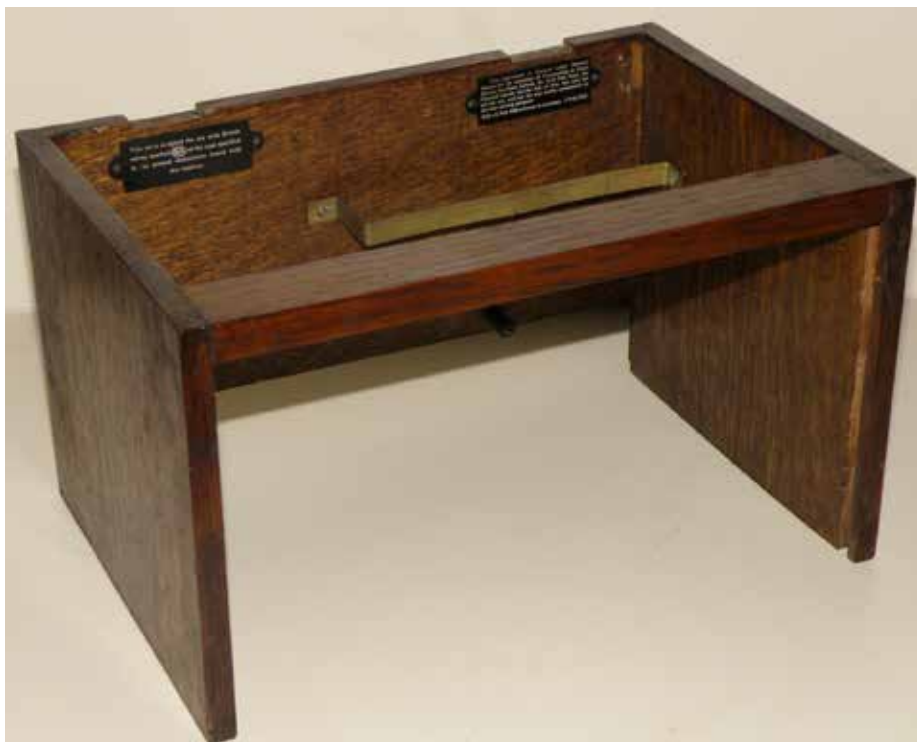
Figure 6: The cabinet, removed from the front panel and base board. The brass bracket holds the grid bias battery. The labels advise the user to use only BVA-manufactured valves, and that 'this instrument is licensed under Marconi Patents for the reception of broadcasting in Great Britain, Northern Ireland, the Irish Free State, the Channel Islands and the Isle of Man, but only for private use, and not for any public, commercial or revenue earning purposes' – you have been warned! It also reminds that a Post Office licence is necessary and mentions that it contains two valves. Did the cost of the licence depend on how many valves the radio used?

Mike Lewis kindly supplied me with a grid bias battery, an Ever Ready 'Winner' brand, which he had already gutted and installed six AA batteries. The batteries were rather tired and so I opened up the cardboard casing and changed them for fresh batteries, which was very easy because Mike's 'old' wiring was in perfect condition. I glued the joints together using Copydex, which should be easy to unpick when a new set of batteries is needed.

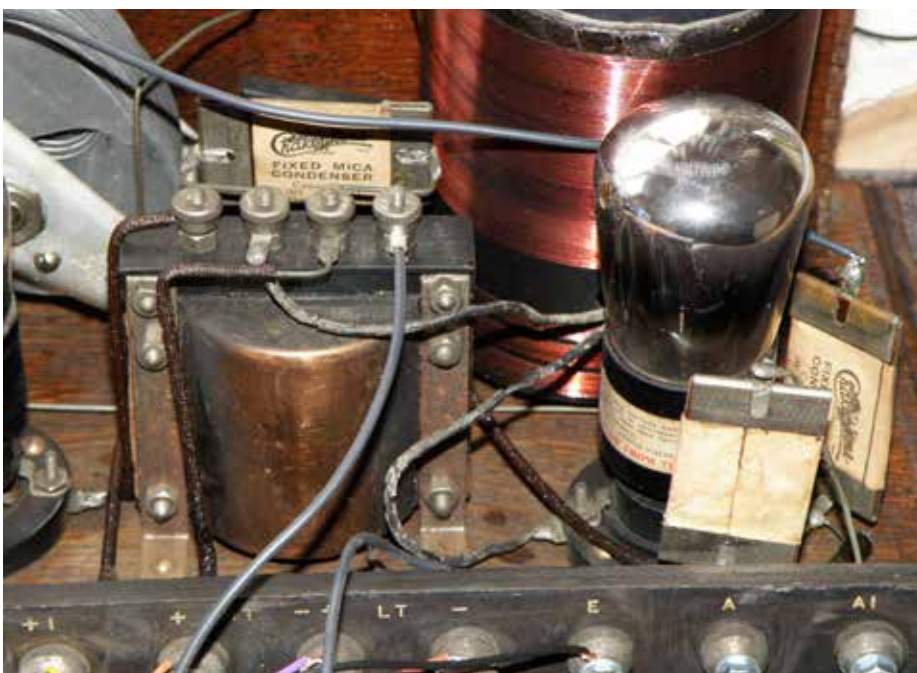
Figure 7: The audio coupling transformer, and the three mica capacitors - all with Chakophone branding and presumably produced locally at the Warwick location – and the PM1HF detector valve.

I could see three flat rectangular components and printed labels on them identified them as Chakophone-branded fixed mica capacitors. Their values were hand written onto the paper labels. A couple of these labels were loose so I carefully glued them back in place. Figure 7 shows these capacitors, along with the Chakophone audio coupling transformer and the PM1HF detector valve.

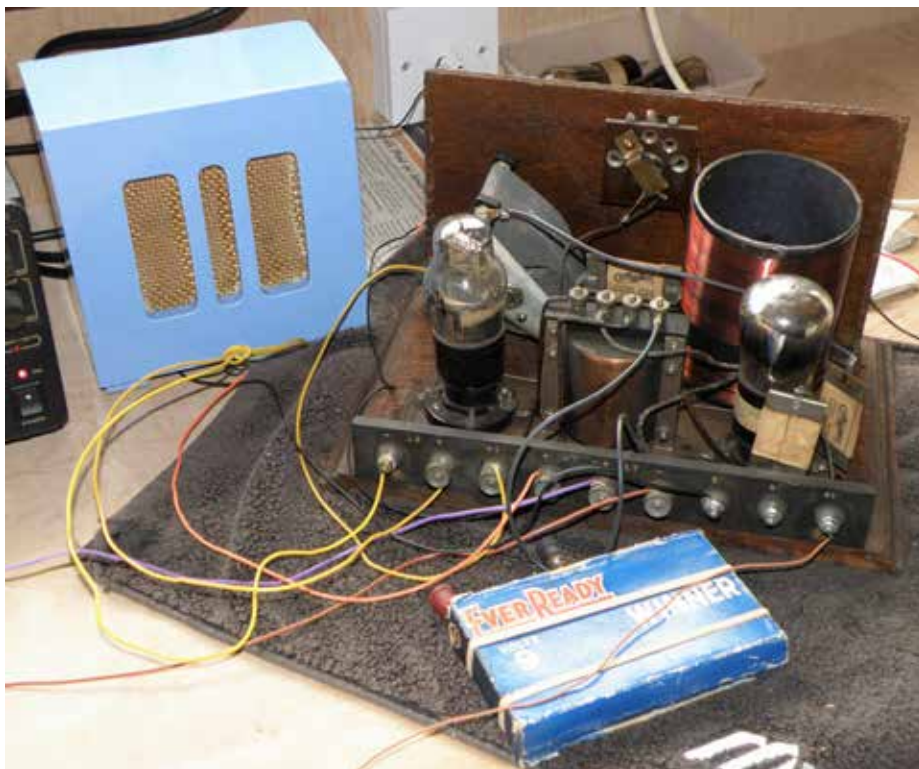
Figure 8: Rear view of the chassis, alongside my distinctly non-period loudspeaker. The connections to the Ever Ready Winner grid bias battery and the other power wiring can be seen.

Most of the terminals of the rear panel (see Figure 8) still retained their knurled nuts, but sadly four were missing. I checked the thread and substituted 4BA brass nuts, so they would have to do until I could find nuts that were closer to the originals.

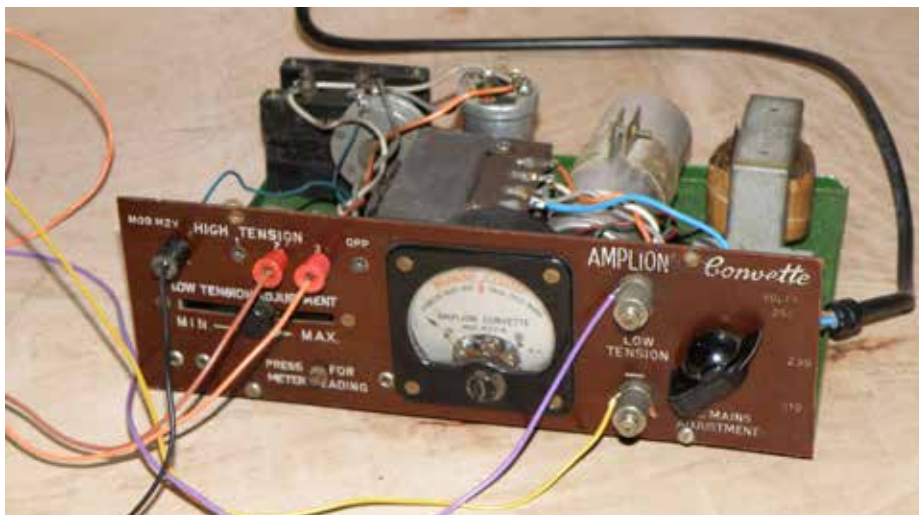
Figure 10: The front panel of the Amplion Convette model M2V mains power supply connected to my radio. The Low Tension Adjustment control adjusts the position of the slider on a 16Ω potentiometer.

I measured the output voltages with no load connected: the HT outputs were all at 98V (this was as expected as no current was being drawn through the series resistors which produce the various HT voltages) and the LT output could be adjusted between 1.6V and 3.5V. I connected an external 6.8Ω resistor to the LT output to emulate the 300mA load of the Junior Two, and adjusted the voltage to as close to 2V as I could get. I connected the Convette to the Junior Two, as shown in Figure 10, and switched on. The radio worked well and was hum-free. I measured the HT voltages being fed to the radio: HT+ was 62V and HT+1 was 76V. These seemed close enough to the ideal voltages needed to power the radio.

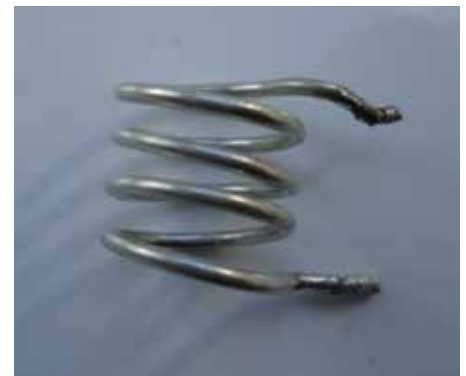
Figure 4: My tuning coil

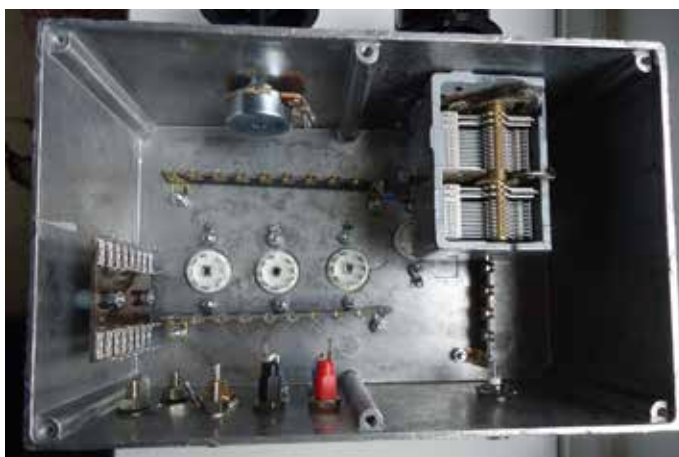
Figure 7: The various controls, sockets and tag strips loosely mounted

I then loosely fitted the various controls, tag strips and sockets on to the chassis to ensure there would be no nasty surprises later on. As a result of doing this I found the socket for the ECF80 valve needed to be re-orientated to keep the tuned circuit wiring as short as possible; the socket hole remained the same but I drilled two new fixing holes which allowed the socket to be rotated by approx 30 degrees. I also re-orientated the tag board for the discriminator and de-emphasis circuitry by rotating it through ninety degrees. With these changes made, I was satisfied that the intended layout was as good as I could make it. See Figure 7.

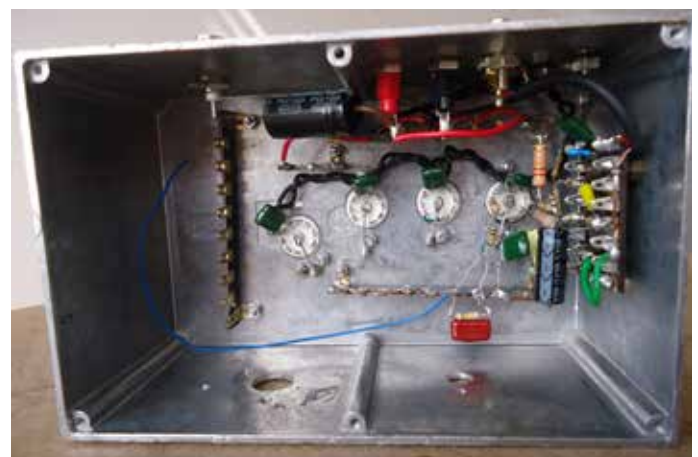
Figure 8: Discriminator tag strip in place and valve heaters wired up

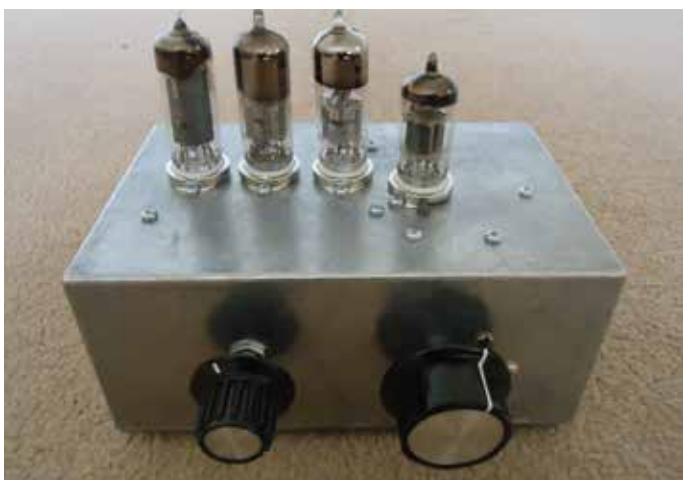
Figure 11: Front view of completed receiver

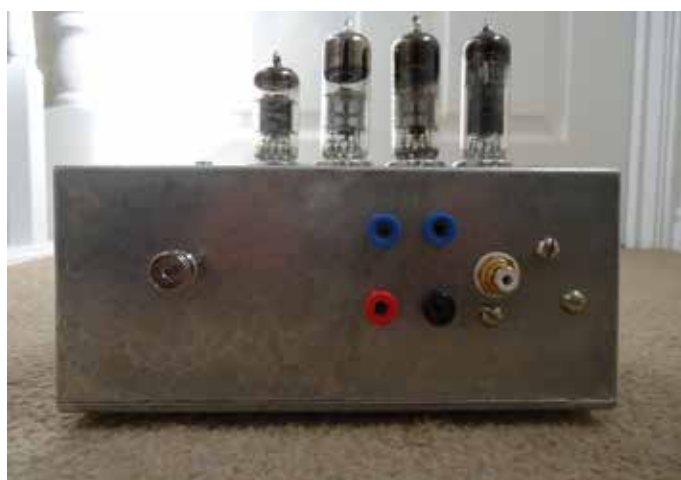
Figure 12: Rear view of completed receiver

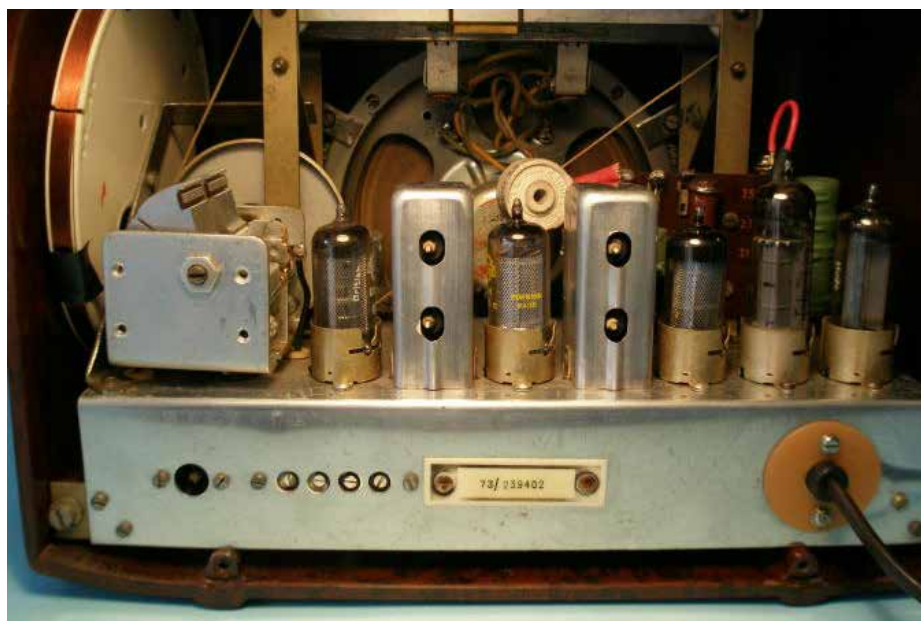
DAC number 1 - Restored chassis

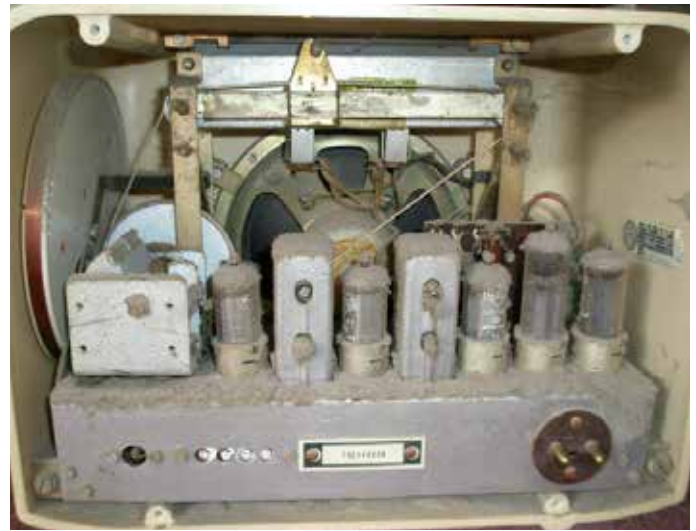
DAC number 3 - chassis as found

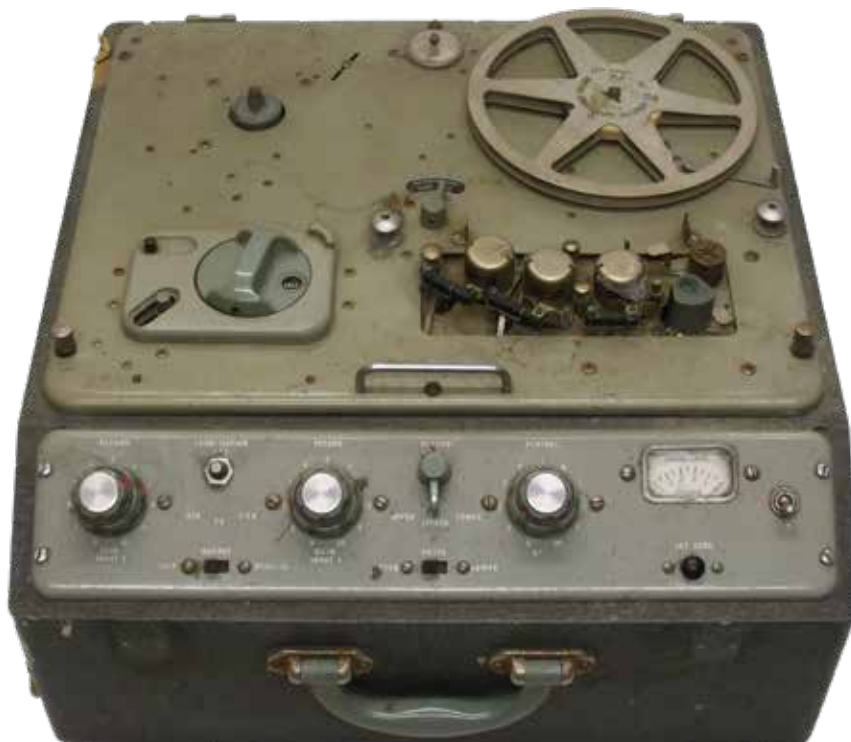
Fig 1 This image gives an indication of the general state of the machine when first found.

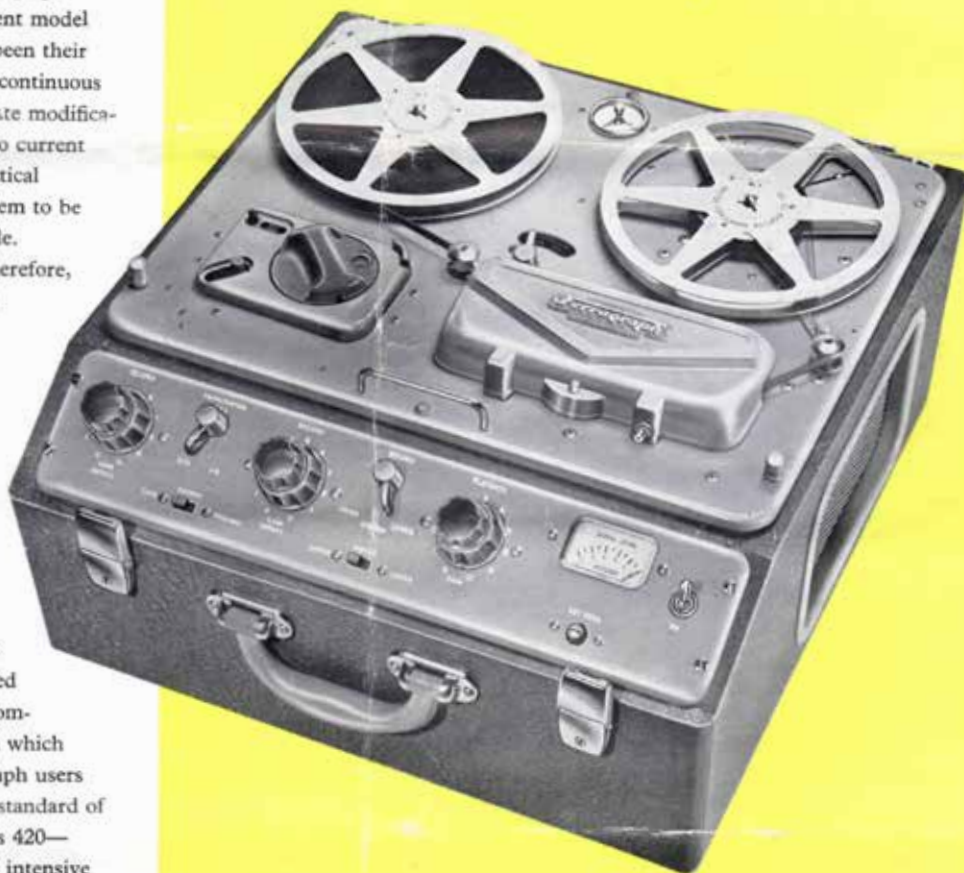
Fig 2 A rare glimpse of the very early version of the Series 420 can be seen in this Ferrograph leaflet before the equalisation switch was modified. The machine is also fitted with a different style of control knobs. It is unknown if any of these machines actually left the Simonside factory.

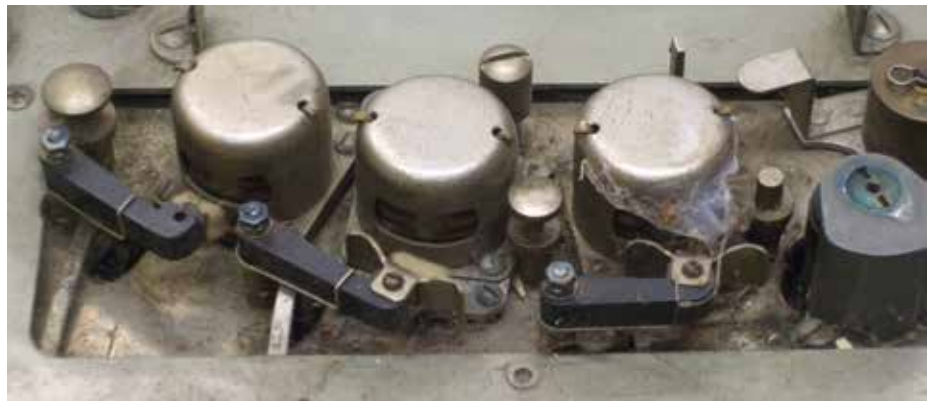
4 A wider view of the general state of the tape path area of the deck and the recently deceased livestock whose home had occupied most of the replay head.

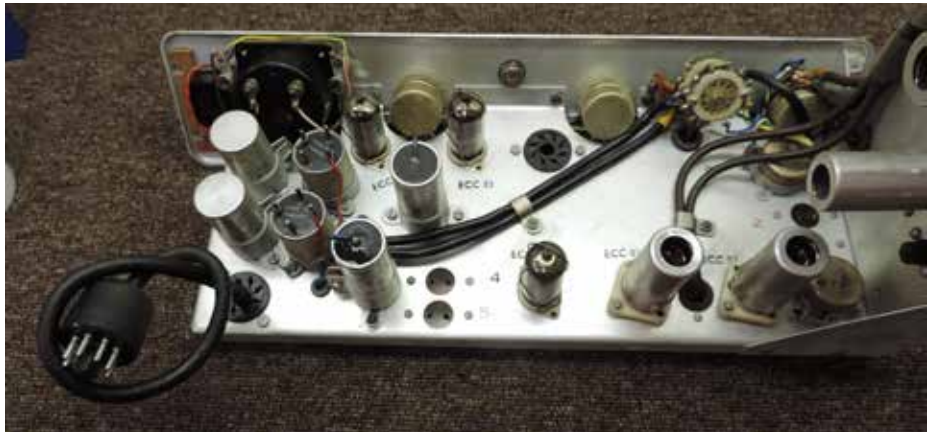
Fig 5 The general view of the front amplifier chassis showing the layout of the valves associated with the recording amplifiers and meter circuit. Note the sticky pool of electrolyte on top of the capacitor towards the lower left of the picture.

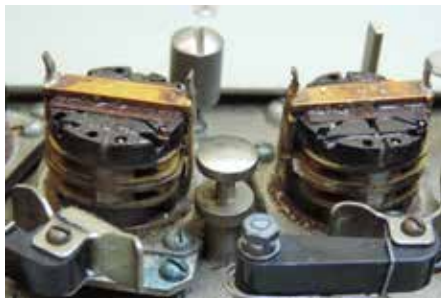
Fig 6 This view of the magnetic heads with their mu-metal shields removed shows just how much further tape oxide and general dirt was found.

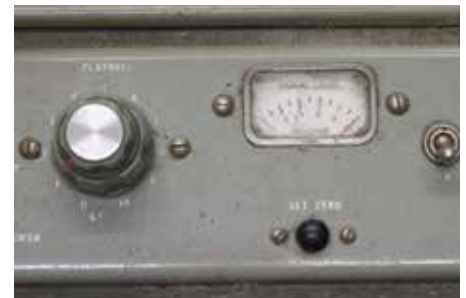
Fig 7 Yuk! What a mess. The screen printing will have to be cleaned very carefully to avoid removing what remains of it.

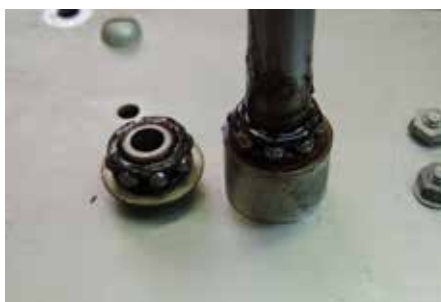
Fig 8 Treacle anyone? This is how the bearing races were found once the capstan had been completely disassembled.

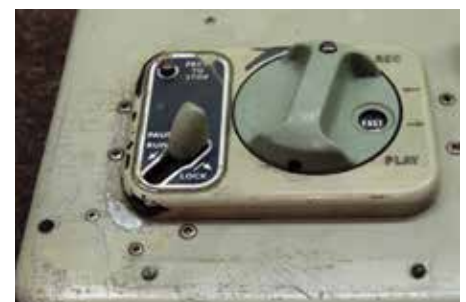
Fig 9 This view of the control knob area fitted on a later series of deck shows quite clearly the wear and tear generally inflicted upon it and the things to look for.

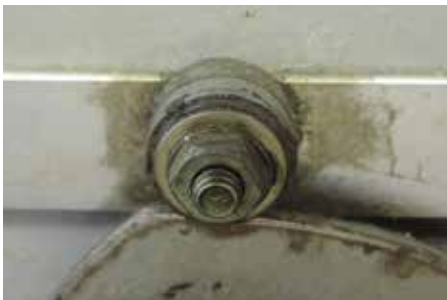
Fig 10 This shows one part of the assembly that needs to be cleaned and re-greased. Wear on this roller guide and the deck function cam can impede smooth operation of the deck

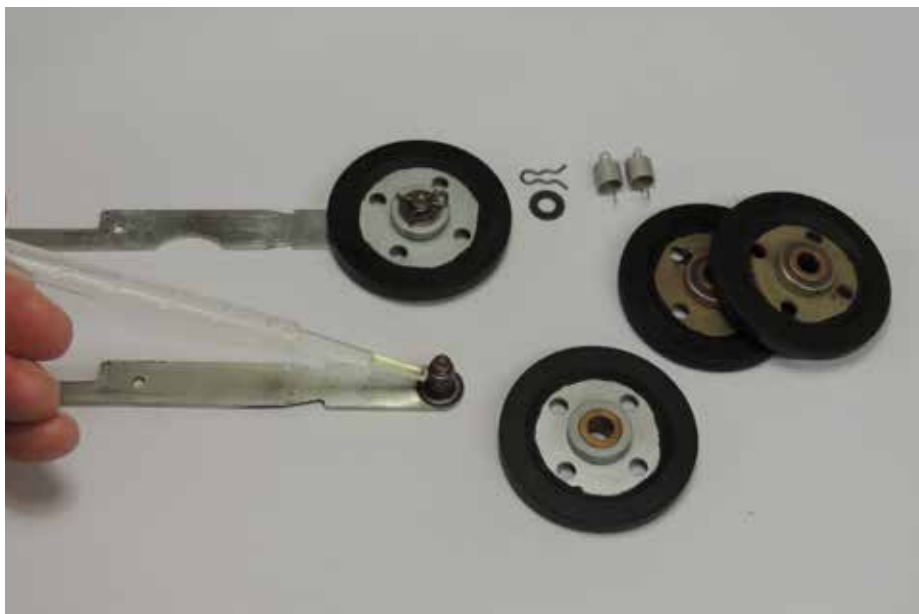
Fig 13 The two idler carriers ready for reassembly with new idler wheels also receiving a single drop of oil prior to reassembly.

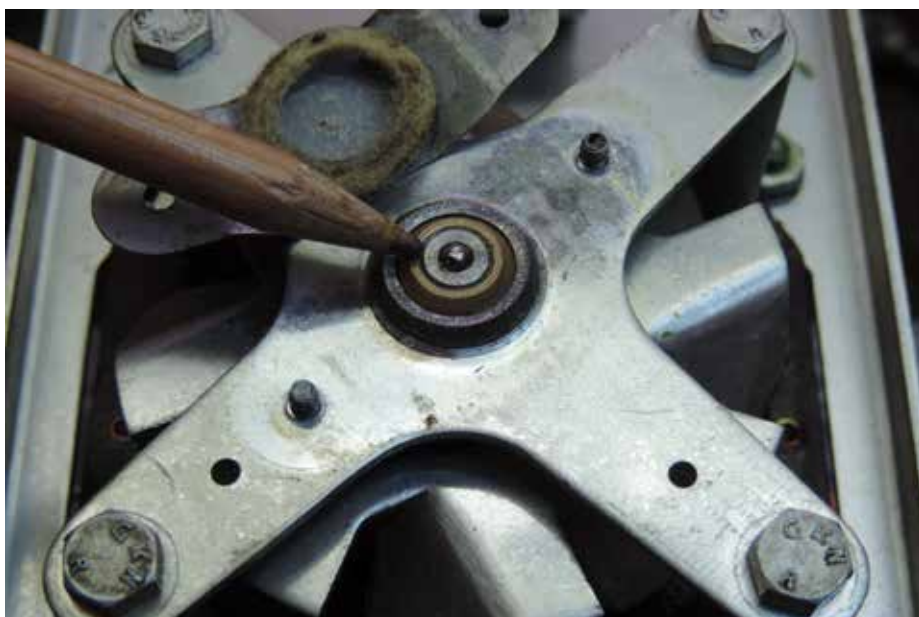
Fig 14 The bottom bearing of the capstan drive motor, this along with the take-up and rewind motors were disassembled, cleaned and re-lubricated

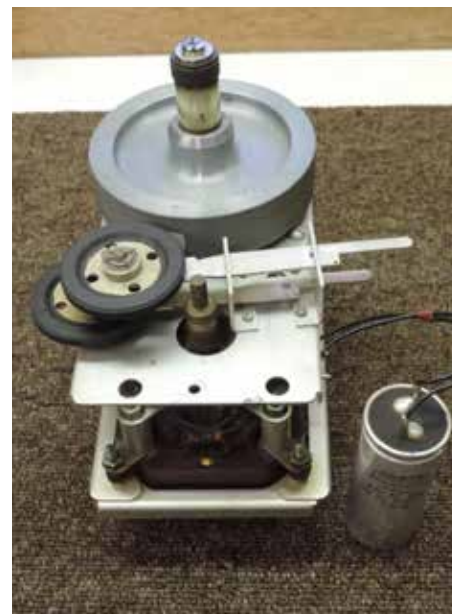
Fig 15 The restored capstan drive sub unit prior to re-assembly onto the main deck showing the relative positions of the idlers, capstan and motor.

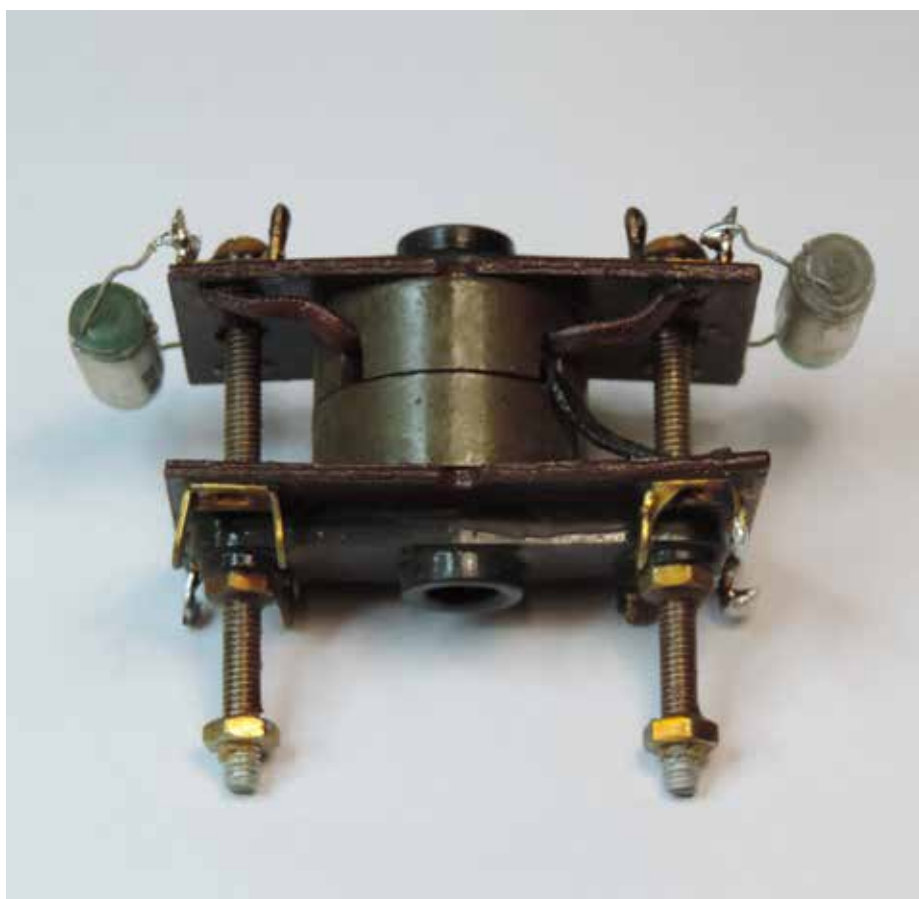
Fig 17 The defective bias/erase oscillator coil referred to in the text. It is very unusual for this component to fail in these machines; in fact almost unheard of.

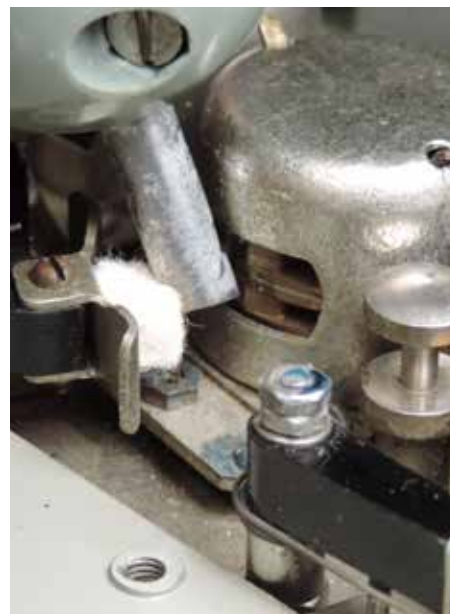
Fig 19 Demagnetising the record and replay heads along with the tape guides is an essential part of the maintenance regime.

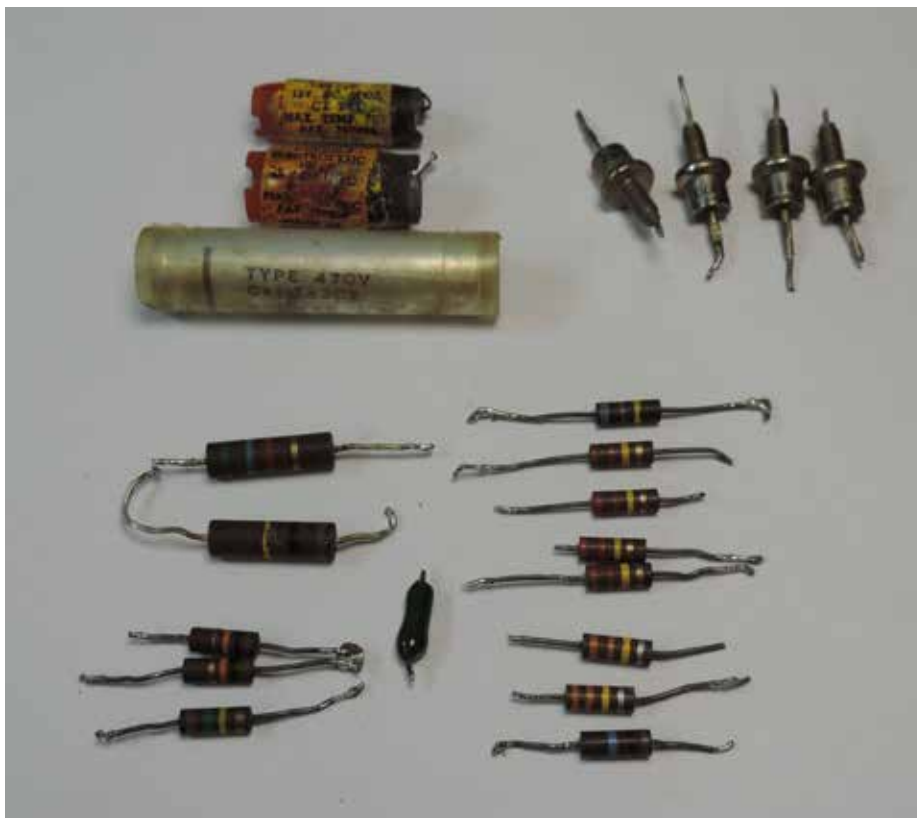
Fig 21 A small number of components were renewed in the Ferrograph mostly resistors associated with the amplifiers. The scorched capacitor (C48) can be seen at the back of the picture.

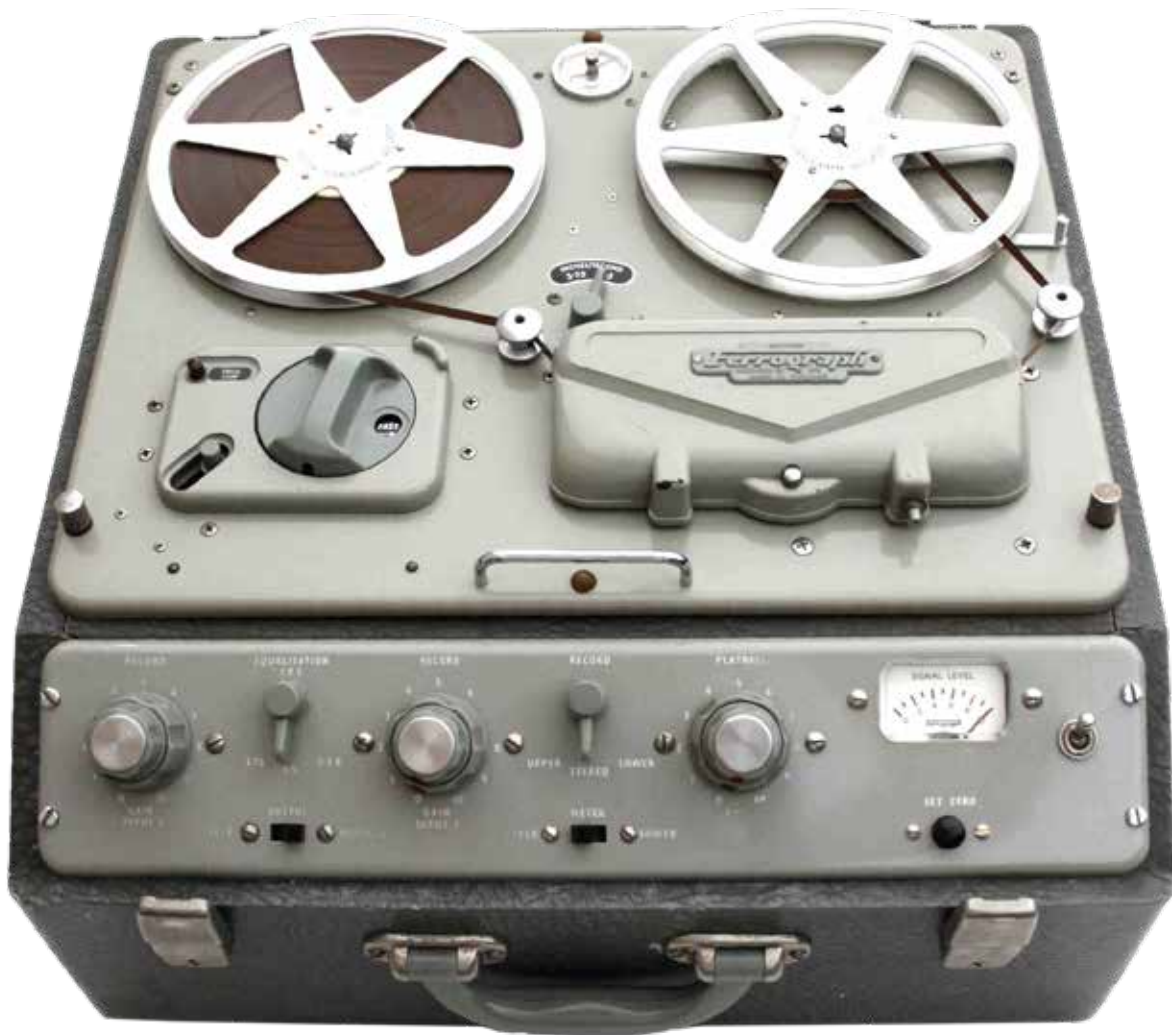
Fig 22 The restored Ferroglyph Series 420, ready to give many years of further service.

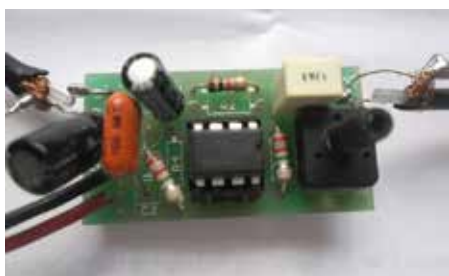
Figure 1

As the results from the Maplins kit, in the application I wanted to use it in, were so poor, I sought Forum advice and adapted it as shown in Figs. 1 and 2. After sorting power supply issues, the revised circuit as shown by Fig 3, was built on a scrap piece of Veroboard as in Fig 4.

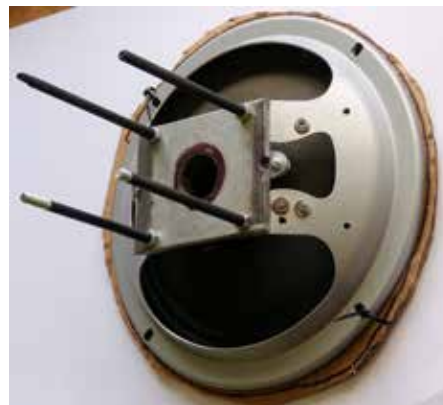
Speaker with assembly studs

For re-assembly what was needed was a way of putting back the field magnet without buckling the edge of the voice coil. The solution (see picture) was to use

pieces of 5 mm studding covered with heat shrink tubing for a snug fit in the holes of the magnet. Of course M5 was not the thread in the speaker but a few turns went in before binding and allowed enough torque to lightly tighten down nuts. A few dummy runs at inserting the magnet were made without the field coil as with it not much can be seen. Finally, it was carefully lowered into place with it for a successful result.

Then it was strip the output transformer and field and rewind them. Whilst the field and magnet were off, the speaker frame was de-rusted and then spray painted after filling all the frame openings to the cone, with soft tissue.

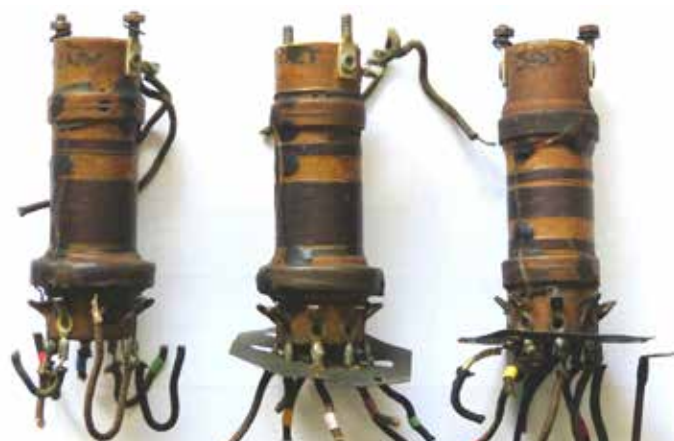
Antenna, bandpass and oscillator coils

new coils for these added at the top of the stack. Just a few turns and micro henries are needed with the 450pF tuning capacitor used.

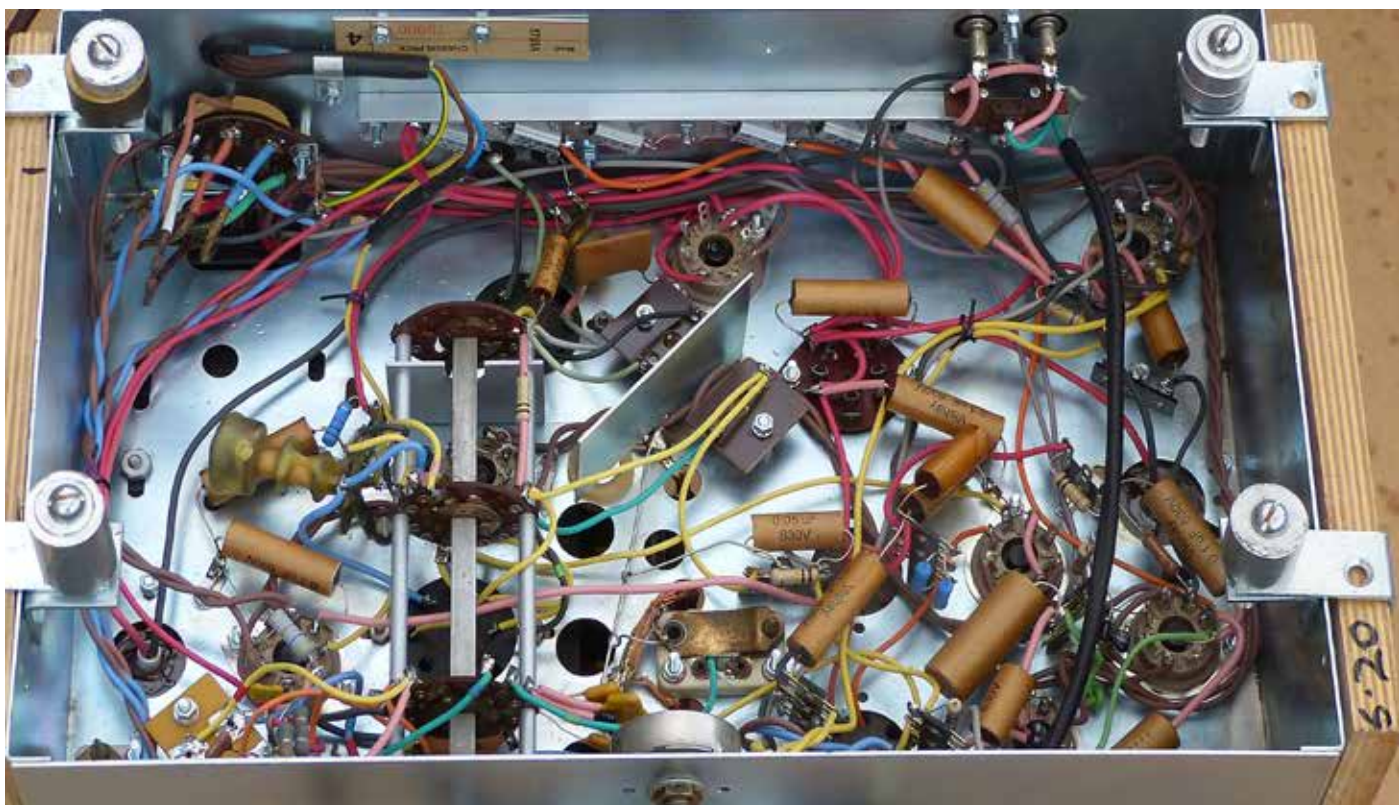
After rebuilding

Then it was a rebuild of the chassis with replacement passive components, the new poly capacitors are housed in styrene tube and covered with PC generated labels, on new mainly vertical tag strips, as used originally, but with more tags. These had been so minimal that up to 8 components and wires could be on one tag and even the band switch had as many as 6. It was far easier to use new valve bases than trying to clean up the old ones.

The Candohm wire wound resistor string, with one section open circuit, was remade with metal clad 10W resistors on an aluminium T section strip. Of course they didn't all need to be this wattage but I wanted to keep the layout roughly the same and the resistors fit in the same space and come with their own tag strip connections. It is a very neat replacement idea.

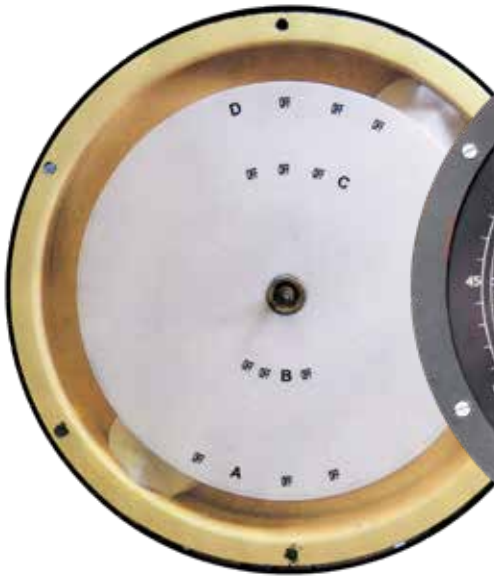
New inner dial

Unfortunately the inner dial, that identifies which waveband is in use, was badly warped and the letters worn.

As usual, I used Papilio decal material

(USA), which is the strongest and has the best adhesion of any that I have tried. After pull off tests on scrap material I found it slightly better to prime the disc with Zinsser Spray Shellac after having randomly flatted the plastic with 600 grit carbide paper. With or without the shellac, in flex tests, through both right angles, there was no sign of the decal material coming away. The front side decal added a slight curl to the disc and so I added a plain decal to the rear which made it perfectly flat again. Finally the decals, deliberately cut a couple of mm smaller in diameter, were sprayed with a sealing coat of matt lacquer.

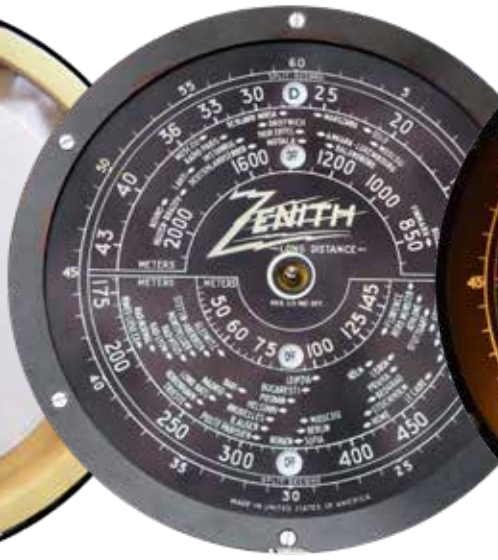
Dial and support ring

Failure to do this distorts the disc as the shaft expands as it is peened, using the ball end of a small hammer, with pressure from a vice.

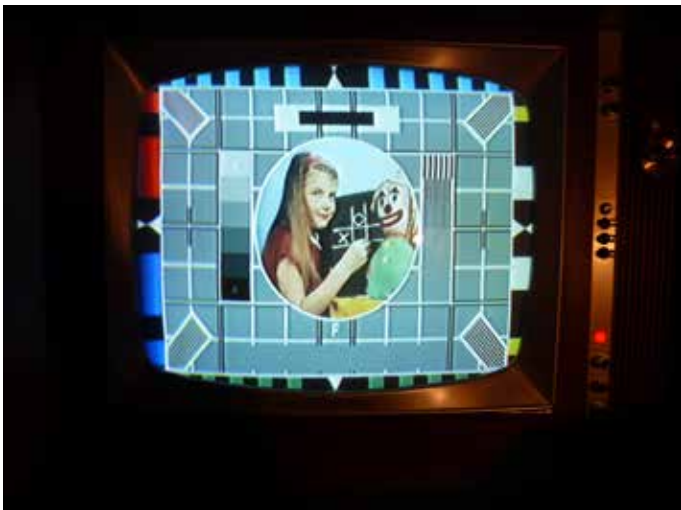
Fig 1: A colour Test Card on a 1967 GEC hybrid . Note the colour patterning in the middle of the frequency bars on the right. This is due to the 4.43 colour sub-carrier falling within the luminance pass-band and is a limitation of the PAL and NTSC systems. The red light on the right comes on to indicate you are receiving a colour picture!

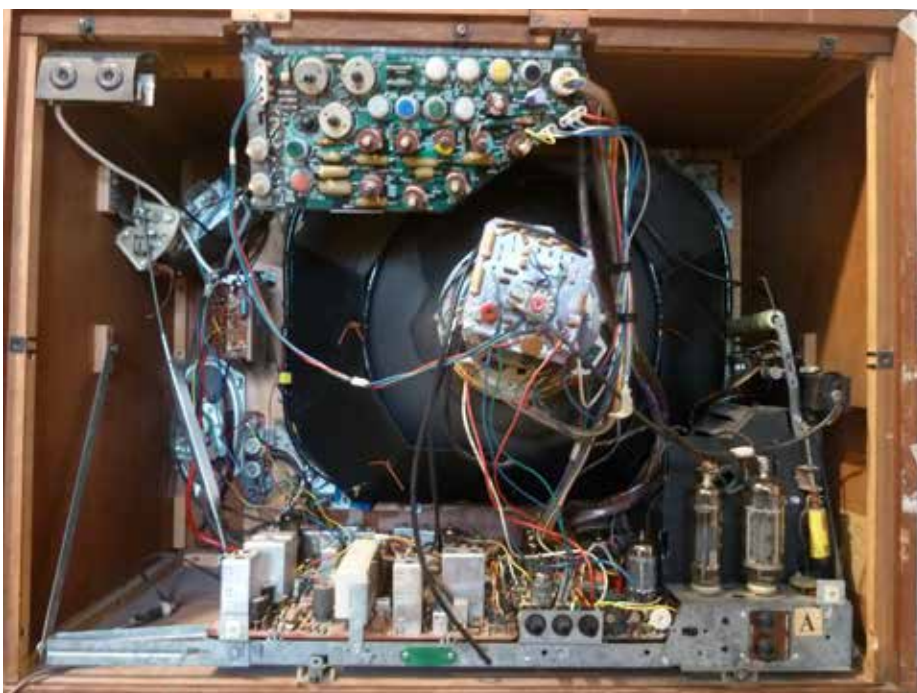
Fig 3: Inside the GEC. A total of 10 valves. The slanting vertical bar on the top left operates a system switch running along the front length of the chassis. The line output is on the right- but no tall 'smokestack' as the set uses an EHT tripler. The chassis hinges upwards to give access to the 'print' side. The convergence panel at the top hinges up and forward for adjustment while viewing the screen.

line stage when the screening was removed. Several manufacturers (including Thorn) went for a much more reliable 8Kv transformer with solid state EHT multiplier and usually no further stabilisation. All sets had some kind of protective 'beam limiting' device designed to reduce picture brightness, and hence EHT load, if for any reason this exceeded a pre-set level (around 1 mA). Two other variations from standard monochrome practice of the time were AFC on UHF, and DC restoration/black level clamping; correct colour rendition required precise tuning of the 4.43 Mhz colour sub-carrier and accurate black levels. These sets came out a couple of years before any integrated circuits for TV use. They were built entirely of discrete components and so in servicing terms represented the most complex domestic electronic device produced to date. They also produced a step change in service engineering skills required (Fig 3). Reliability

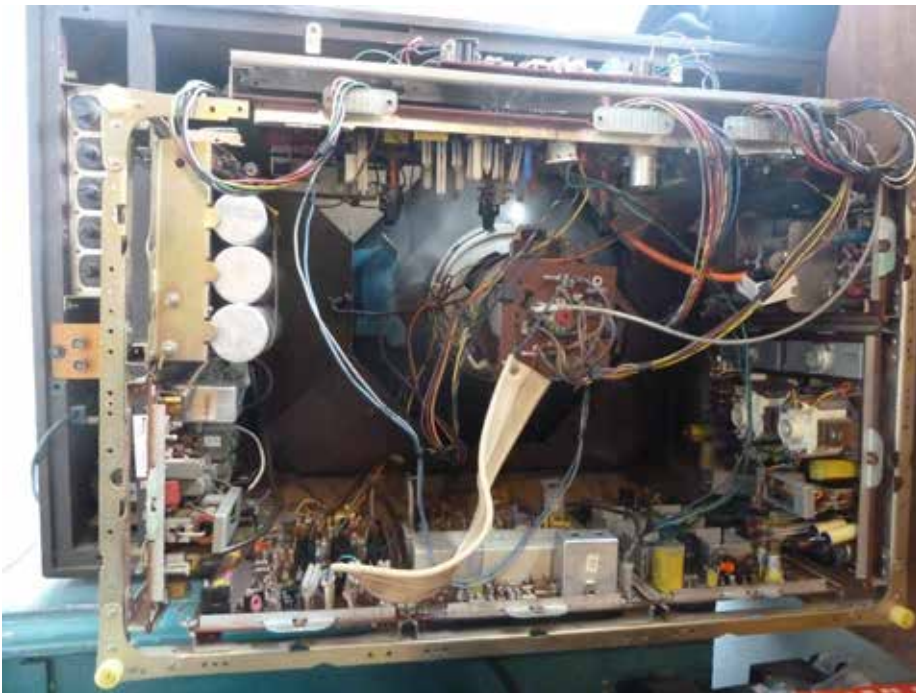
Fig 4: The 2000 showing chassis pulled back for service. The two line output transformers and the EHT transformer are visible on the right. The large mains transformer is concealed in the front of the cabinet on the other side. The largish grey block bottom centre is the PAL delay line. The convergence adjustment panel, inverted at the top, slides out and can be mounted on the top of the cabinet for adjustment from the front.

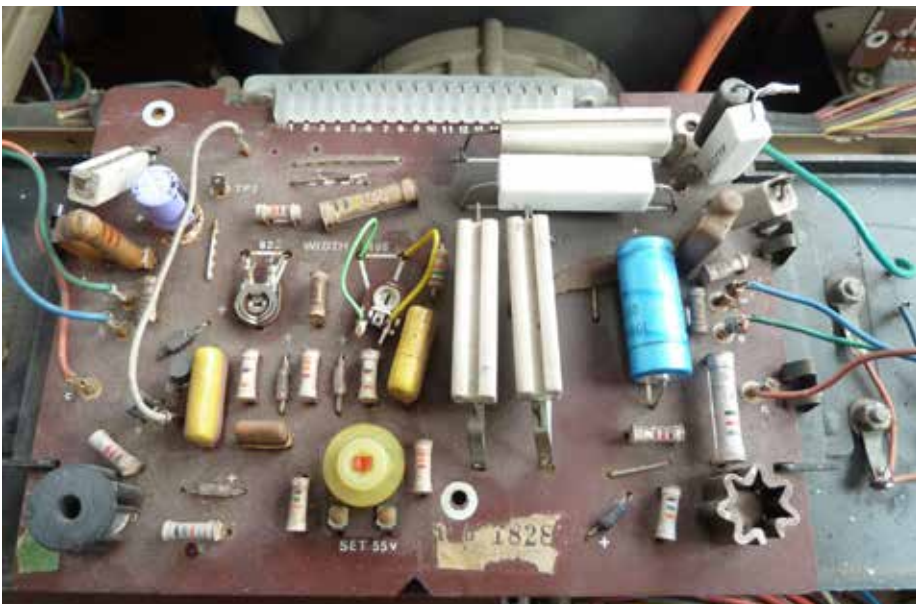
Fig 5: The main power regulator board

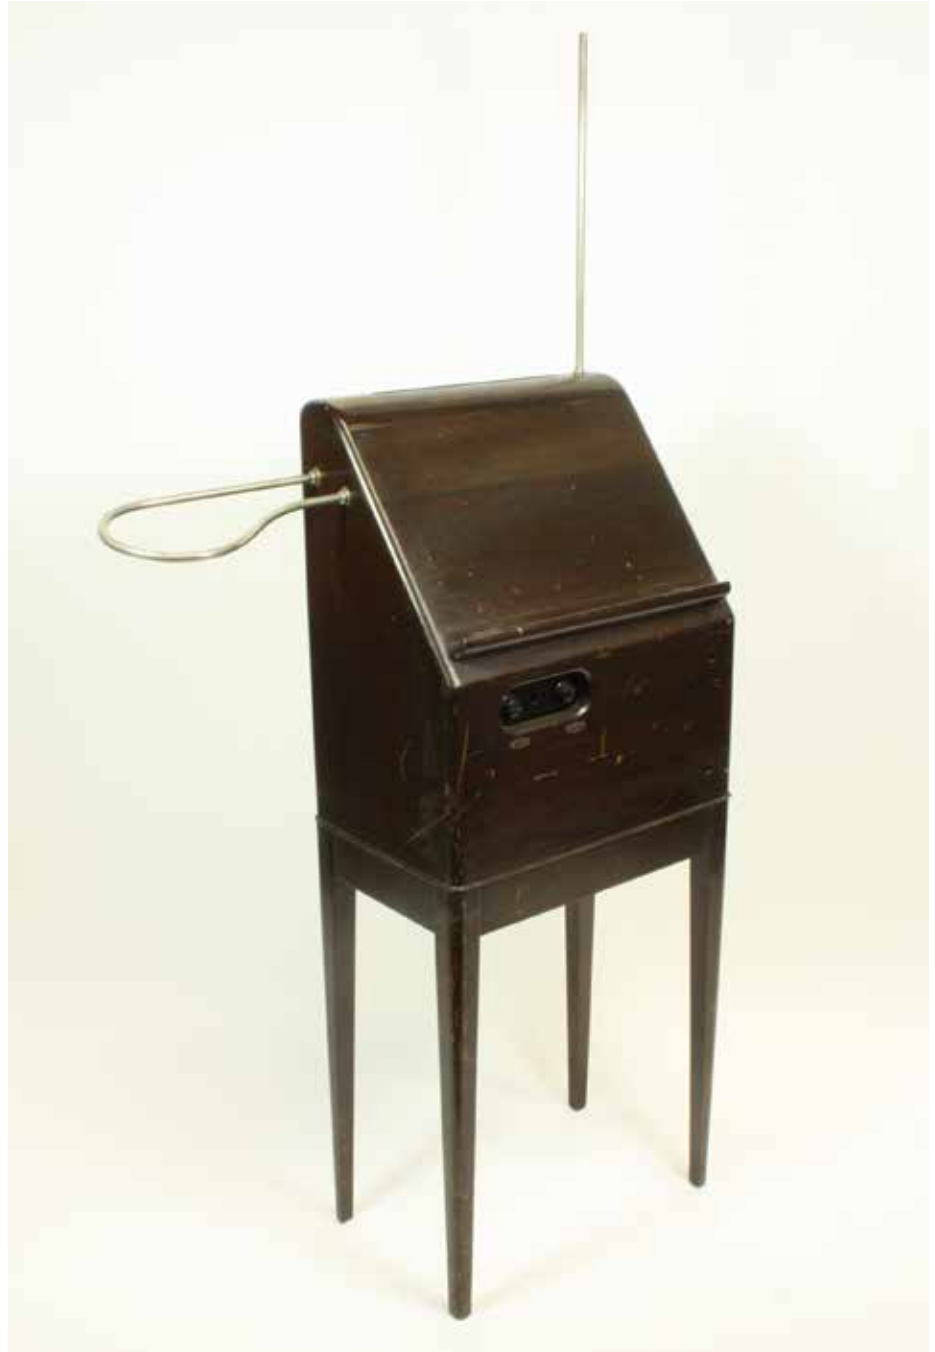
The Theremin comprises two metal antennas which act as plates of a variable capacitor. In the case of the RCA Model AR-1264 Theremin, the pitch control antenna is a vertical rod and the volume control antenna is a horizontal loop. The Theremin uses the heterodyne principle to generate an audio signal. The instrument's pitch circuitry includes two RF oscillators set below 500 kHz to minimize radio interference. One oscillator operates at a fixed frequency. The frequency of the other oscillator is controlled by the performer's distance from the pitch control antenna. The performer's hand acts as the grounded plate of a variable capacitor in an L-C circuit. The fixed and variable frequencies 'beat' against each other to produce the audio frequency. To control

RCA AR 1264 Theremin S/N 200052, Cabinet viewed from performer's side

volume, the performer's other hand acts as the grounded plate of another variable capacitor.
