BRITISH VINTAGE WIRELESS SOCIETY  
= BULLETIN =

VOL 42 • WINTER 2017

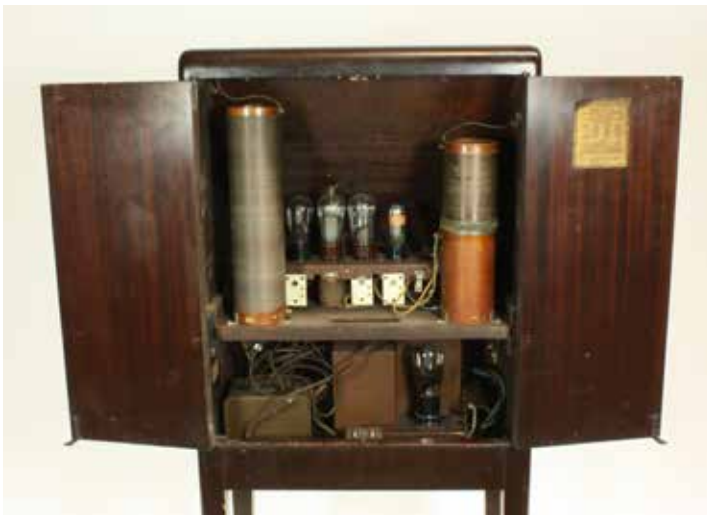
The power supply carries a single UX-280 full wave rectifier valve.

RF chassis (above) and power chassis (below) with 240 to 110V transformer on left.

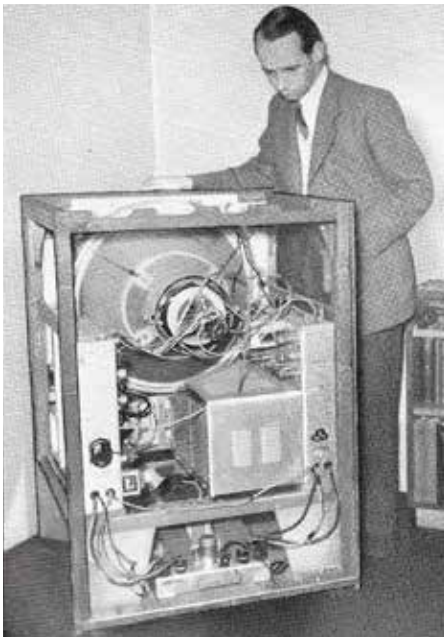
Figure 6 Colour from the inside
